Railroad Investigation Report: RIR-24-03

# Union Pacific Railroad Employee Fatality

El Paso, Texas  
August 29, 2022

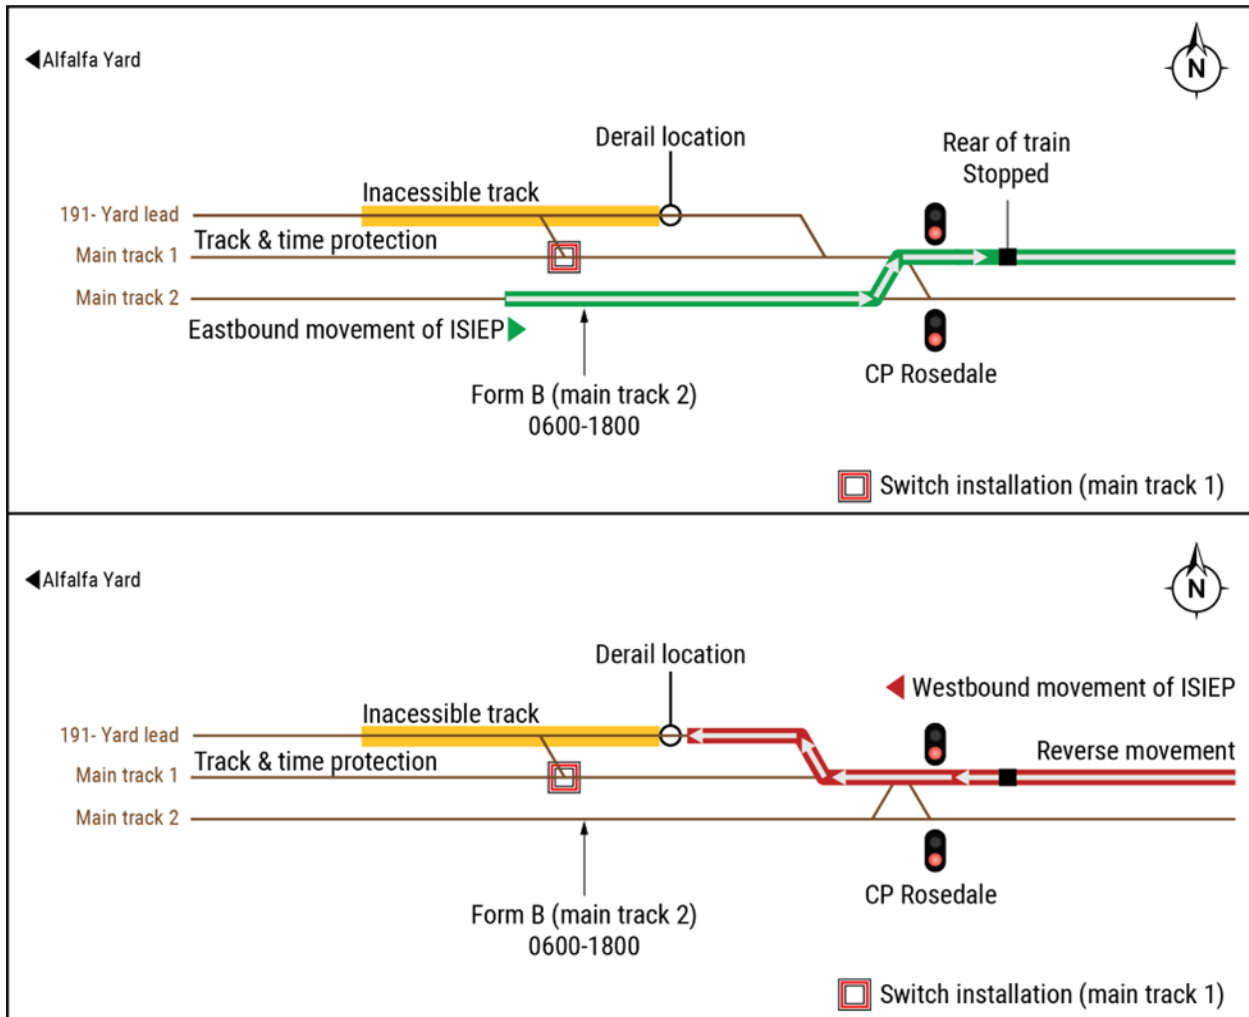
About 9:14 p.m., railcar 1 contacted the derail and derailed. The train's emergency braking application was activated as a result of the derailment.<sup>6</sup> Railcar 1 derailed and overturned on its side to the north, and into the backyard of a residence where it contacted a natural gas line. (See figure 2.)

**Figure 2.** Main tracks 1 and 2 in Alfalfa Yard.

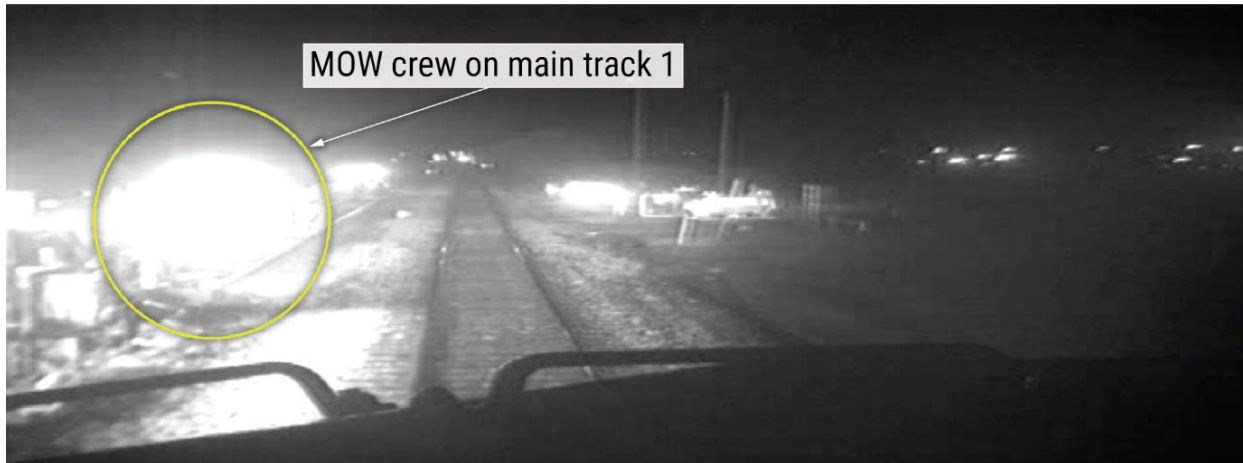
Upon arriving at Alfalfa Yard, the UP dispatcher routed the train from main track 2 through a set of switches at CP Rosedale, located at milepost 820, onto main track 1.<sup>11</sup> Before arriving at CP Rosedale, the train passed main track 1 where the MOW employees were installing a new switch to control yard access. (See figure 3.)

**Figure 3.** Train ISIEP 29 passing the MOW employees.

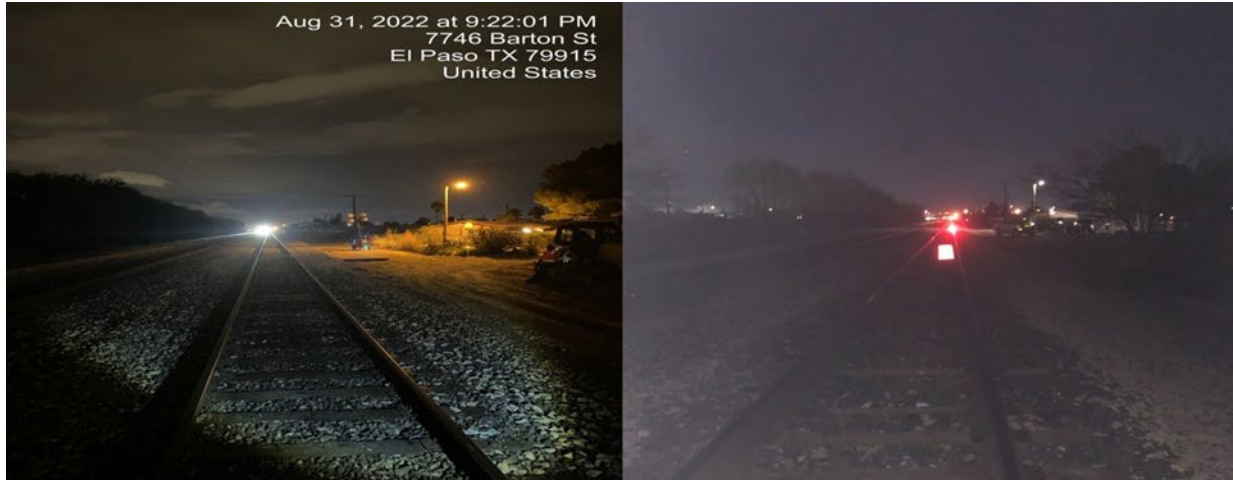
**Figure 5.** Derail with a sign on the night of the accident (left), derail with the reflectorized flag and red light after rule changes (right). (Left image: courtesy of UP; right image: courtesy of the International Association of Sheet Metal, Air, Rail and Transportation Workers.)

After the accident, UP updated the Chief Engineering Instructions Bulletin - Rule 136.4.2: Inaccessible Track, by System General Order on September 26, 2022.<sup>22</sup> Updates included requiring the use of a red reflectorized flag 150 feet in advance of the placement of a portable derail and requiring the placement of a red light at night when a portable derail is installed and the track made inaccessible.

The NTSB requested UP to provide an exemplar display of the placement of a portable derail using the new instructions provided in UP's engineering bulletin. Figure 5

shows a comparison of the placement of the derail and illumination at the time of the accident and after changes were made to the Chief Engineering Instructions Bulletin.
