Railroad Investigation Report: RIR-24-04

Port Authority Transit Corporation Train Strikes Two Subcontractor Employees

Camden, New Jersey
October 14, 2022

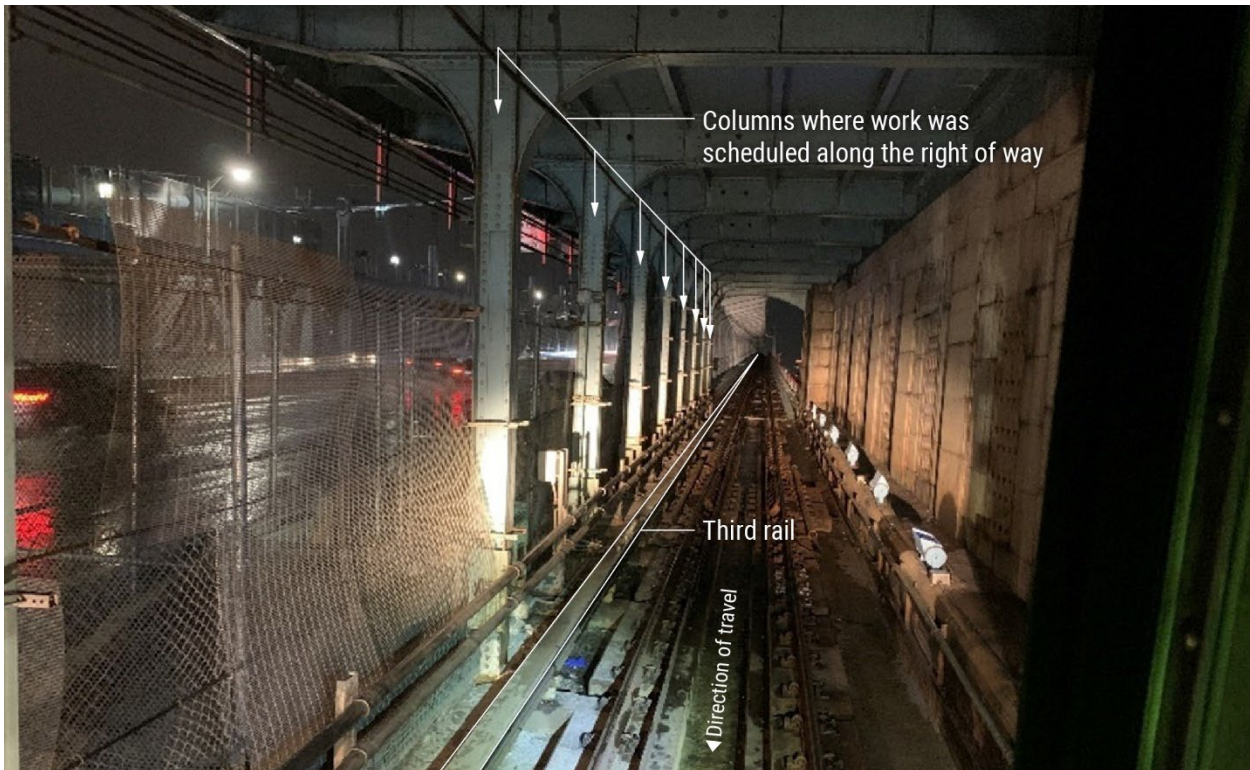
Figure 2. Photograph of Main Track 2, facing west, where the subcontractor employees were struck by PATCO train Westbound #1.

On the night of the accident, the subcontractor JPC Group employees met for a preshift meeting, including a job briefing, at 8:30 p.m. There were five employees in attendance, including the JPC Group supervisor. A Skanska Koch superintendent conducted a job hazard analysis with JPC Group employees. According to interviews the NTSB conducted with surviving attendees of the preshift meeting, the job briefing included work tasks and other safety points; however, it did not include ROW information, despite it being required as part of PATCO's ROW Safety Plan.⁸ According to interviews, JPC Group subcontractor employees and a supervisor went to their work staging yard following the job briefing to get materials. The group departed in two vehicles to the bridge work areas. One vehicle had two JPC Group subcontractor employees that would be working in the ROW where the accident occurred, and the other vehicle had the JPC Group supervisor and the remaining employees that were working in a different work area—a pedestrian sidewalk not on the ROW. The two subcontractor employees that were assigned to work the site near the ROW were tasked with putting new caulking on 11 columns that were located next to the tracks. (See figure 2.) This was their third night working in this work area.
