Railroad Investigation Report RIR-24-05

Norfolk Southern Railway Derailment and Hazardous Materials Release

East Palestine, Ohio
February 3, 2023

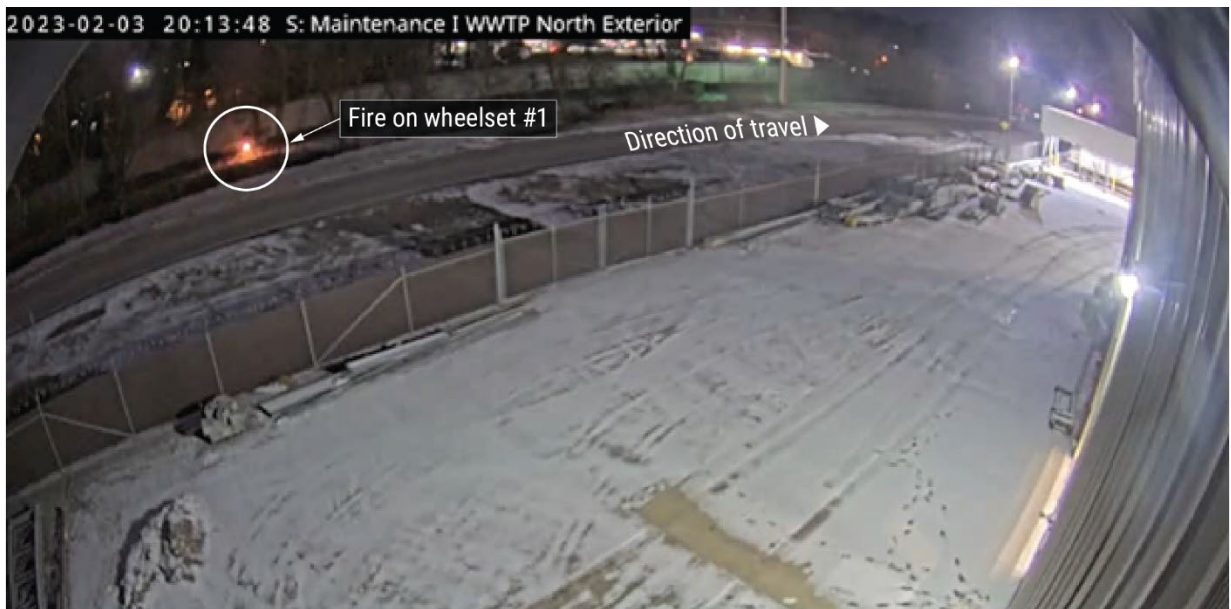
Between 8:11 p.m. and 8:14 p.m., train 32N passed four surveillance cameras in Salem, Ohio, that recorded images of the train. The images showed a fire on wheelset #1 of the hopper car. (See figure 5 for an image from a surveillance camera positioned on South Lincoln Avenue.) The images did not show signs of fire on other railcars.

Figure 5. Fire on wheelset #1 of the hopper car passing through Salem, Ohio.

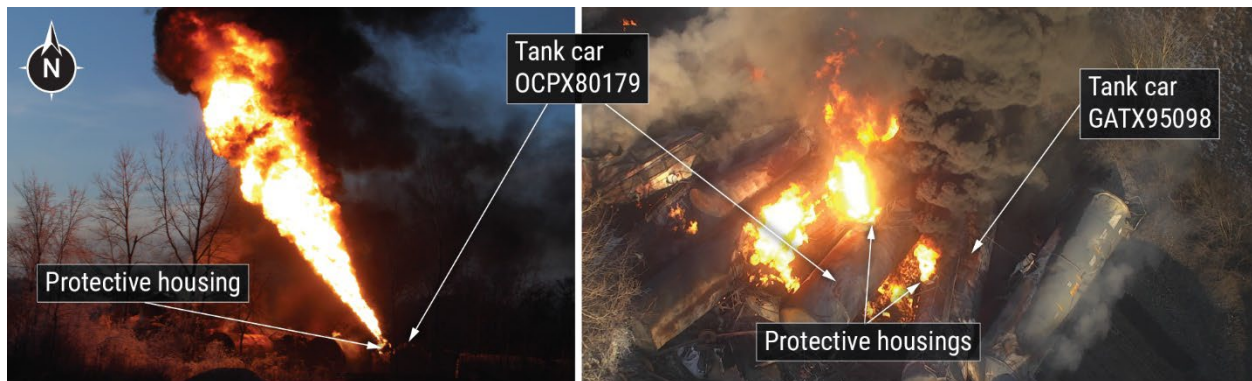
The first PRD actuation on a VCM tank car occurred shortly after midnight on February 4. A PRD actuates when the pressure inside a tank reaches the PRD's start-to-discharge pressure—a pressure high enough to open a valve held closed by a spring. The PRD opens until the tank's pressure falls low enough for the valve to re-close. A PRD on a tank car exposed to a pool fire will typically go through this cycle multiple times. PRD cycling continued for the four fire-exposed VCM tank cars until midafternoon on February 4, when the pool fires near four of the tanks had largely subsided. After 1.5-2 hours without visible PRD activity, the PRD on tank car OCPX80179 actuated about 5:30 p.m. and vented continuously for about 70 minutes. This venting was more energetic than other PRD actuations on the VCM tank cars. (See figure 8 for a comparison.) The PRD on tank car OCPX80179 eventually re-closed and did not actuate again. NS and contractor personnel did not observe any further PRD activity from the VCM tank cars.

Figure 8. PRDs venting material energetically (left) and more typically (right).

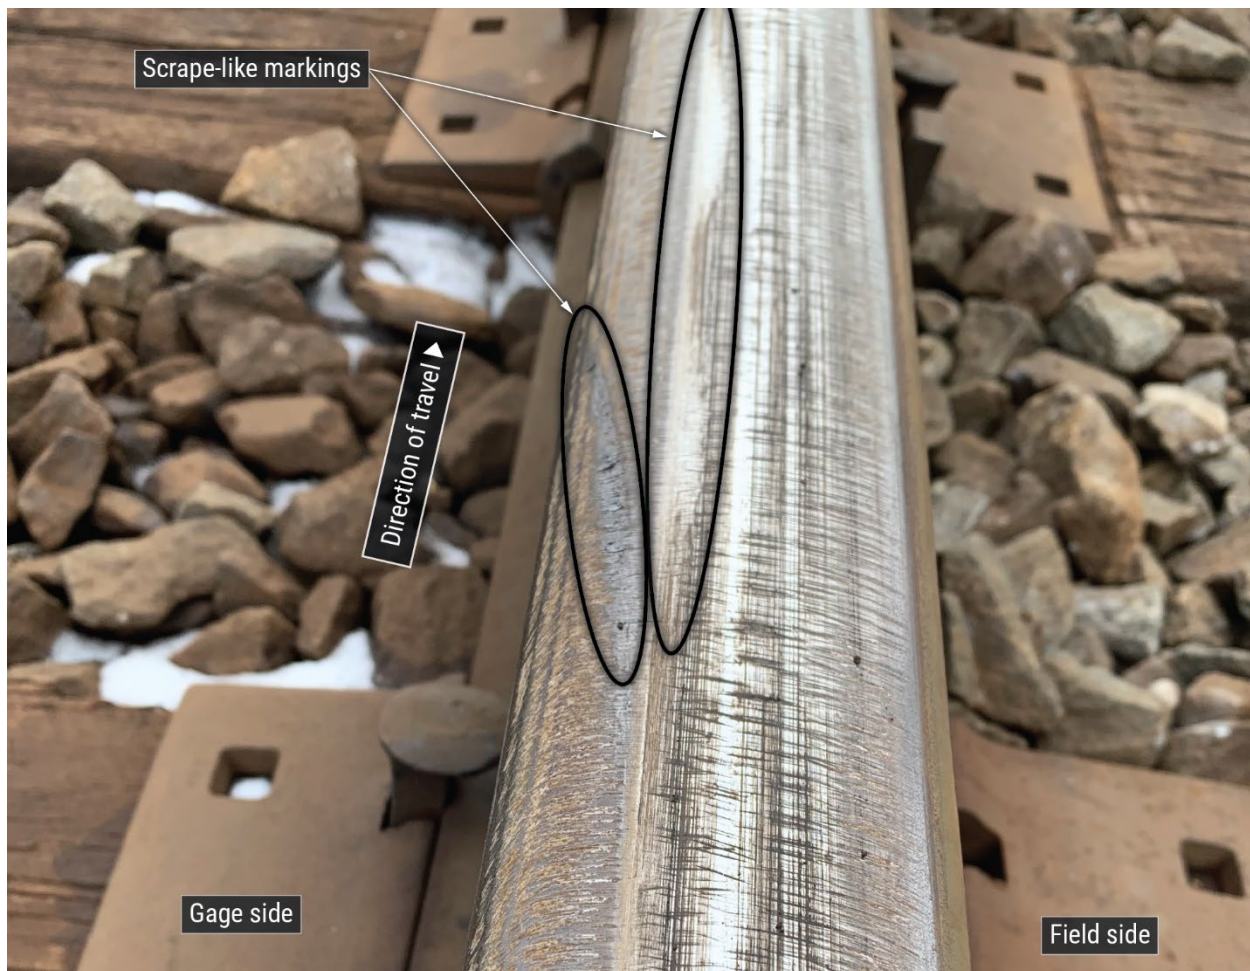
The grooves and markings on the rail were consistent with a point of derailment at MP 49.5.

Figure 11. South running rail at MP 49.5.

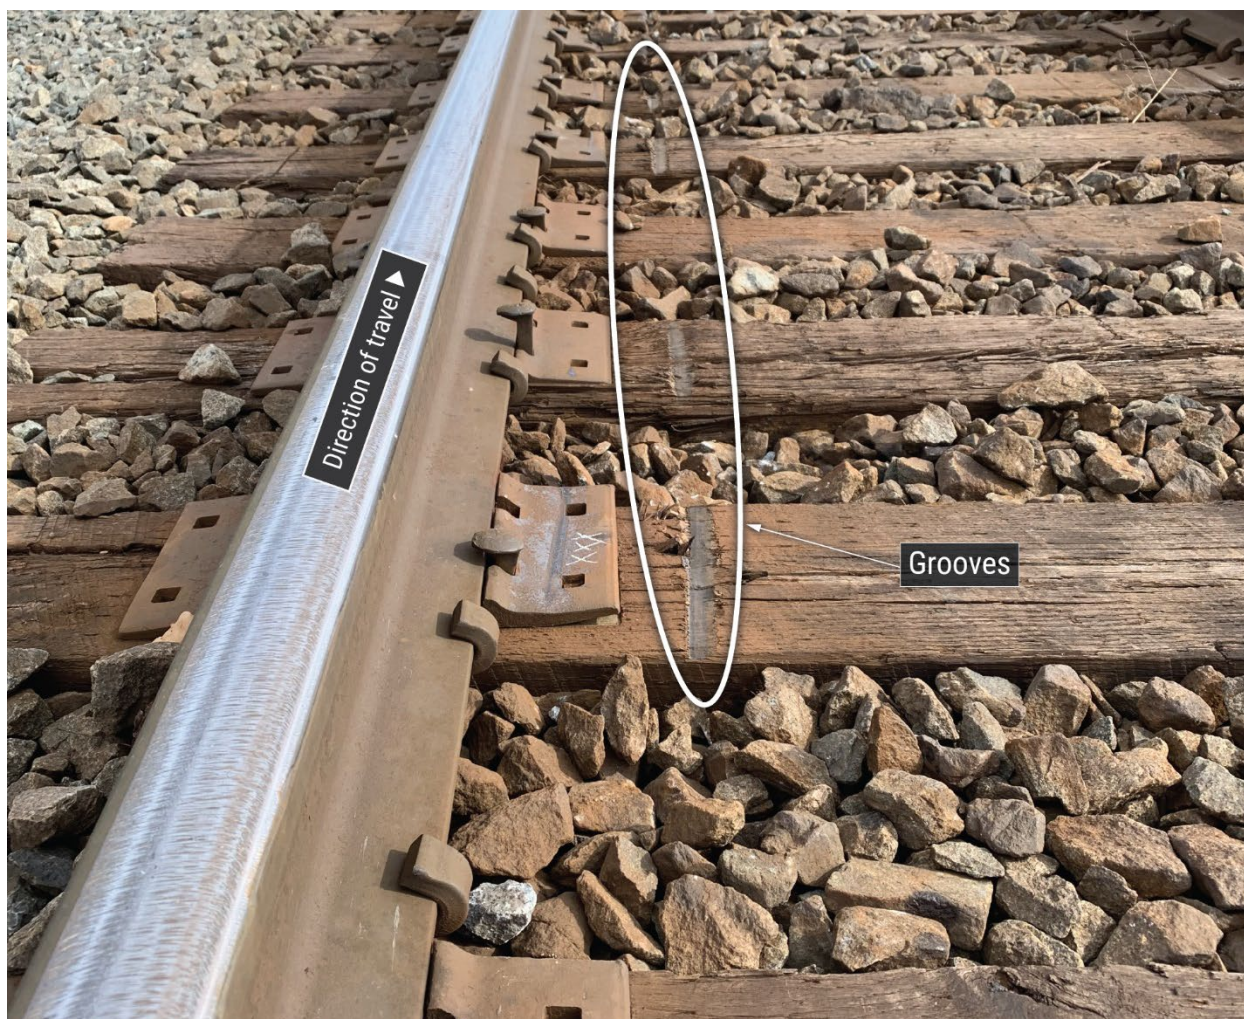
Figure 12. Wheel flange marks on cross-ties east of MP 49.5.

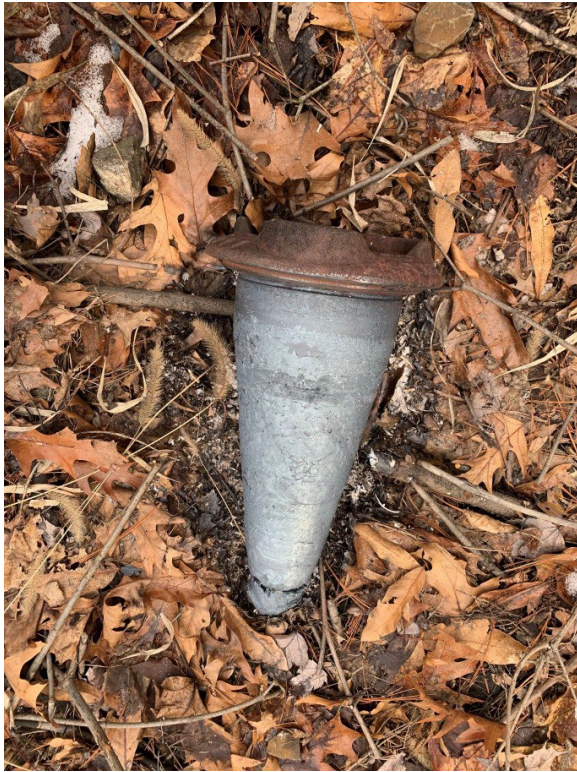
Figure 15. L1 journal as found on the scene.

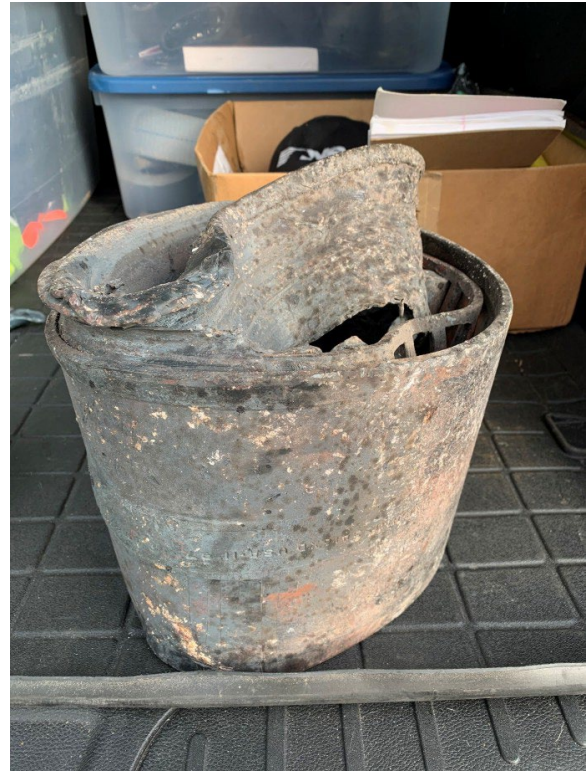
Figure 16. Other L1 bearing components post recovery.

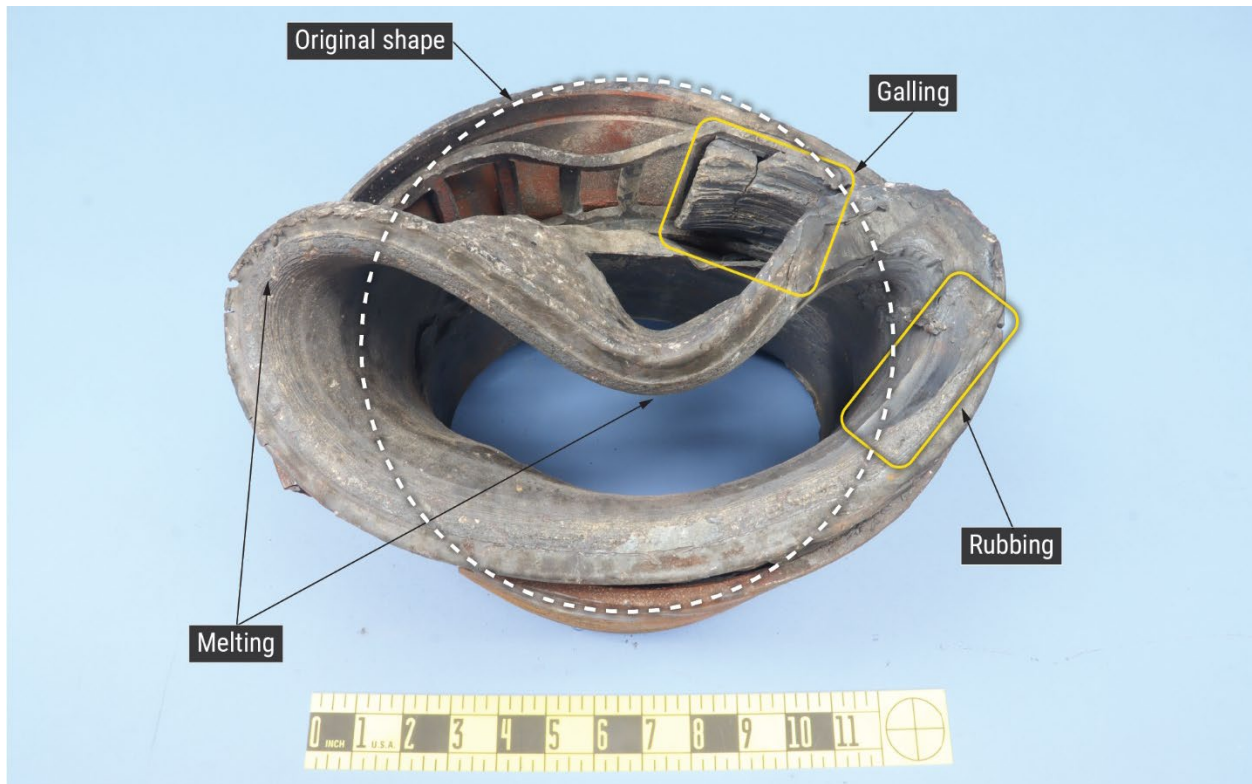
An NTSB contractor disassembled and documented these components in the presence of the NTSB and party members on April 11, 2023. Markings on the components indicated that the bearing had been reconditioned in June 2011.⁷⁷ The L1 bearing's polymer grease seals were missing, and its steel components had sustained extensive damage as shown in figure 18 and figure 19, including:

Figure 18. Recovered bearing cup and other components.

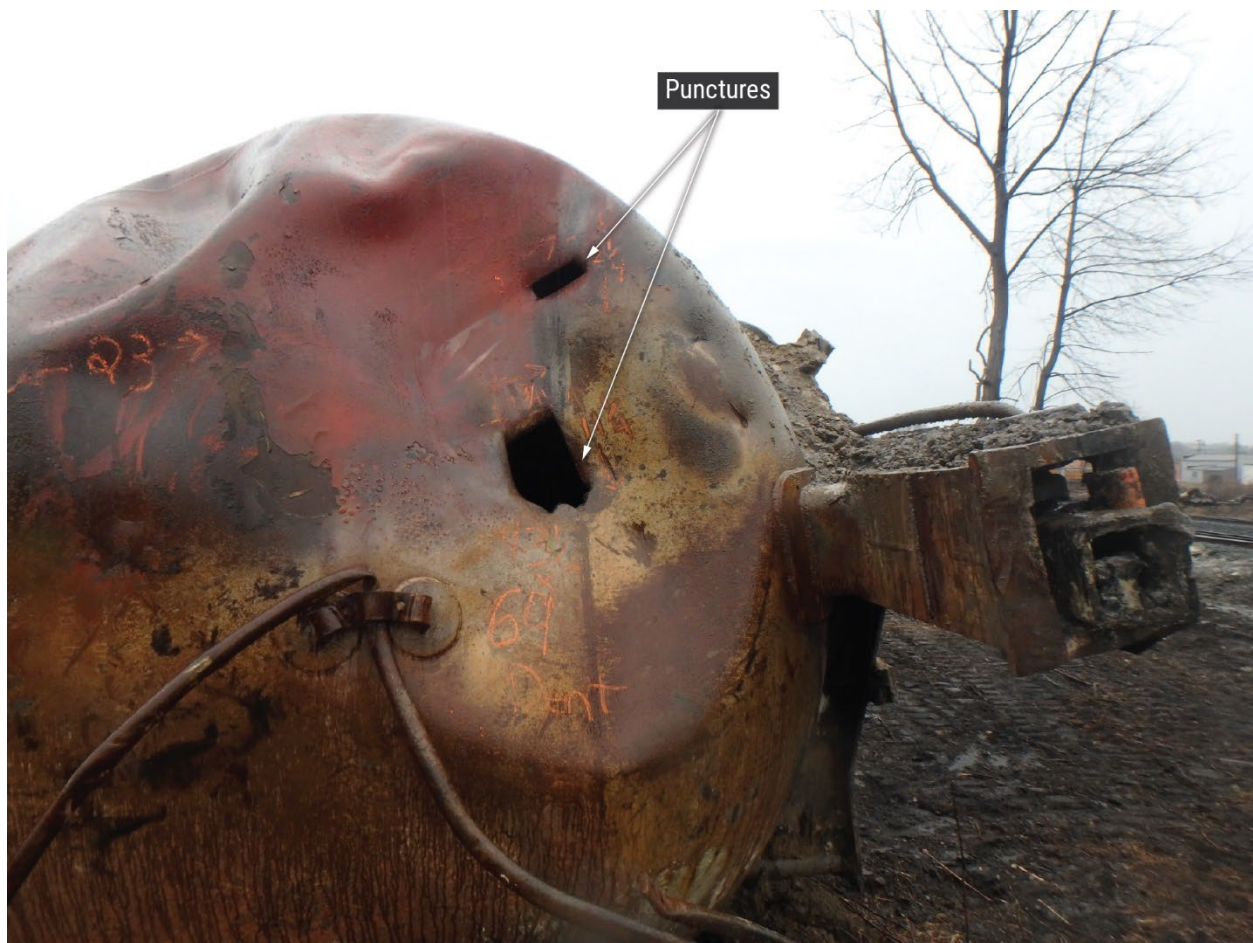
Figure 16 shows an example of tank head punctures sustained by a DOT-111 tank car, UTLX205907, which was constructed of non-normalized steel (which is less damage tolerant than normalized steel) and not equipped with a head shield.

Figure 20. Leading A-end head punctures on tank car UTLX205907.

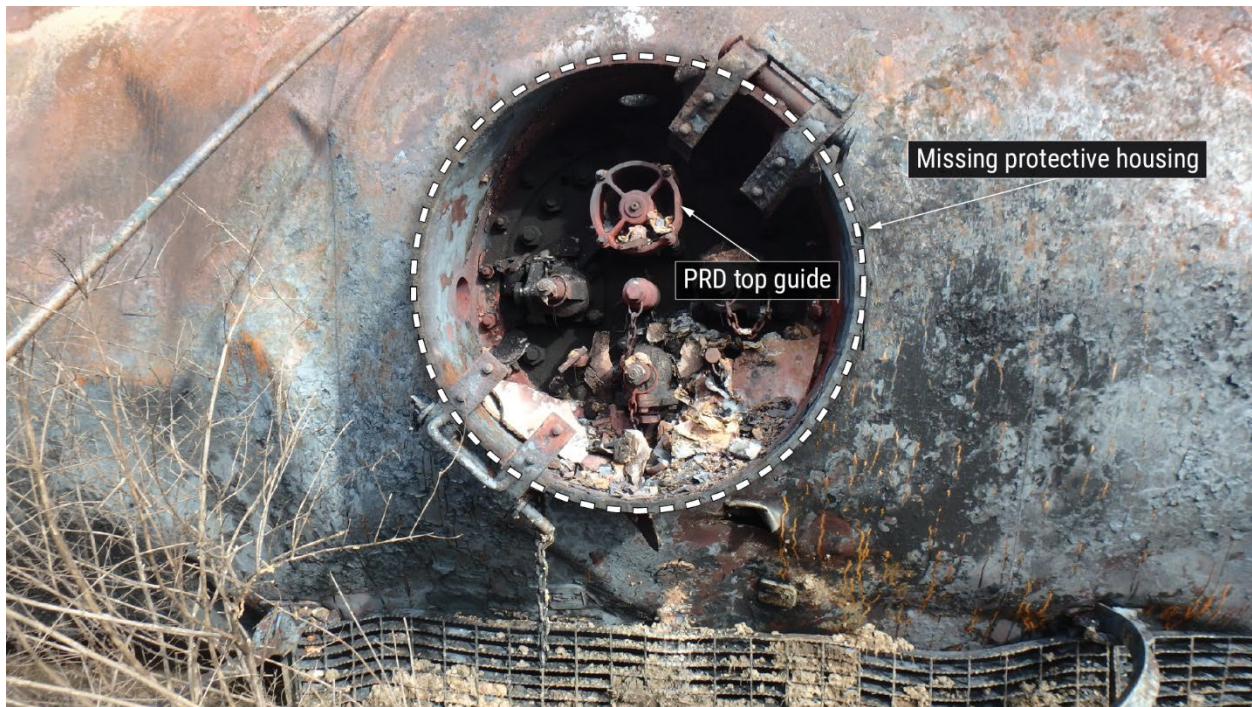
Figure 21. Tank car OCPX80235's protective housing with the aluminum cover missing.

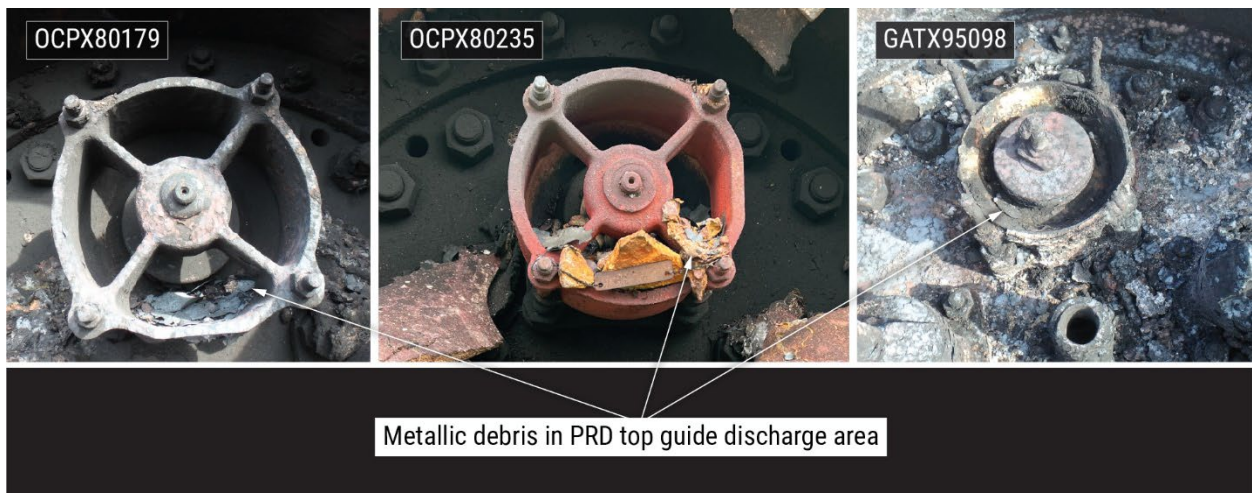
Figure 22. Metallic debris in the PRDs of tank cars equipped with aluminum protective housing covers.

Investigators collected samples of metallic debris and sent them to the NTSB Materials Laboratory in Washington, DC, for examination. After NS contractors removed pressure plates from all five VCM tank cars, the NTSB recovered the PRDs for bench testing at the Trinity Rail Maintenance Services Saginaw Plant in Saginaw,

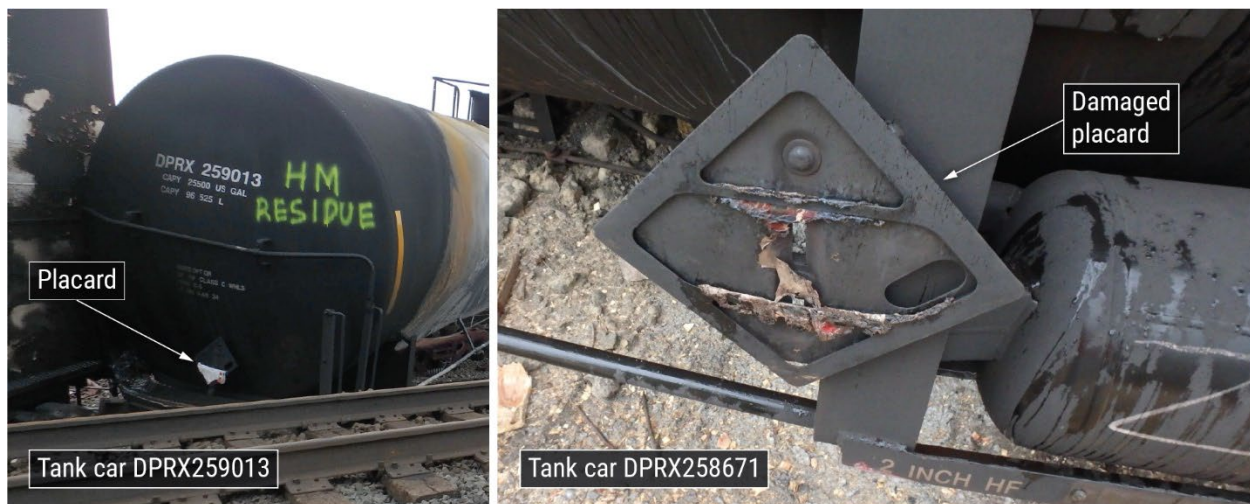
When interviewed by the NTSB, the EPFD deputy fire chief reported that the placards affixed to several railcars had sustained damage and became illegible after being exposed to heat. The NTSB photographed several damaged placards during its on-scene investigation. Figure 26 provides two examples.

Figure 26. Postderailment photographs of placards exposed to heat.

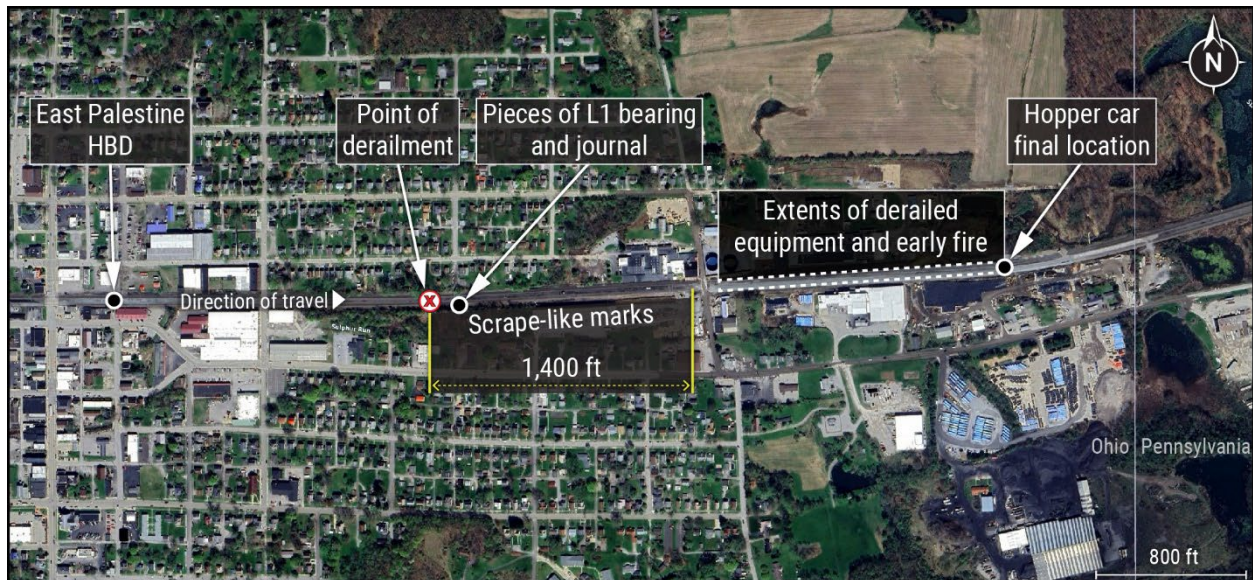
The NTSB recovered components from the L1 bearing and journal near the tracks west of the derailment pileup. (See figure 28.) The components’ positions west of the pileup and far from the rest of the wheelset indicate that they became separated from the hopper car in the earliest moments of the derailment, when the hopper car was still west of its final, postderailment location.

Figure 28. Locations of derailment evidence.

The recovered L1 bearing components were heavily damaged. Two of the types of damage identified during NTSB Materials Laboratory examination—galling and rub damage—are characteristic of metal surfaces experiencing the excessive friction of a burn-off. The bearing cup showed signs of melting, another indication of excessive friction producing high temperatures and causing the bearing to overheat. The deformation of the journal from a cylinder into a cone shape was also characteristic of a burn-off.
