Railroad Investigation Report: RIR-24-07

Union Pacific Railroad Head-On Collision with Stationary Intermodal Railcars

Imperial County, California
September 8, 2022

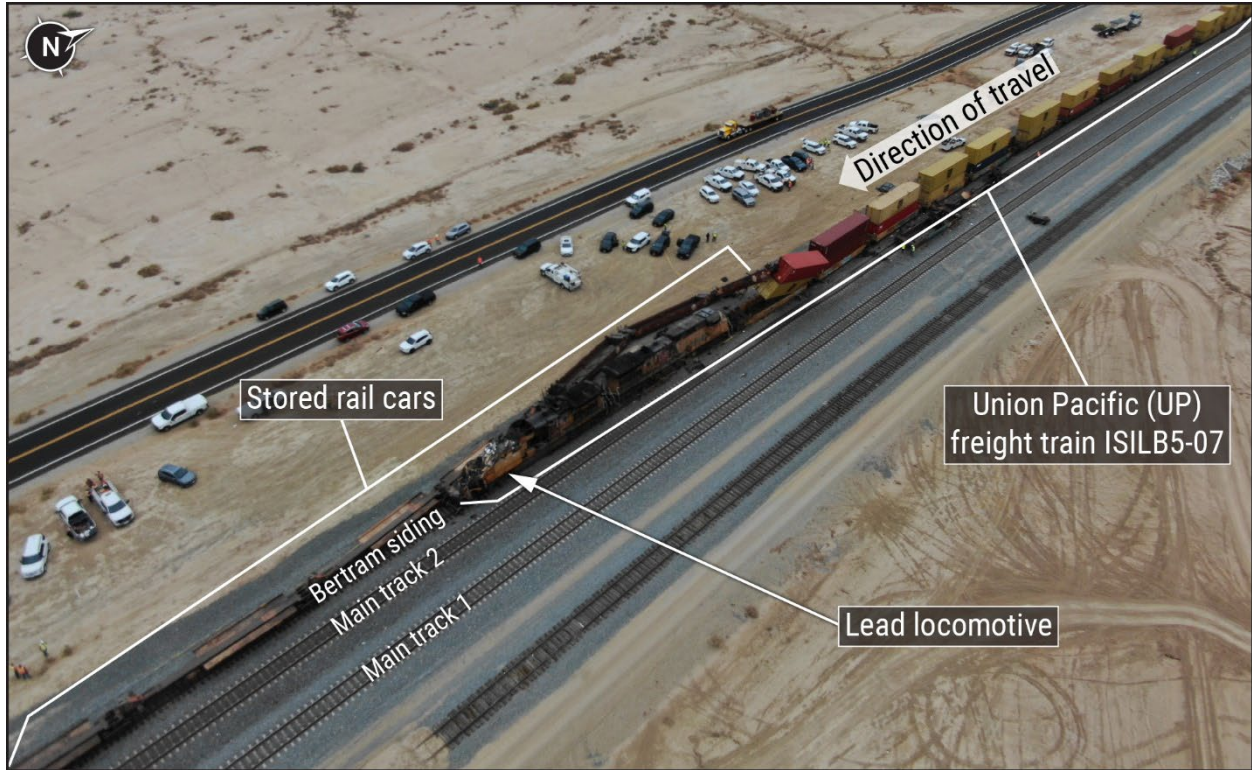
On September 8, 2022, about 2:40 a.m. local time, a conductor and engineer of Union Pacific Railroad (UP) train ISILB5-07 were killed when the train collided with railcars stored in a siding in Imperial County, California.¹ Train ISILB5-07 had been traveling timetable eastbound on main track 2 of the Yuma Subdivision when, because of a change of route plans, the train reversed direction into Bertram siding, a signal-controlled siding at milepost 646.1.² Upon entering the siding, with helper locomotives in the lead, the train traveled about 802 feet before colliding with a string of 74 empty intermodal railcars that had been stored in the siding since December 2021.³ The two lead locomotives and one intermodal railcar of train ISILB5-07 derailed, along with two of the empty stored intermodal railcars. (See figure 1.) Visibility conditions at the time of the accident were dark and clear with a haze near the ground, there was no precipitation,

Figure 1. Aerial view of accident scene. (Source: UP.)

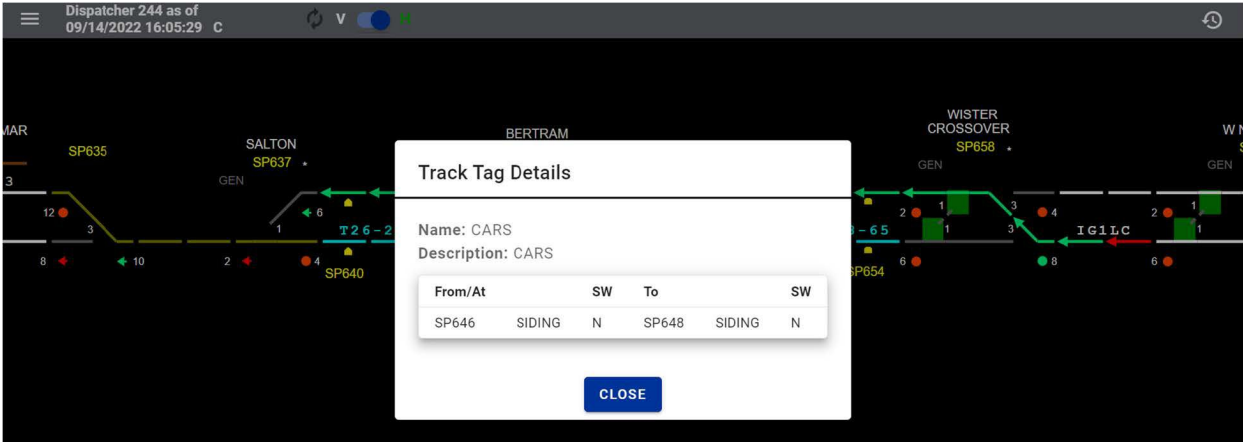
During a postaccident interview with the National Transportation Safety Board (NTSB), a dispatcher stated that on August 29, 2022, 10 days before the accident, he saw a blue block on the Bertram siding track’s CAD display.⁹ The dispatcher also stated that he also saw a track tag stating “CARS” associated with the blue block on the display. (See figure 3.) According to CAD logs viewed by the NTSB, both the track tag and blue block had been manually applied by a dispatcher when railcars had been stored at Bertram siding in December 2021.

Figure 3. The Bertram siding track tag that was removed on August 29, 2022. (Source: UP.)

The second-shift dispatcher recalled that because he saw no track occupancy indication/track block (that is, no magenta-colored line), he removed the Bertram siding track tag but left the blue block in place. (See figure 4.) In his interview, he stated that he left the block in place to prevent trains from entering the siding and that it is common both for a dispatcher to forget to remove a track tag after a section has been cleared of rail equipment and for another dispatcher to later remove a forgotten tag, as he did.¹⁰ He did not confirm the track was clear of standing equipment before removing the track tag, which he was required to do according to UP operating rules.¹¹ (See section 1.6 for more on these rules.)

After the accident, UP conducted a safety briefing for dispatchers, reviewing with each individual dispatcher the rules and processes for removing protection for standing equipment. UP updated operating rule 22.4.2 to require that the dispatcher confirm verbally that a track is clear of standing equipment before removing protection.

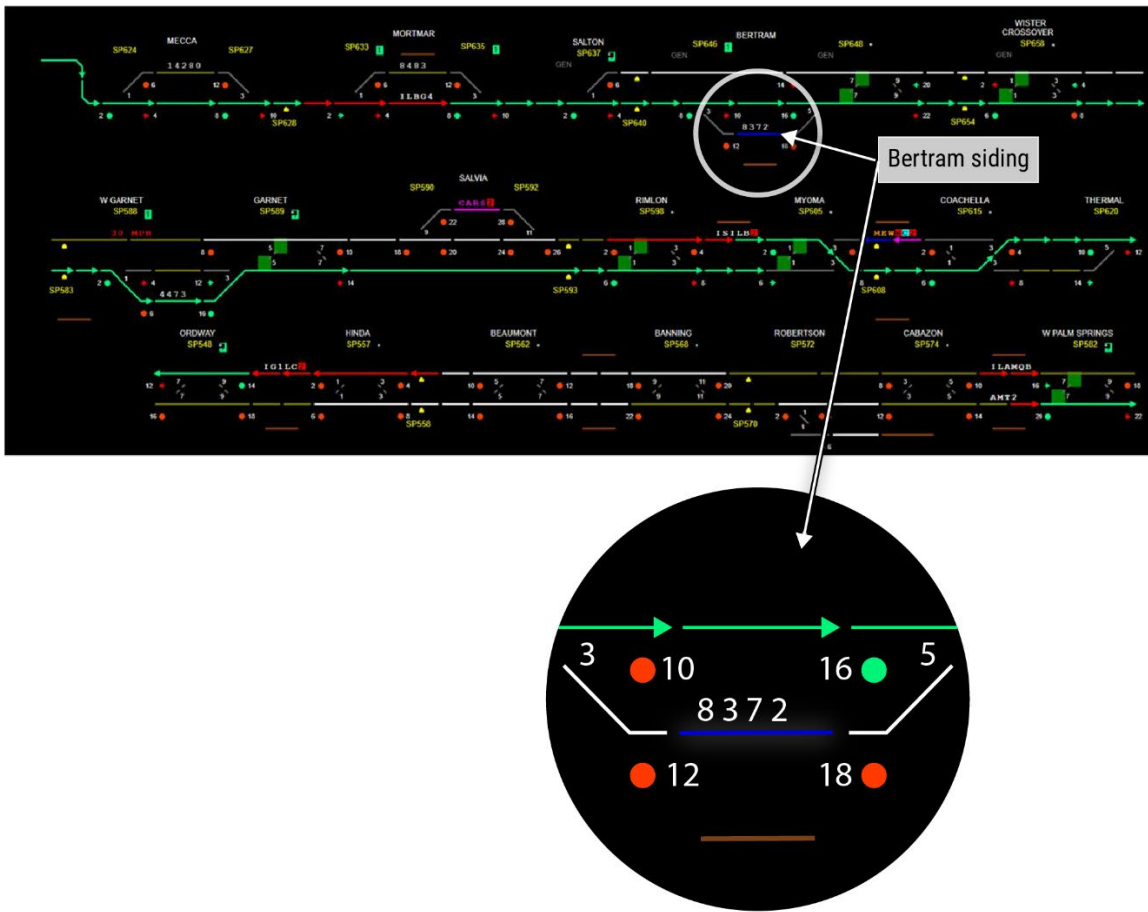
Figure 4. Bertram siding had a blue block when the second-shift dispatcher removed the track tag on August 29. (Source: UP.)

In December 2021, when the empty railcars were first stored on the siding, personnel at HDC had placed a track block and track tag on the CAD display for Bertram siding. But about 2 weeks before the accident, the second-shift dispatcher removed the track tag and left the blue block in place without verifying that the siding was

unoccupied, contrary to UP operating rules directing dispatchers to confirm that a track is clear of equipment before removing protection. Then, on the night of the accident, the third-shift dispatcher looked at the CAD display to route train ISILB5-07 into Bertram siding and saw a blue line, incorrectly indicating that the siding was unoccupied. The dispatcher was therefore able to line the wayside signal at the siding for entry, and did so also without first confirming that the Bertram siding track was unoccupied.

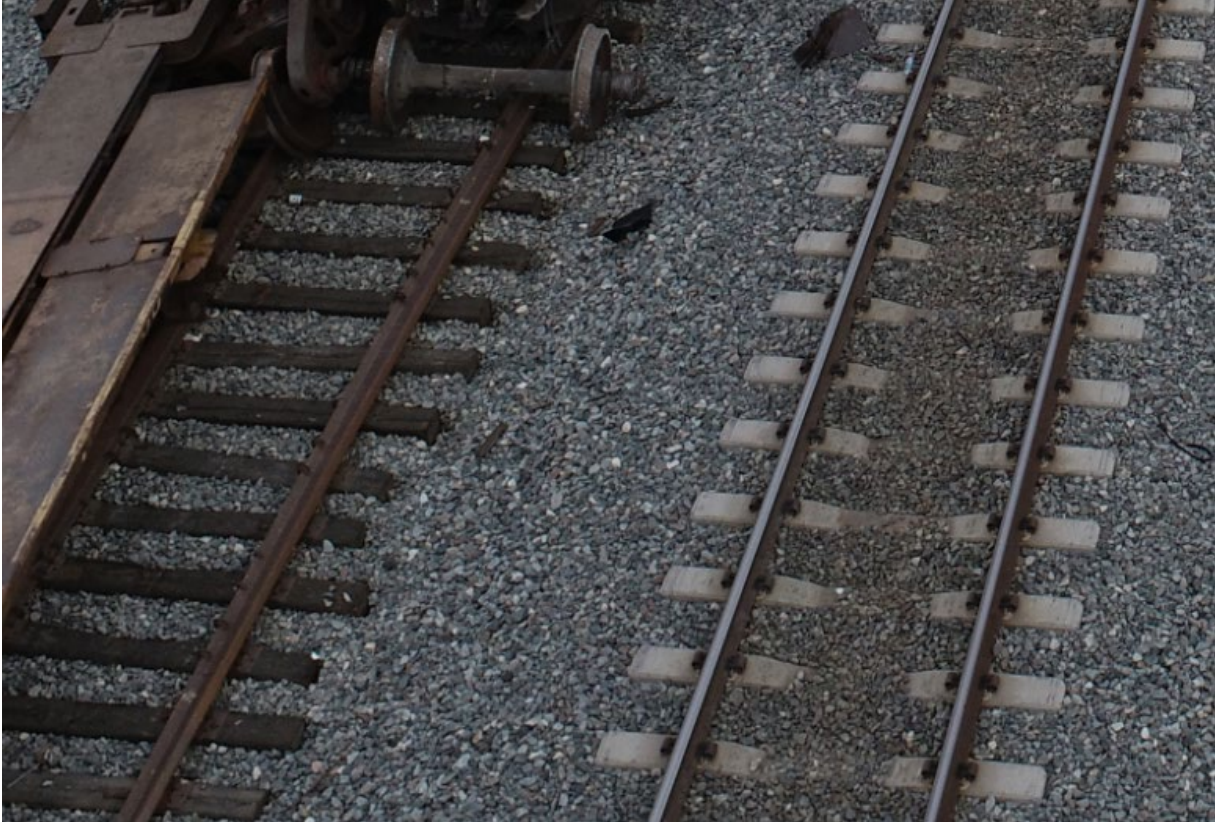
The NTSB examined main tracks 1 and 2 between mileposts 646.00 and 648.00 and observed no track defects or conditions that, if unaddressed, would lead to track defects. Throughout the Bertram siding track, the NTSB observed surface rust along the top of the rail head, web, and base of the rail. (See figure 5.) Surface rust, or corrosion, can cause oxidation of a metal surface, which leads to a decrease in electrical conductivity. Title 49 *Code of Federal Regulations* 236.56 states that “each track circuit controlling home signal or approach locking shall be so maintained that track relay is in deenergized position, or device that functions as a track relay shall be in its most restrictive state if, when track circuit is dry, a shunt of 0.06-ohm resistance is connected across the track rails of the circuit, including fouling sections of turnouts.”¹⁹ (The prescribed shunt sensitivity of 0.06 ohms allows for some contaminants on the track, such as grease, rust, and other foreign materials.) When the NTSB conducted a shunt sensitivity test on the Bertram siding track, the rust buildup prevented a 0.06-ohm shunt from connecting and prevented the track circuit from appearing occupied.

Figure 5. Rail conditions on Bertram siding (*left*) and main track (*right*).

After the accident, the NTSB examined the derailed equipment and tracks at Bertram siding and observed that the wheels of the stored railcars, as well as the tracks they sat on, were covered in surface rust. Bertram siding track runs alongside the Salton

Sea, a large, highly saline lake. Corrosion on steel rails and other steel equipment can be severe in salt-lake areas or coastal zones because of the high levels of salt in the atmosphere.³¹

Friction between a traveling train's wheels and the rail removes rust and other contaminants from the rail surface. The amount of rust removed from the rail surface in this manner depends on a track's traffic flow—an inactive track will therefore have rustier rails than an active one. In this accident, the Bertram siding track had not been used since the 74 empty intermodal railcars were first stored there in December 2021, leaving rust to build up on the rail surface and the wheels of the railcars themselves for more than 8 months.

When a train shunts the rail, it creates an electrical short circuit on that section of the track, also called a track circuit. Although clean steel rail and clean steel wheels are good conductors of electricity, rust buildup is known in the rail industry to degrade the electrical path between rail and wheels.³² This can create poor shunting conditions and degrade track circuit performance, as it did in Bertram siding. When investigators tested the track circuit, it failed to meet federal regulations: a test with a 0.06-ohm shunt did not cause the track circuit to register as occupied.

According to the FRA, track circuit performance degradation has “potentially significant safety consequences for track circuit-based train detection devices.”³³ This was borne out in the weeks leading up to the accident: because the surface rust on the rails and wheels of the stored railcars had degraded the track circuit performance in Bertram siding, the CAD system at HDC inaccurately and intermittently indicated the siding was unoccupied dozens of times.
