Railroad Investigation Report RIR-24-10

CSX Transportation Employee Fatality

Walbridge, Ohio

September 17, 2023

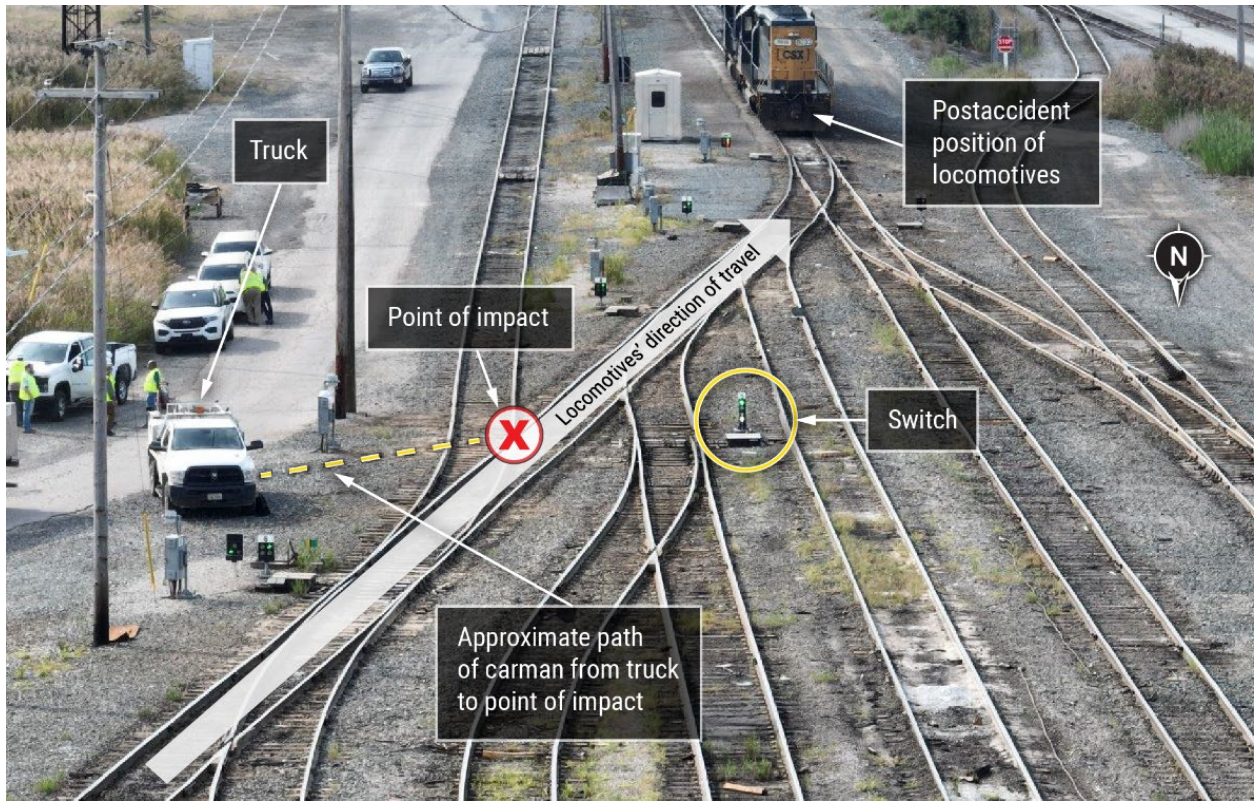
On September 17, 2023, about 3:24 a.m. local time, a member of a CSX Transportation (CSX) mechanical department crew (the accident carman) was struck and killed by a pair of remote-control locomotives during switching operations in a remote-control zone (RCZ) on the Walbridge Yard lead track in Walbridge, Ohio.¹ At the time of the accident, the accident carman was walking across multiple tracks to line and lock a switch to prepare for railcar inspections.² The locomotives were operating as yard job Y397 and were being used to perform switching operations under the control of a single remote-control operator (referred to as a conductor in this report) positioned on the lower ladder on the west side of the trailing locomotive. As the accident carman began crossing the lead track to access the switch, he was struck by the locomotives, which were traveling south about 10 mph. (See figure 1.) Visibility conditions at the time of the accident were dark and clear, but the area was illuminated with overhead lighting. The temperature was 63°F with no precipitation.

Figure 1. Accident scene. (Source: CSX.)

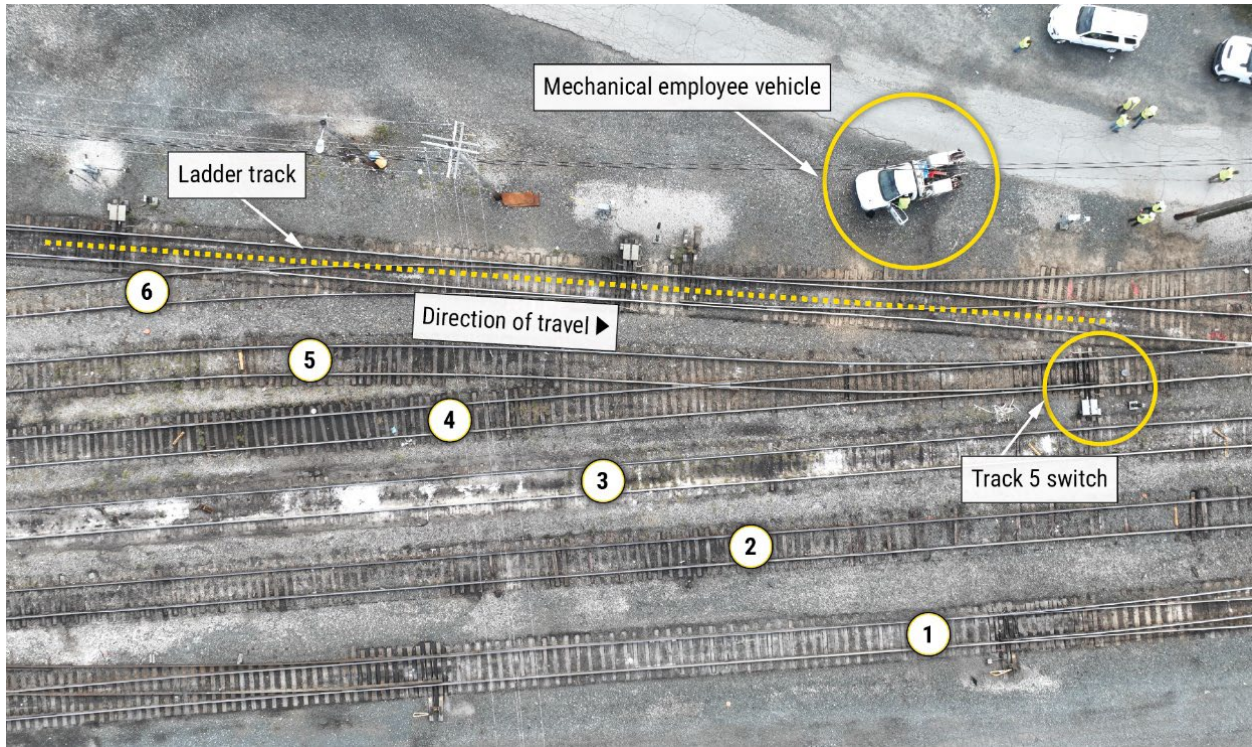
Figure 2. Aerial view of the tracks.
