Railroad Investigation Report: RIR-24-11

Southeastern Pennsylvania Transportation Authority Trolley Derailment

Philadelphia, Pennsylvania
July 27, 2023

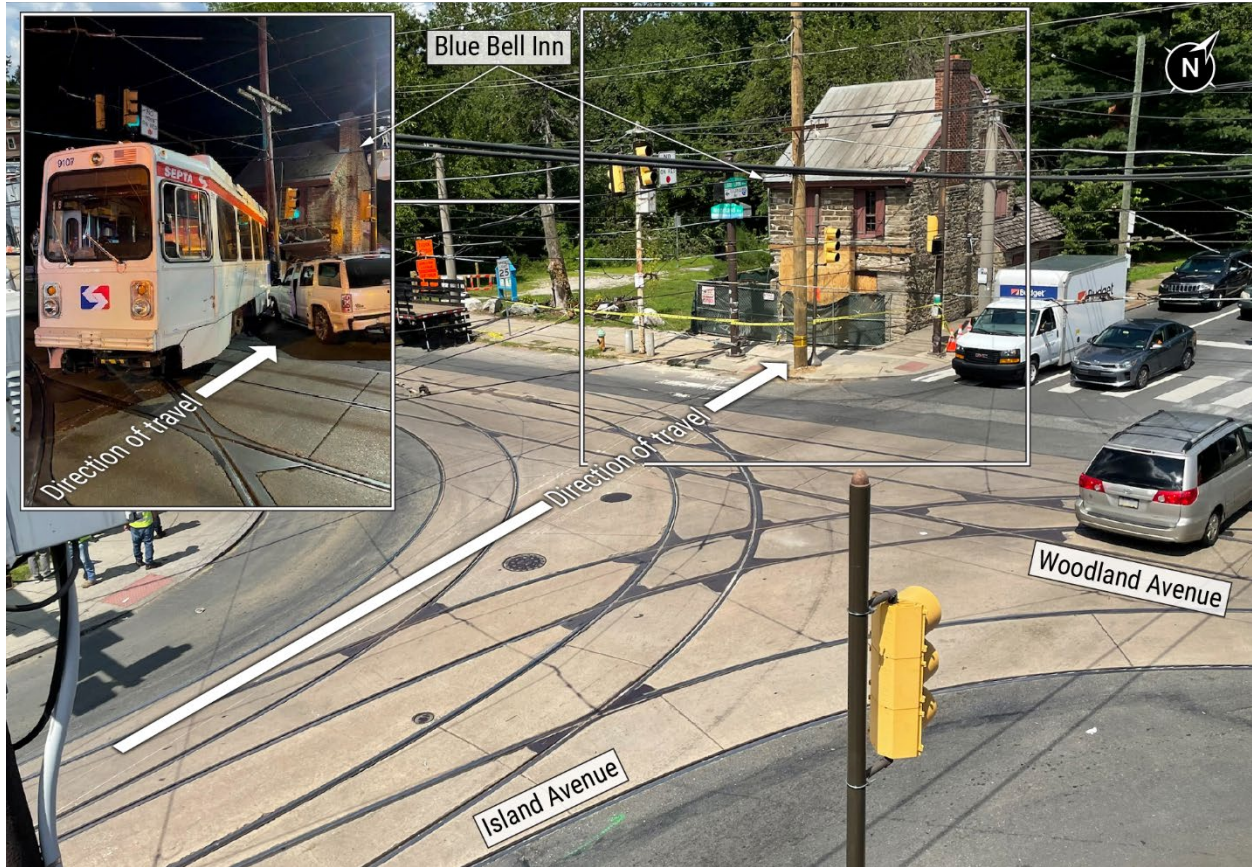
On July 27, 2023, about 10:18 p.m. local time, Southeastern Pennsylvania Transportation Authority (SEPTA) trolley 9107 derailed at the intersection of Island Avenue and Woodland Avenue in Philadelphia, Pennsylvania, and struck a sport utility vehicle and the Blue Bell Inn.¹ (See figure 1.) Shortly before the derailment, an electronics specialist began operating trolley 9107 from SEPTA's Elmwood maintenance facility toward an adjoining yard for storage.² As the trolley left the facility, the electronics specialist attempted to apply the air brakes to stop the trolley from moving downhill into Island Avenue, but the brakes had been rendered inoperable during maintenance and did not activate. The electronics specialist jumped out of the trolley before the derailment and collision with the sport utility vehicle and Blue Bell Inn. He sustained minor injuries. The sport utility vehicle was occupied by four people, two of whom were transported to a local hospital with minor injuries. The Blue Bell Inn was occupied by one resident, who was not injured. Visibility conditions were dark, but the area was illuminated by ambient and street lighting; the temperature was 84°F with light wind and

no precipitation. SEPTA estimated equipment damage to be about \$500,000. Longcare Appraisal & Adjustment estimated damage to the Blue Bell Inn to be about \$300,000.

Figure 1. Overview of the accident area.

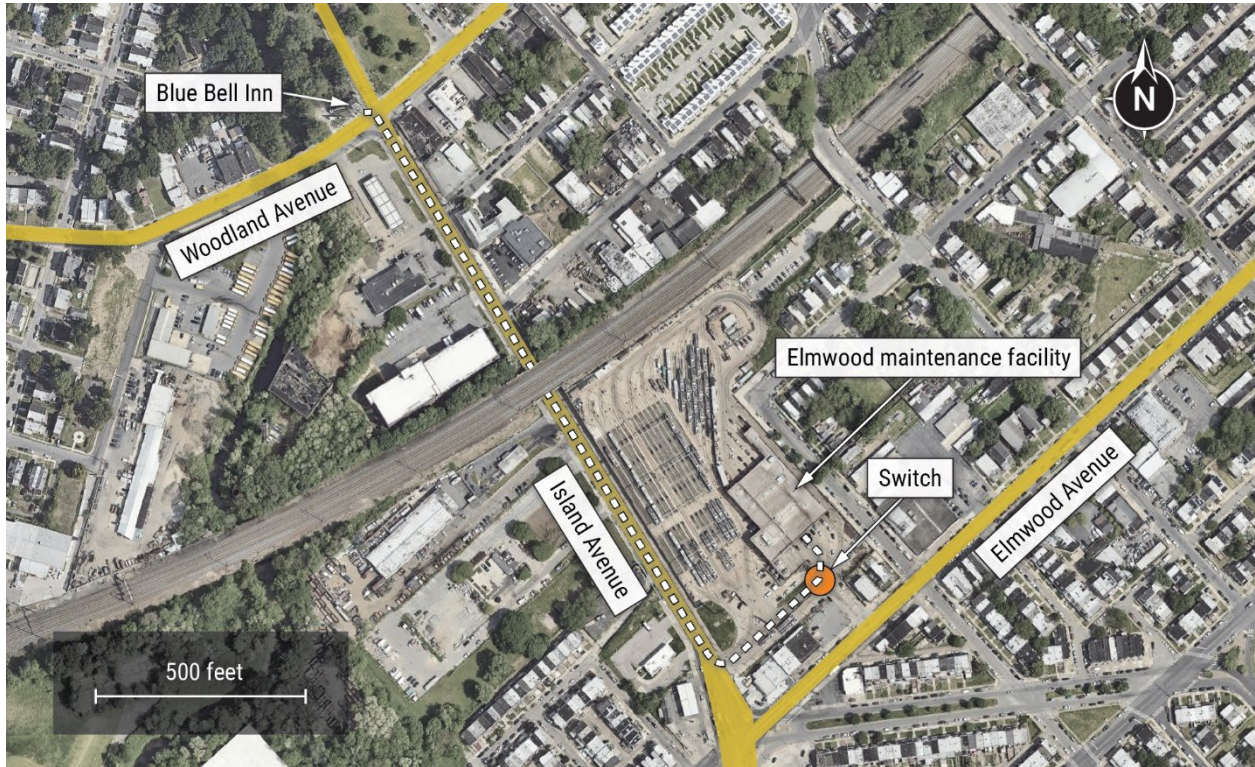
maintenance facility on an uphill grade toward a switch to change direction and move into the storage yard.³ When he attempted to apply the brakes and change direction, the trolley failed to stop and continued on a downhill grade from the switch toward Island Avenue. The trolley made a right turn onto Island Avenue and continued downhill. The trolley derailed as it was traversing the curve at the intersection of Island Avenue and Woodland Avenue about 20 mph. (See figure 2.)

Figure 2. The movement of the trolley from the Elmwood maintenance facility to the intersection of Island Avenue and Woodland Avenue.
