Railroad Investigation Report: RIR-24-12

Union Pacific Railroad Train Collision

Chico, Texas
April 16, 2023

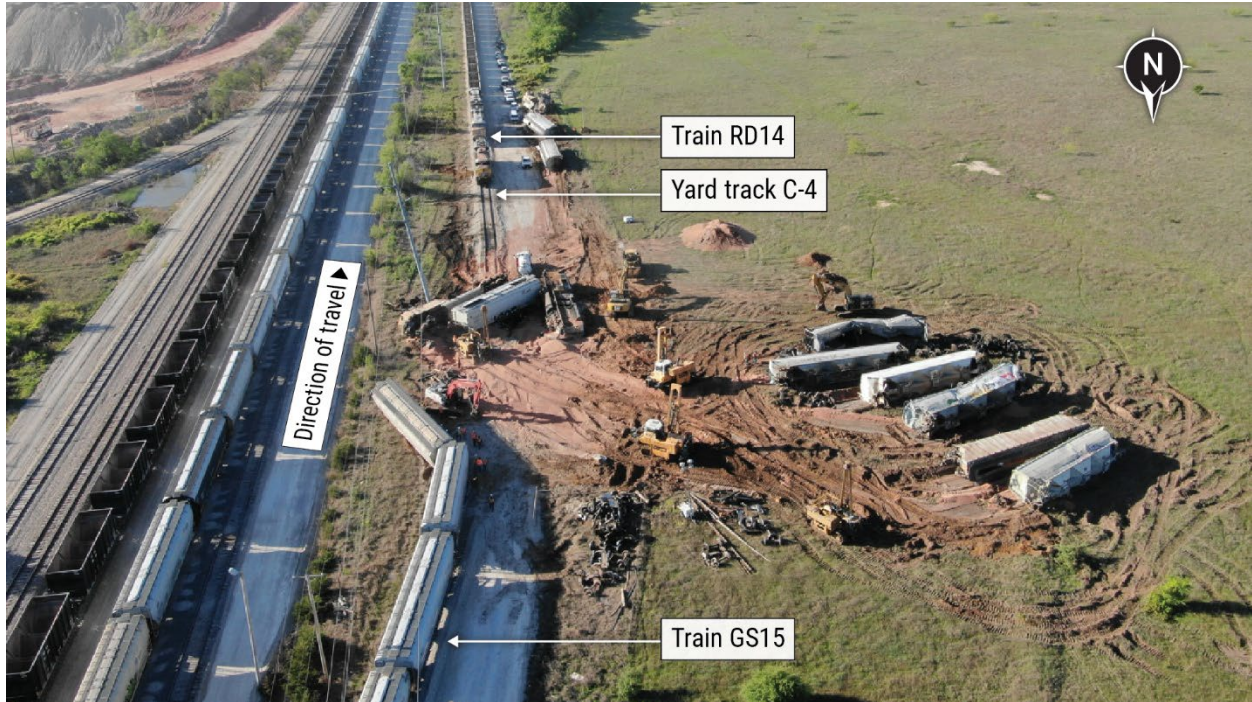
On April 16, 2023, about 6:44 p.m. local time, southbound Union Pacific Railroad (UP) train GSHFCC 15 (train GS15) crossed a main track switch lined toward yard track C-4 and collided with parked UP train RDACO 14 (train RD14) in Chico Yard in Chico, Texas.¹ (See figure 1.) As a result of the collision, 12 loaded hopper railcars and 2 locomotives from train GS15 derailed, and 1 empty gondola railcar and 2 locomotives from train RD14 derailed. Two crewmembers from train GS15 were seriously injured. UP estimated damages to equipment and track infrastructure to be about \$4.9 million. Visibility conditions at the time of the accident were daylight and clear, and the temperature was 68°F with no precipitation.

Figure 1. Aerial view of the collision scene. (Courtesy of UP.)

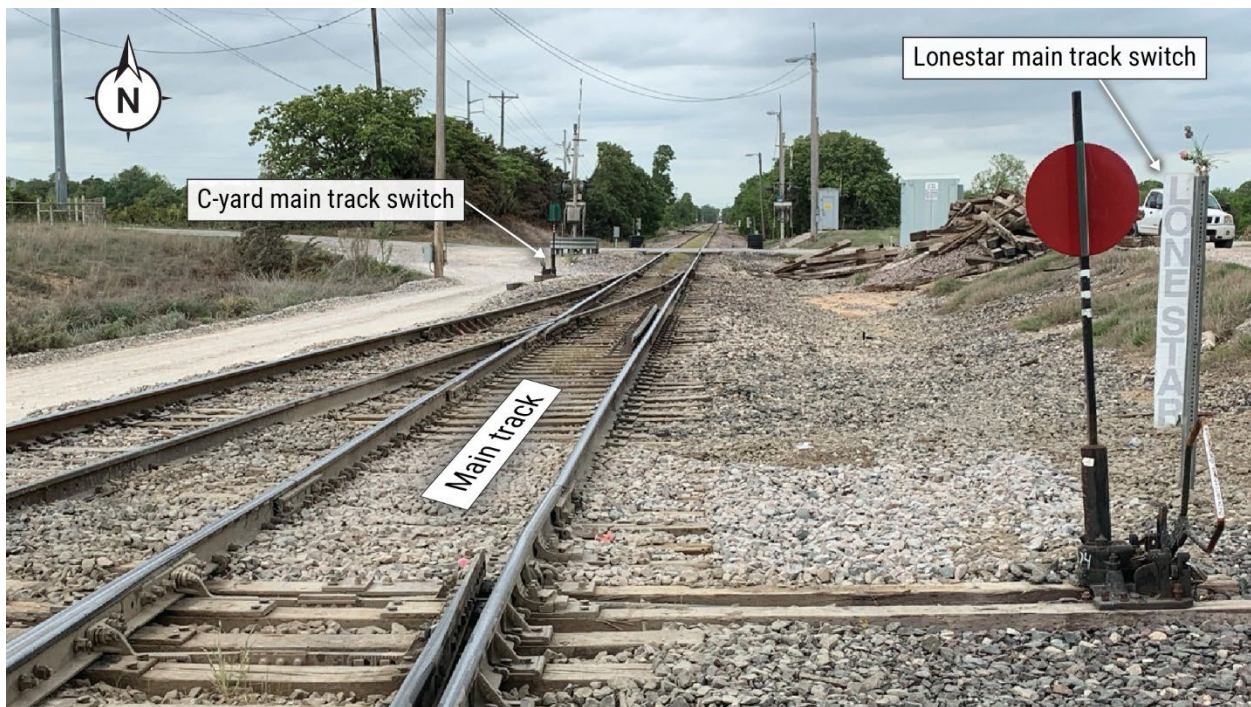
The events before the collision involved three trains (see table 1) and two main track switches in Chico Yard, which is located on the UP Duncan Subdivision near milepost (MP) 564.2. Trains operate through Chico Yard on a single main track that runs north to south. Two tracks branch off from the main track through two separate main track switches. The track west of the main track enters a small yard, the C-yard, and is accessed by a hand-operated switch called the "C-yard" main track switch. The track east of the main track enters the Lonestar siding and is accessed by a hand-operated switch called the "Lonestar" main track switch. The C-yard and Lonestar main track switches have the same handle and target; however, the Lonestar main track switch also has a two-sided vertical sign that reads "Lonestar." The switches are about 135 feet apart.² Figure 2 is a photograph taken after the collision that shows the C-yard and Lonestar main track switches (the switch alignments in the photograph do not show how authorities found the switches lined immediately after the collision).

Figure 2. Photograph of the main track, the C-yard main track switch, and the Lonestar main track switch. (Courtesy of UP.)

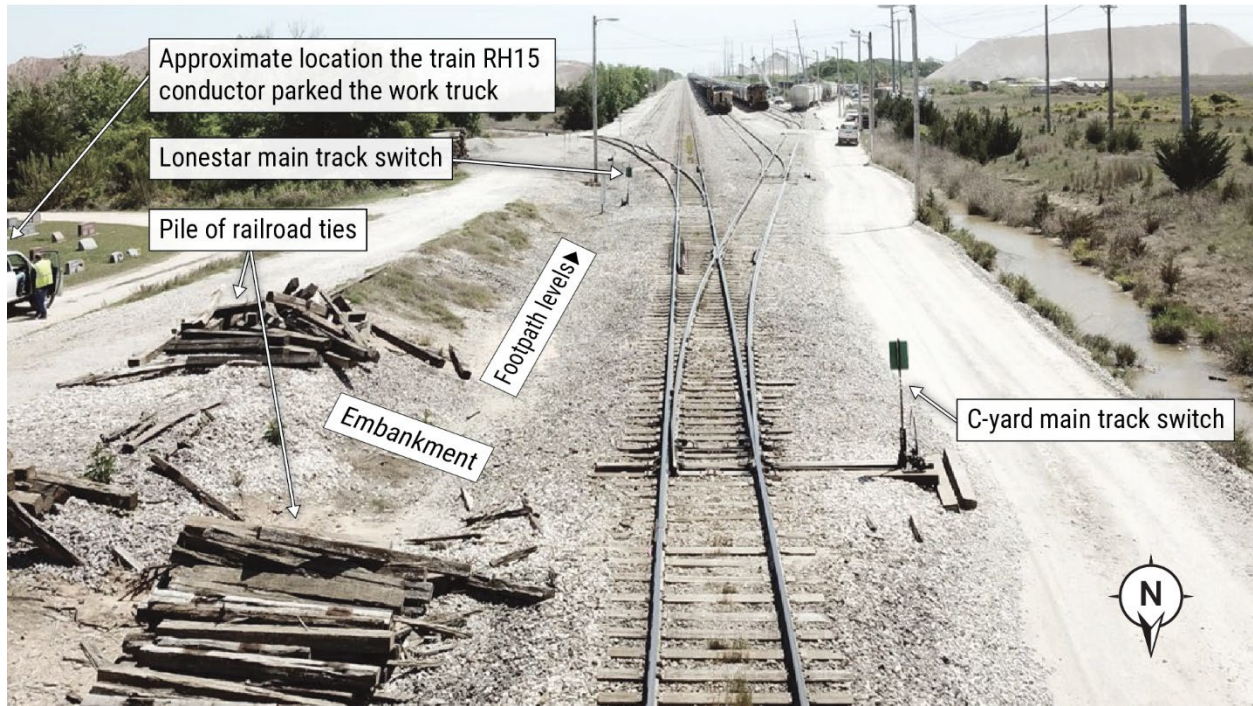
During postcollision site examinations 2 days after the accident, the NTSB saw a pile of railroad ties and an embankment (incline) across from the C-yard main track switch. The NTSB also saw that the footpath was level near the Lonestar main track switch. In addition, the NTSB noted the approximate location the train RH15 conductor parked the work truck when he went to reline the Lonestar main track switch. (See figure 4.)

Figure 4. Photograph of the C-yard and Lonestar main track switches and the surrounding area. (Courtesy of UP.)

The crew lined the Lonestar main track switch away from the main track to park their train in the Hanson Rock Plant. When the conductor went by himself to restore the Lonestar main track switch, he walked downhill and lined a switch across from a pile of railroad ties and a downward-sloping embankment, a location consistent with the C-yard main track switch, not the Lonestar main track switch. (The Lonestar main track switch was in a flat area with no railroad ties nearby, about 135 feet south of the C-yard main track switch.) The conductor likely lined the C-yard main track switch away from the main track and toward yard track C-4 when he intended to restore the Lonestar main track switch.
