Chicago Transit Authority Yellow Line Train Collision with Snow Removal Machine

Chicago, Illinois
November 16, 2023

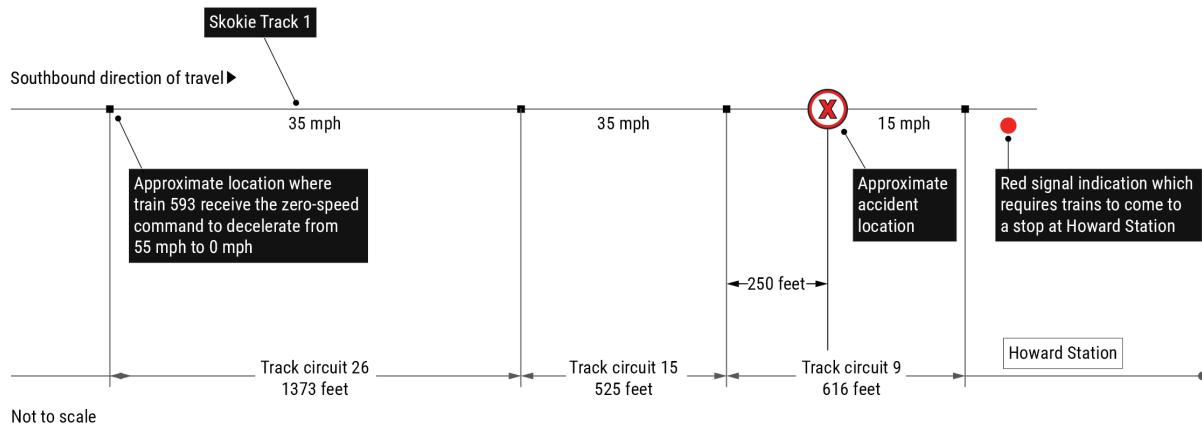
Shortly before the collision, during a southbound movement, the snow removal machine had stopped in track circuit 9 about 370 feet north of a red signal indication before entering Howard Station. At this time, train 593 was traveling southbound toward Howard Station about 54 mph on the same track. At 10:30:22 a.m., as the train entered track circuit 26, the operator received an in-cab zero-speed command from the ATC system, because the snow removal machine was already present within the signal block.⁷ The train received the zero-speed command about 2,150 feet from the stopped snow removal machine. The train operator initiated a full-service braking application about

1 second later.⁸ When interviewed by the NTSB, the operator said that he noticed that the train had started sliding and was not slowing down as much as it should have. The NTSB’s subsequent review of event recorder data showed that the train’s wheel slide protection system activated during the full-service braking application and modulated the train’s dynamic and friction brakes. The operator saw the snow removal machine and initiated an emergency braking application at 10:30:41 a.m., which activated the train’s dynamic, friction, and track brakes.⁹ The train decelerated to about 23 mph before striking the snow removal machine at 10:30:50 a.m. (See figure 3 and figure 4.)

Figure 3. Movement of Train 593 on Skokie Track 1 on November 16, 2023. (Courtesy of CTA).

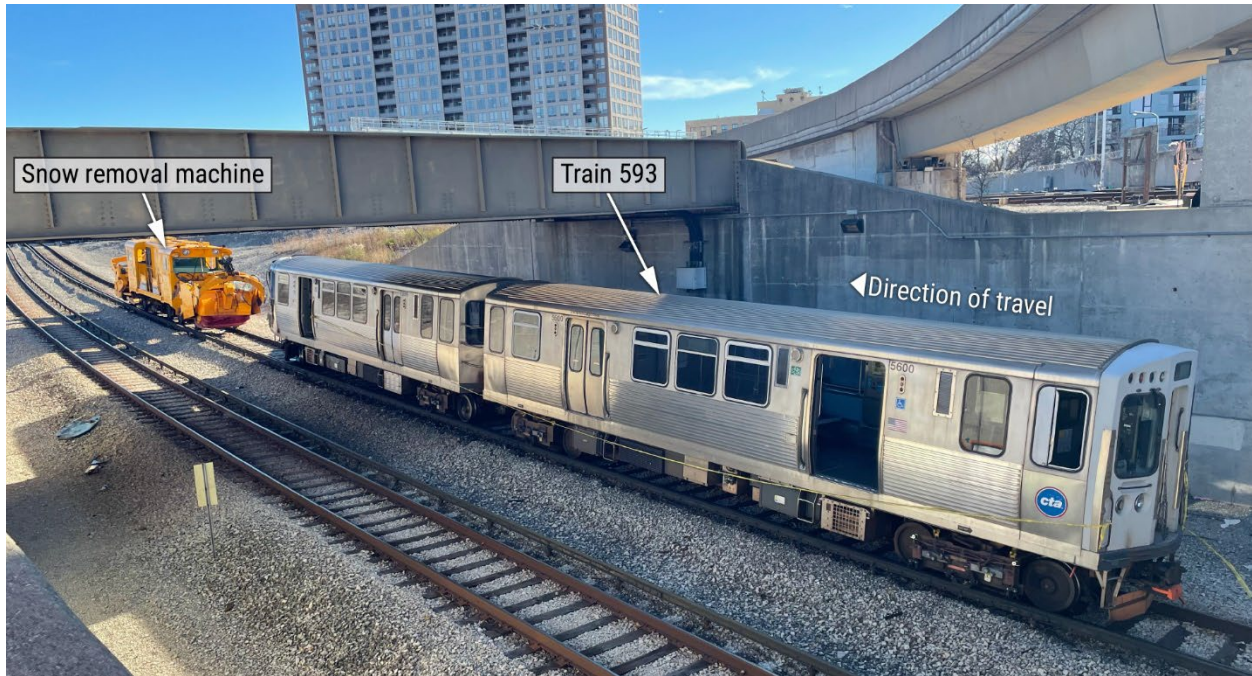
Figure 4. Train 593 and the snow removal machine on the Yellow Line after the accident.

The National Transportation Safety Board determines that the probable cause of the collision between Chicago Transit Authority (CTA) passenger train 593 and snow removal machine S-500 was a combination of three factors: (1) an aggressive speed reduction command that resulted in wheel slide and degraded the train's braking performance, (2) CTA's decision to disable the automatic track brake application feature of the train's wheel slide protection system, delaying application of the track brake and further reducing the train's braking performance, and (3) the presence of organic material on the rails that caused slippery conditions that worsened the wheel slide and further degraded the train's braking performance.

CTA reduced the maximum authorized speed on the Yellow Line from 55 mph to 35 mph to eliminate the possibility of a speed reduction from 55 mph to 0 mph and reduce the incidence of wheel slide and the subsequent activation of the wheel slide protection system. CTA enabled the automatic track brake application feature of the wheel slide protection system on its 5000-series railcars. CTA cleaned the Yellow Line track of debris and fallen leaves, removed material that had accumulated on the rails, and issued bulletins to remind employees of best practices for operating trains under slippery conditions to reduce the risk of a train sliding after the brakes are applied. Finally, CTA modified its track inspector certification training program to include information about the build-up of material on the rails. This program is intended to make track inspectors aware of the hazards of the build-up of material on the rails which makes the rails slippery and degrades the braking performance of trains.
