Railroad Investigation Report: RIR-25-02

# CSX Transportation Head-on Train Collision

<b>Location</b>	Folkston, Georgia
<b>Date</b>	April 15, 2024
<b>Accident type</b>	Head-on collision
<b>Northbound striking train</b>	Freight train CSX I03215 2 crewmembers 2 locomotives, 27 intermodal railcars
<b>Southbound stationary train</b>	Freight train CSX L74314 2 crewmembers 3 locomotives, 83 railcars
<b>Track</b>	Main track, signalized
<b>Hazardous materials</b>	None
<b>Fatalities</b>	0
<b>Injuries</b>	3
<b>Damages</b>	\$720,000

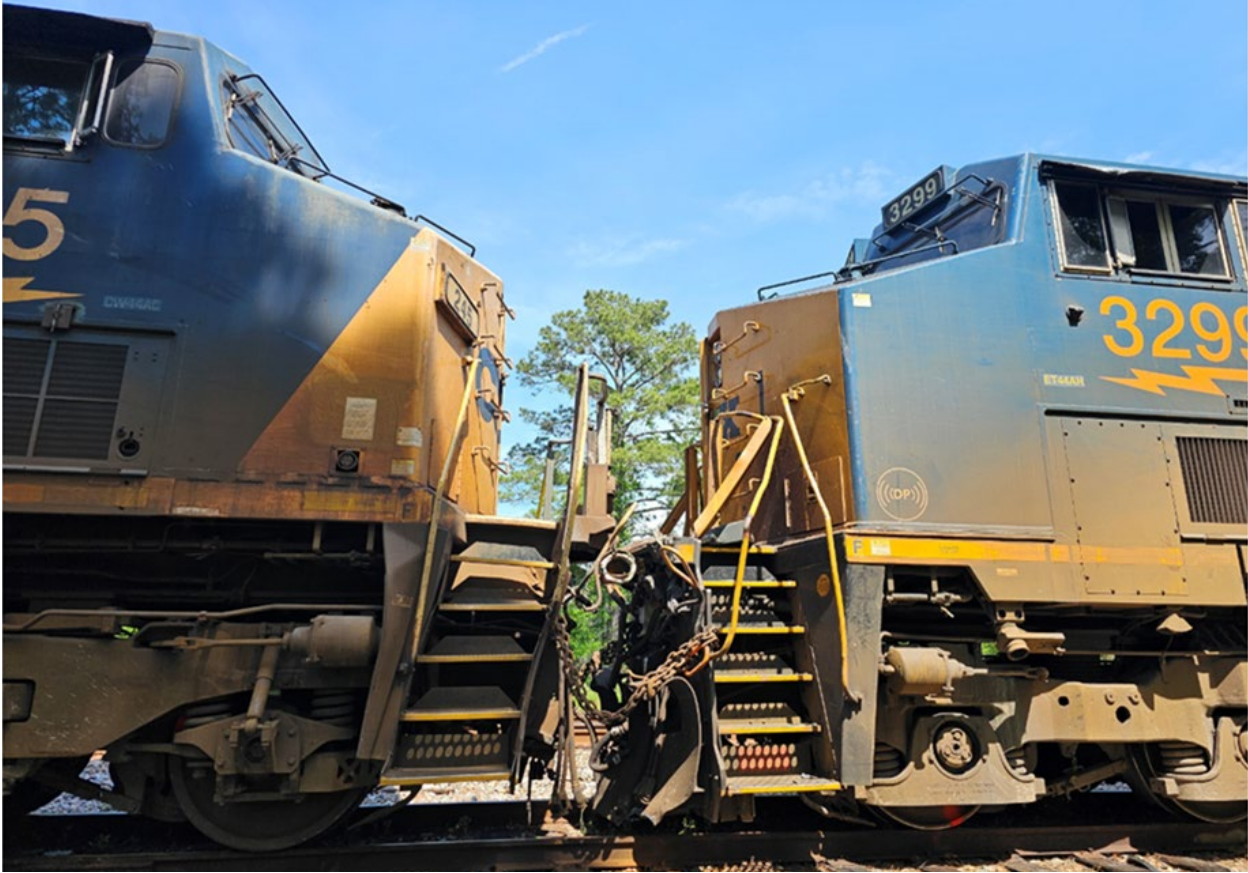
Images from forward-facing locomotive image recorders captured shortly before the collision showed that one of these four switches was reversed. This switch was lined to divert traffic from main track 1 onto main track 2, where train L74314 was parked. Train I03215, which was intended to remain on main track 1, approached this switch while traveling about 39 mph. The crew saw that the switch was misaligned before the train reached it and began braking. The train decelerated but still traversed the switch and diverted onto main track 2 where it struck the parked train (see figure 1).

**Figure 1.** Lead locomotives from both trains after impact.

This collision resulted from an improperly lined switch. The conductor likely threw the main track 1 switch once—the typical procedure for normalizing a reversed manual switch—and inadvertently left it lined for main track 2. When interviewed by the NTSB, he did not remember training on or ever operating a dual-controlled, power-operated switch in manual mode. Thus, he likely did not recognize that the hand-throw lever may need to be cycled back and forth to line the switch to the intended position. The training he was provided during his 3-year tenure with CSX was insufficient to prepare him with the knowledge, skills, and abilities to perform this infrequent task on the day of the accident.

The NTSB determines that the probable cause of the CSX Transportation head-on train collision was a combination of an improperly lined dual-controlled, power-operated switch that a conductor did not know how to properly operate, and the conductor’s failure to verify its position as required. Contributing to the accident was CSX Transportation’s insufficient training (recurring) and failure to implement operational procedures, such as a restricted speed requirement and secondary verification of switch position, to mitigate the risk of misaligned switch accidents during a signal suspension.

On April 18, 2024, CSX published a safety alert in response to the collision in Folkston, Georgia. The safety alert discussed operating requirements for dual-controlled, power-operated switches. The alert also emphasized that “all trains must approach all switches within the limits of the signal suspension at restricted speed until it is known they are lined for the authorized and intended route.” This change is intended to give train crews time to stop if they see that they are approaching a misaligned switch. In addition, CSX published a signal suspension safety bulletin that discusses signal suspension job briefing protocols and field management audits and testing. These protocols include secondary switch verification by including a signal maintainer in the job briefing and having the signal maintainer double-check a conductor’s alignment of each switch.
