# BNSF Railway Derailment with Bridge Strike and Fatality

<b>Location</b>	Pueblo, Colorado
<b>Date</b>	October 15, 2023
<b>Accident type</b>	Derailment
<b>Train</b>	Freight train C-ATMCRD0-31D 2 crewmembers 3 locomotives, 124 railcars
<b>Track</b>	Main track, signalized
<b>Hazardous materials</b>	None
<b>Fatalities</b>	1
<b>Injuries</b>	0
<b>Damages</b>	\$15.6 million

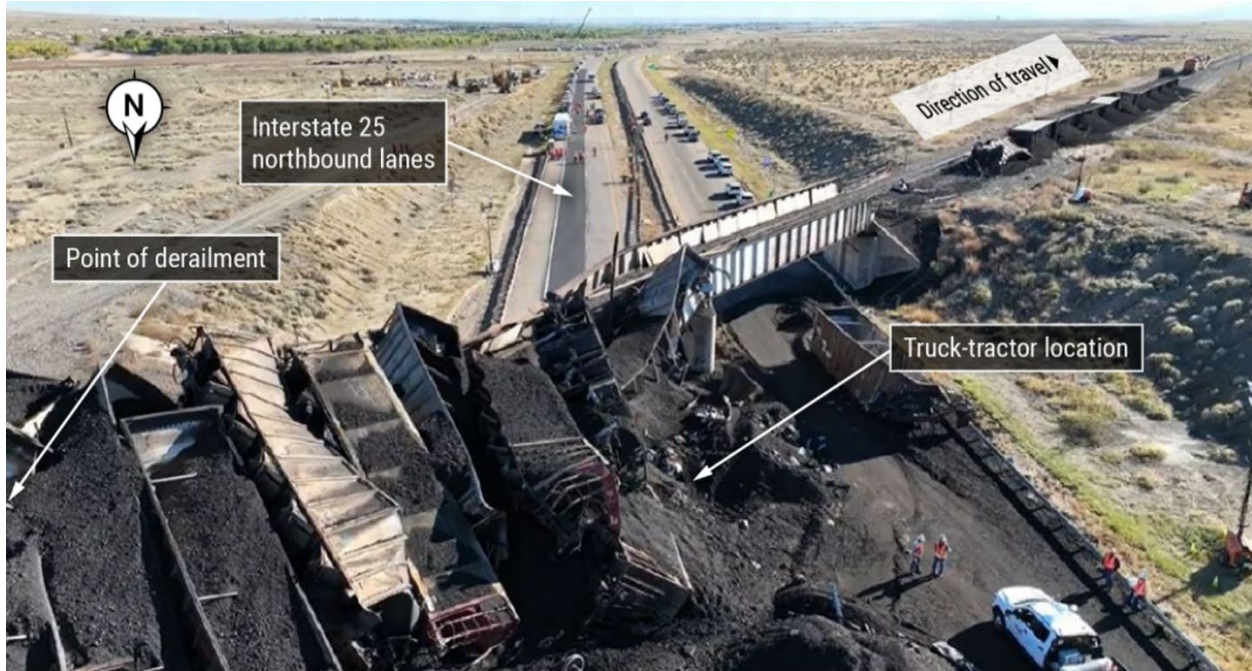
On October 15, 2023, about 3:24 p.m. local time, southbound BNSF Railway (BNSF) freight train C-ATMCRD0-31D derailed 31 hopper cars loaded with coal and subsequently killed a nearby driver in Pueblo, Colorado.<sup>1</sup> The hopper cars derailed near a track switch north of a railroad bridge that crosses over Interstate 25.<sup>2</sup> Derailed hopper cars struck and partially collapsed the bridge over the northbound lanes. Six derailed hopper cars fell to the interstate below, with at least one falling on a northbound truck-tractor in combination with a utility trailer (combination vehicle), killing the driver.<sup>3</sup> The combination vehicle came to rest beneath the collapsed bridge span, derailed hopper cars, and lading. (See figure 1.) No members of the train crew were injured.

**Figure 1.** The derailment site. (Courtesy of BNSF.)

A truck driver was killed following the derailment because the train derailed near a bridge. Derailed hopper cars had enough energy to strike the bridge, partially collapse it, and fall to the interstate below, landing on a combination vehicle and killing the driver.
