Railroad Investigation Report: RIR-25-06

Norfolk Southern Railway Multitrain Collision and Derailment

Location	Easton, Pennsylvania
Date	March 2, 2024
Accident type	Multitrain collision and derailment
Eastbound striking train	Freight train NS268H429 2 crewmembers 2 locomotives, 39 intermodal railcars
Stopped train	Freight train NS24XH101 2 crewmembers 3 locomotives, 27 intermodal railcars
Westbound striking train	Mixed freight train NS19GH501 3 crewmembers 3 locomotives, 199 mixed manifest railcars
Track	Main track, signalized
Hazardous materials	Ethanol residue and butane residue
Fatalities	0
Injuries	4
Damages	\$2.5 million

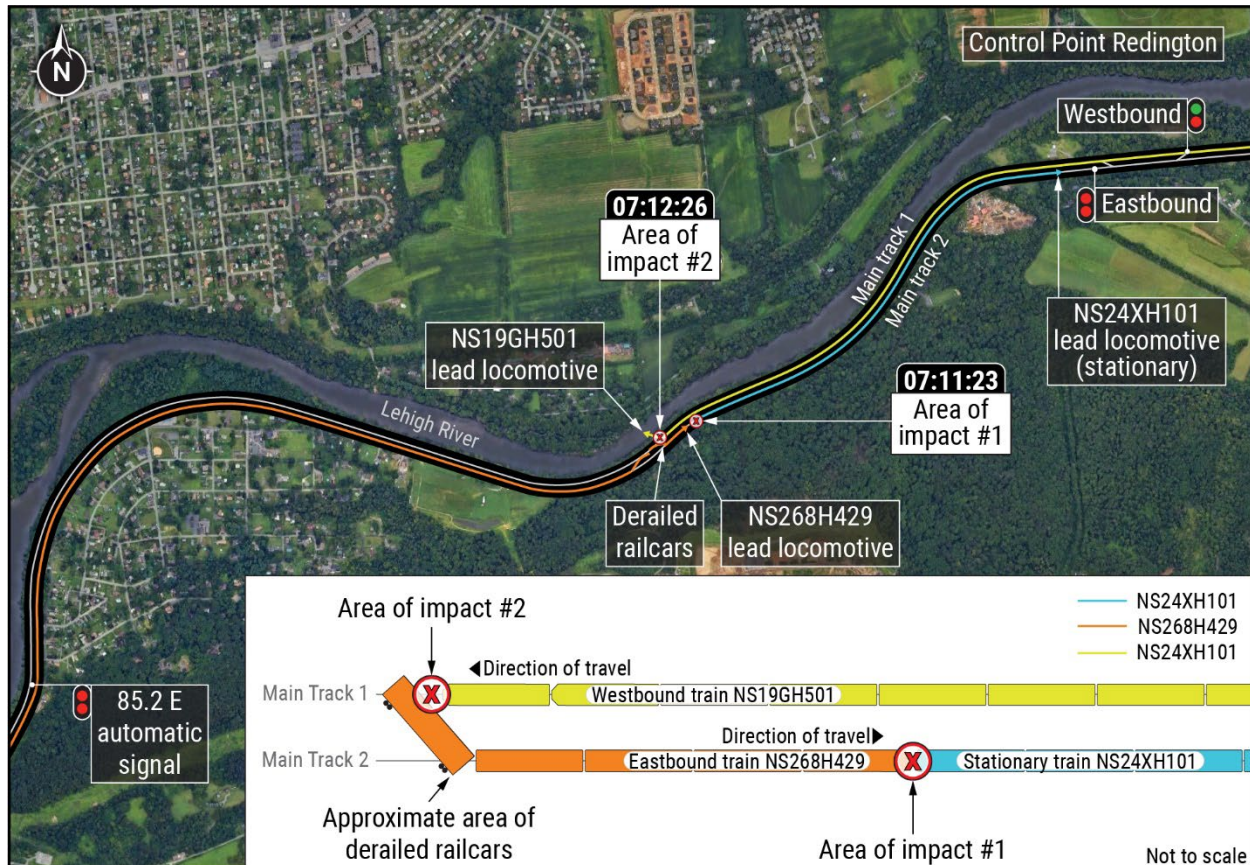
placarded as hazardous materials tank cars: one containing ethanol residue and two containing butane residue.³ The tank cars did not breach or release hazardous materials. The two derailed locomotives partially submerged in the Lehigh River and discharged locomotive diesel fuel into the water. (See figure.) Four crewmembers from the accident trains were transported to a local hospital, treated for minor injuries, and released. At the time of the collisions, visibility conditions were daylight and overcast; the weather was 35°F with light rain.

Figure. Graphic showing aerial view of train routes and derailment illustration. (Source: Google Earth.)
