PRELIMINARY REPORT
RAILROAD
CSX Transportation
Roadway Maintenance Machine Operator Fatality

Wartrace, Tennessee
March 12, 2018
RRD18FR004

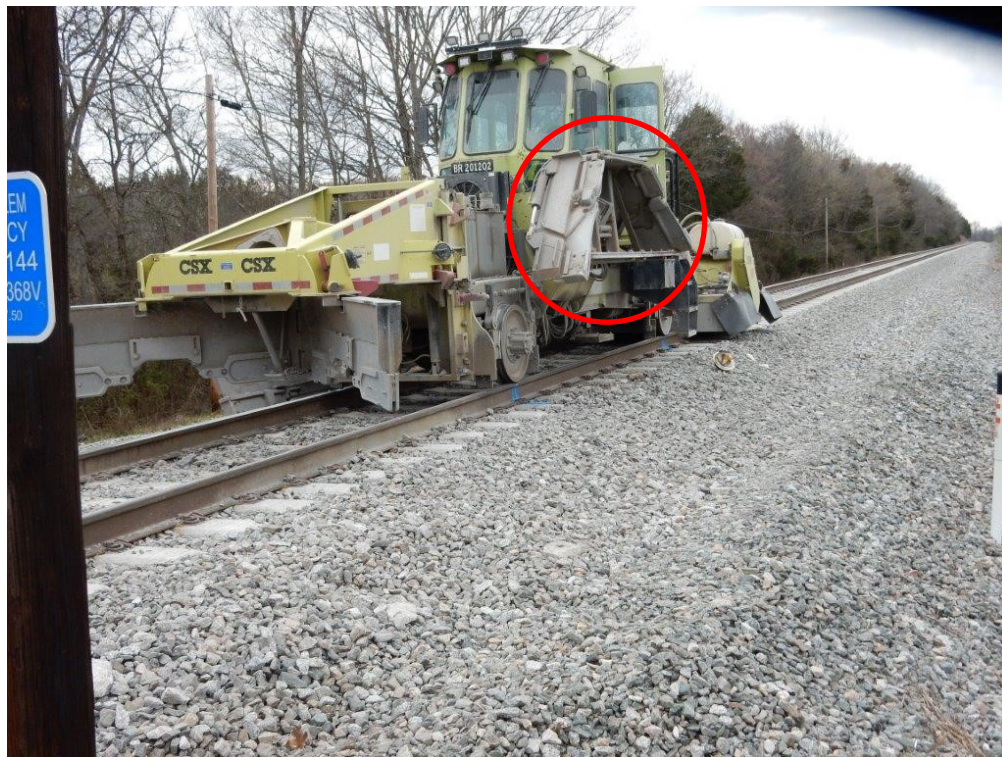
Figure. Photograph of the ballast regulator at the accident site. The area where the operator was trapped is circled. (Photograph provided by the Federal Railroad Administration.)
