PRELIMINARY REPORT

Railroad Rear-End Collision Between UP Freight Trains

**Granite Canyon, Wyoming
October 4, 2018
RRD19FR001**

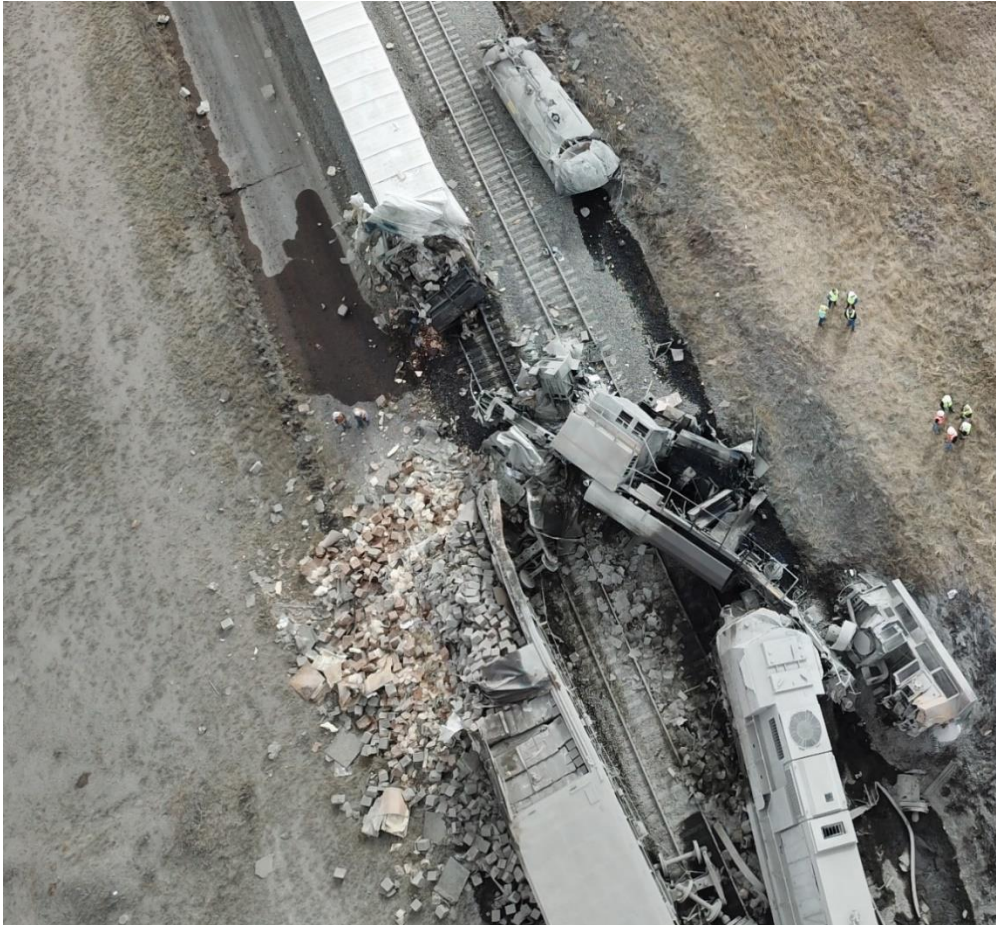
Figure 1. Drone image of resting location of the head-end locomotive from the striking train. Photo provided by UP.
