Illustrated Digest

Norfolk Southern Railway Derailment and Subsequent Hazardous Materials Release

East Palestine, Ohio • February 3, 2023

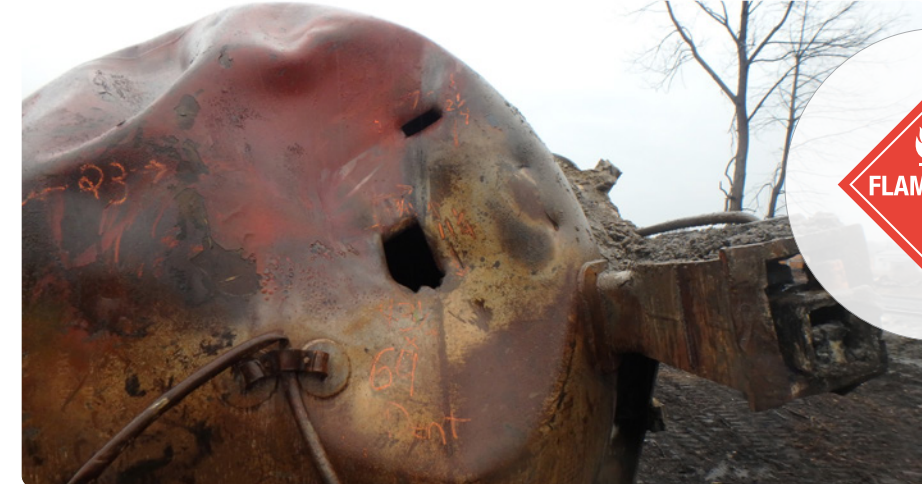
Punctured DOT-111 tank car that released butyl acrylates, a flammable liquid, likely starting the postderailment fires.

A fire breaks out, likely due to butyl acrylates released from a punctured DOT-111 tank car.

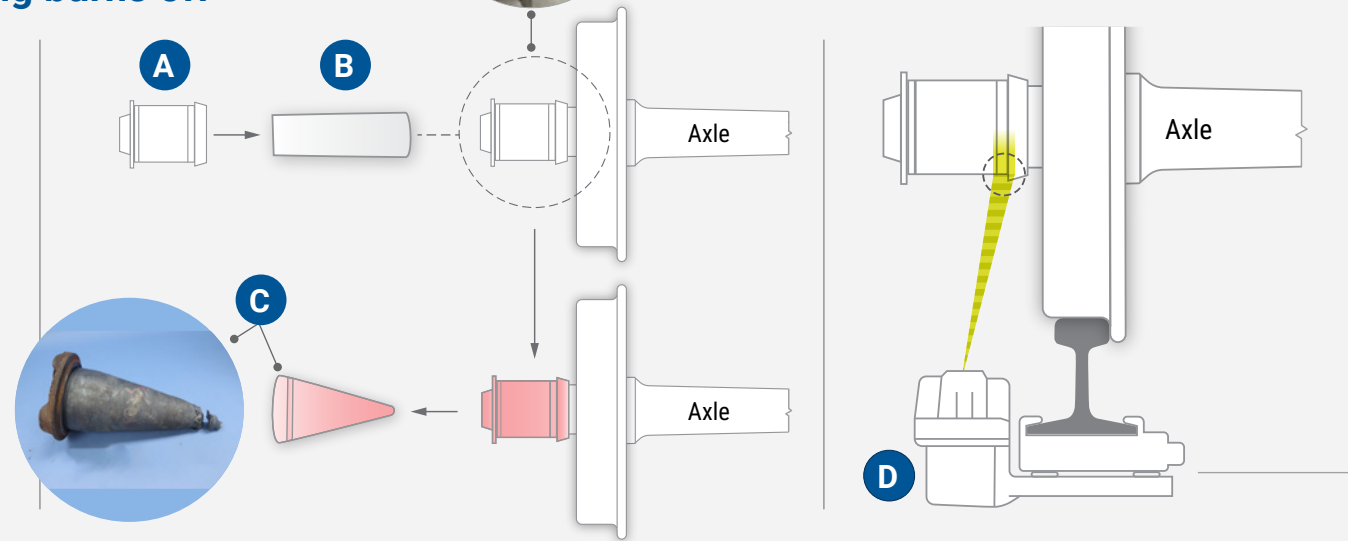
The undetected hot bearing burns off

1. HBDs (D) measure the temperature on the outside of the bearing cup. When a bearing heats up inside, it may take 30-60 minutes for the HBD to sense it from the outside. The HBD in Salem measured a temperature of only 103° above ambient, despite the fact that the bearing was on fire. So, it generated an alert to the Wayside Help Desk, not an alarm to the train crew.

2. By the time the alarm sounded at the East Palestine HBD, the journal was worn down to a cone, and it was too late. The hopper car and 37 others derailed as the train's emergency braking system activated.

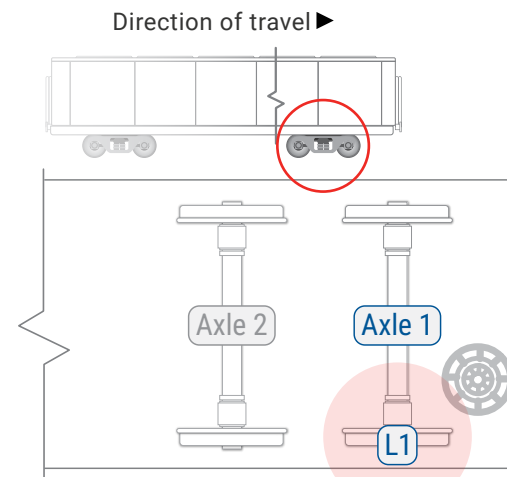
The L1 bearing

The bearing that caused the accident hopper car to derail was its L1 bearing, which is on the right side of the car, facing the direction of travel.

Railcar axles are numbered starting from the end of the railcar with the brake wheel (the "B end"). When the B end is in the front of the car (when it faces the direction of travel) the "left-side" wheels and bearings are on the right.

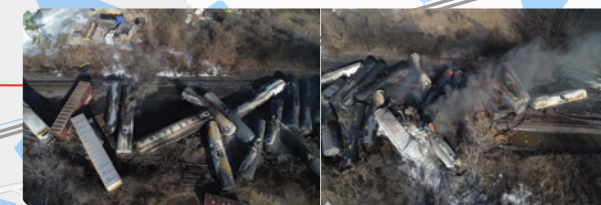
- Placards on tank cars became illegible due to fire.
- Responders asked NS for the consist at about 9:04 p.m. NS did not provide it until shortly before 10 p.m.
- Written guidance and information about chemical hazards was misleading.

Diamond-shaped placards are required on each side and each end of a rail car carrying hazardous materials. They show at a glance which of the nine classes of hazardous materials is present. An identifying number must also be displayed, within the diamond or in a separate rectangular placard, specifying which of the thousands of hazardous materials is being carried.

- Make hazardous materials placards able to survive accidents and fire.

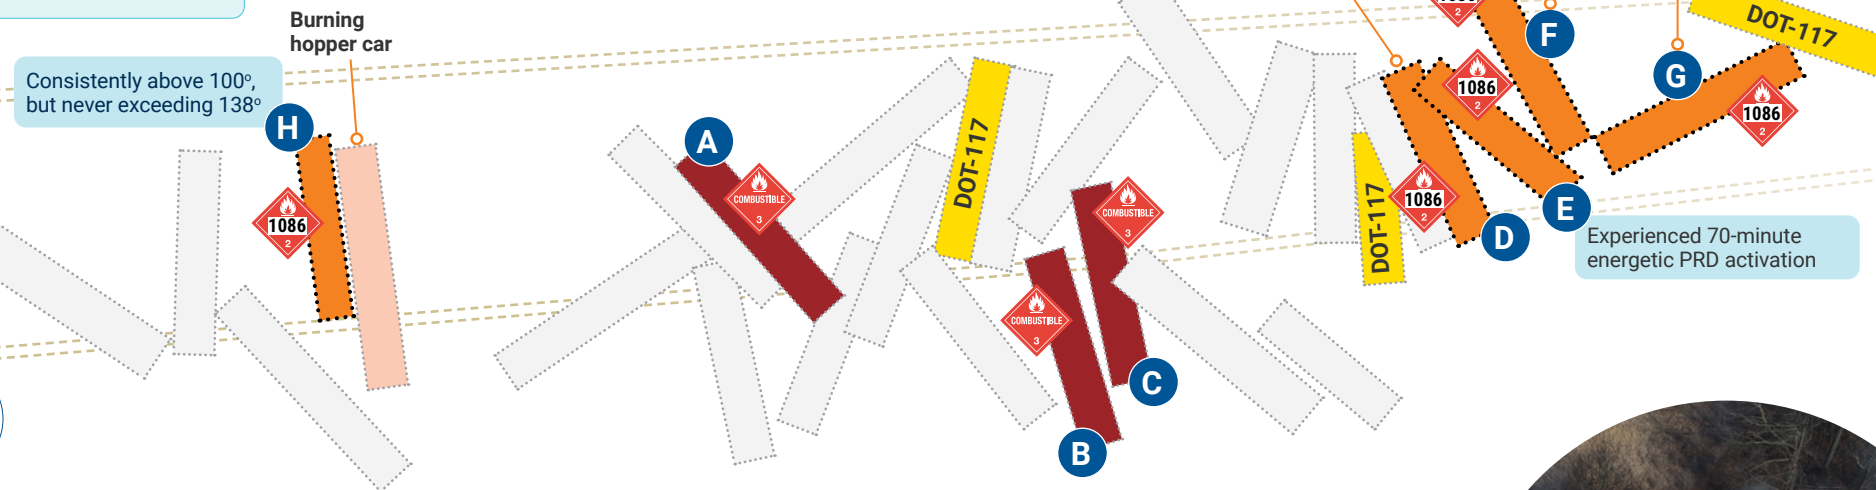
What happened to each derailed car

At right, you can see the fate of the derailed cars. All of the DOT-117 (yellow, black labels) tank cars resisted damage and did not spill their contents. Three DOT-111 tank cars (A-C) did release their flammable and combustible contents through punctures and/or cracks from the derailment, releasing flammable or combustible liquids.

Five DOT-105 cars carrying VCM (D-H) survived the derailment without punctures or tears but contractors vented and burned their contents 3 days later. Four of them had withstood fires without cracks or punctures, even though their PRDs activated and vented some contents.

The initial 2- to 3-hour pool fire that burns in the ditch alongside the derailment is likely fueled by butyl acrylates from tank car (A) in the diagram. Other candidates include the two other red tank cars in the diagram, which carry combustible liquids (B and C).

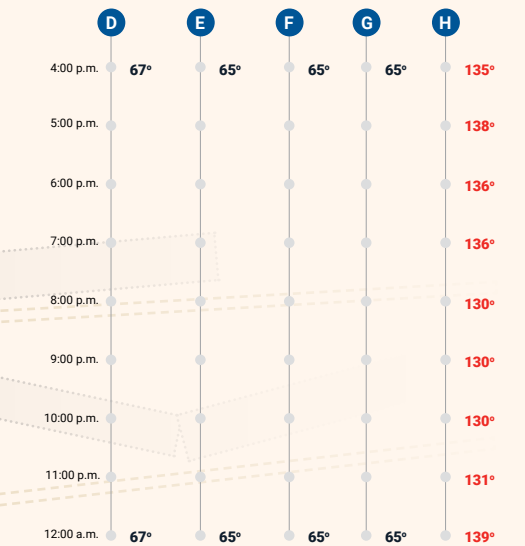
Tank car temperatures, February 5

Most temperatures were in the 60s—room temperature. Other than the VCM tank car at the western edge of the pileup (H), only two readings, both at 7:00 a.m. February 6, were warmer; one was 90° and another was 115°. After that time, only tank car (H) was warmer than room temperature. No car was warmer than 139°.

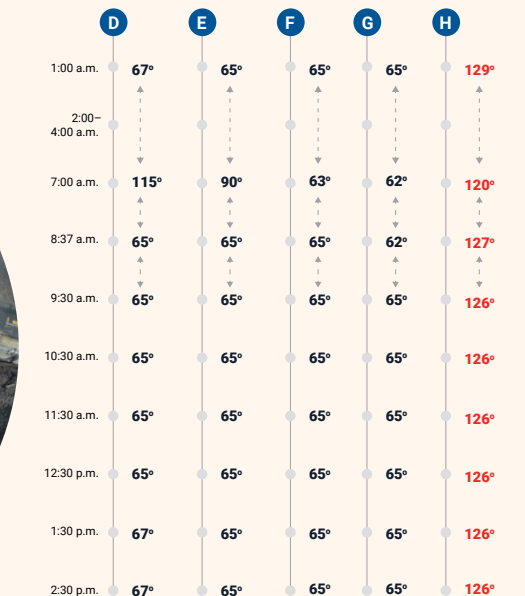
Tank car temperatures, February 6

The temperatures of the five cars, measured on February 5 and 6, do not approach the 185 °F that caused the initial PRD actuations, and temperature trend was even declining (see charts at right).
