Aviation Investigation Preliminary Report

Location:	Newark, NJ	Accident Number:	DCA26FA194
Date & Time:	May 3, 2026, 17:50 UTC	Registration:	N77066
Aircraft:	Boeing 767-424ER	Injuries:	1 Minor, 231 None
Flight Conducted Under:	Part 121: Air carrier - Scheduled

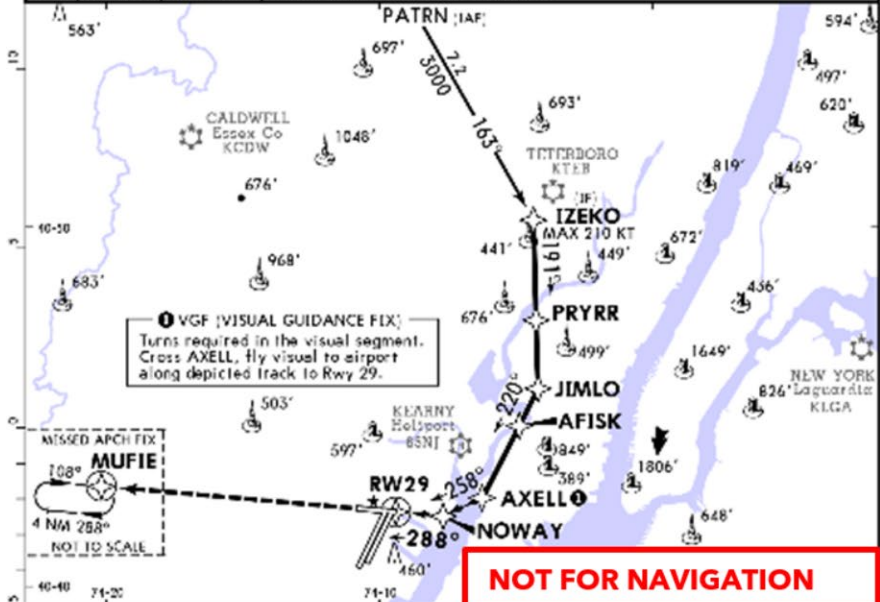
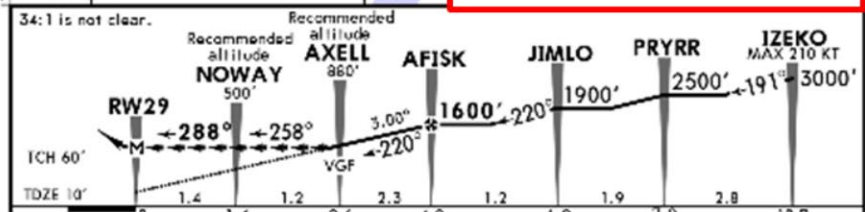
The crew slowed to 250 knots in anticipation of holding. The runway was changed again, this time to runway 29 and the crew was assigned the RNAV W RWY 29 approach, see figure 1. The captain stated he briefed the new approach after each change and that even though they were compressed briefings, all required items were covered.

Figure 1. RNAV (GPS) W Rwy 29 approach into Newark. Note: after crossing AXELL, a visual approach is to be flown along the depicted track to runway 29.

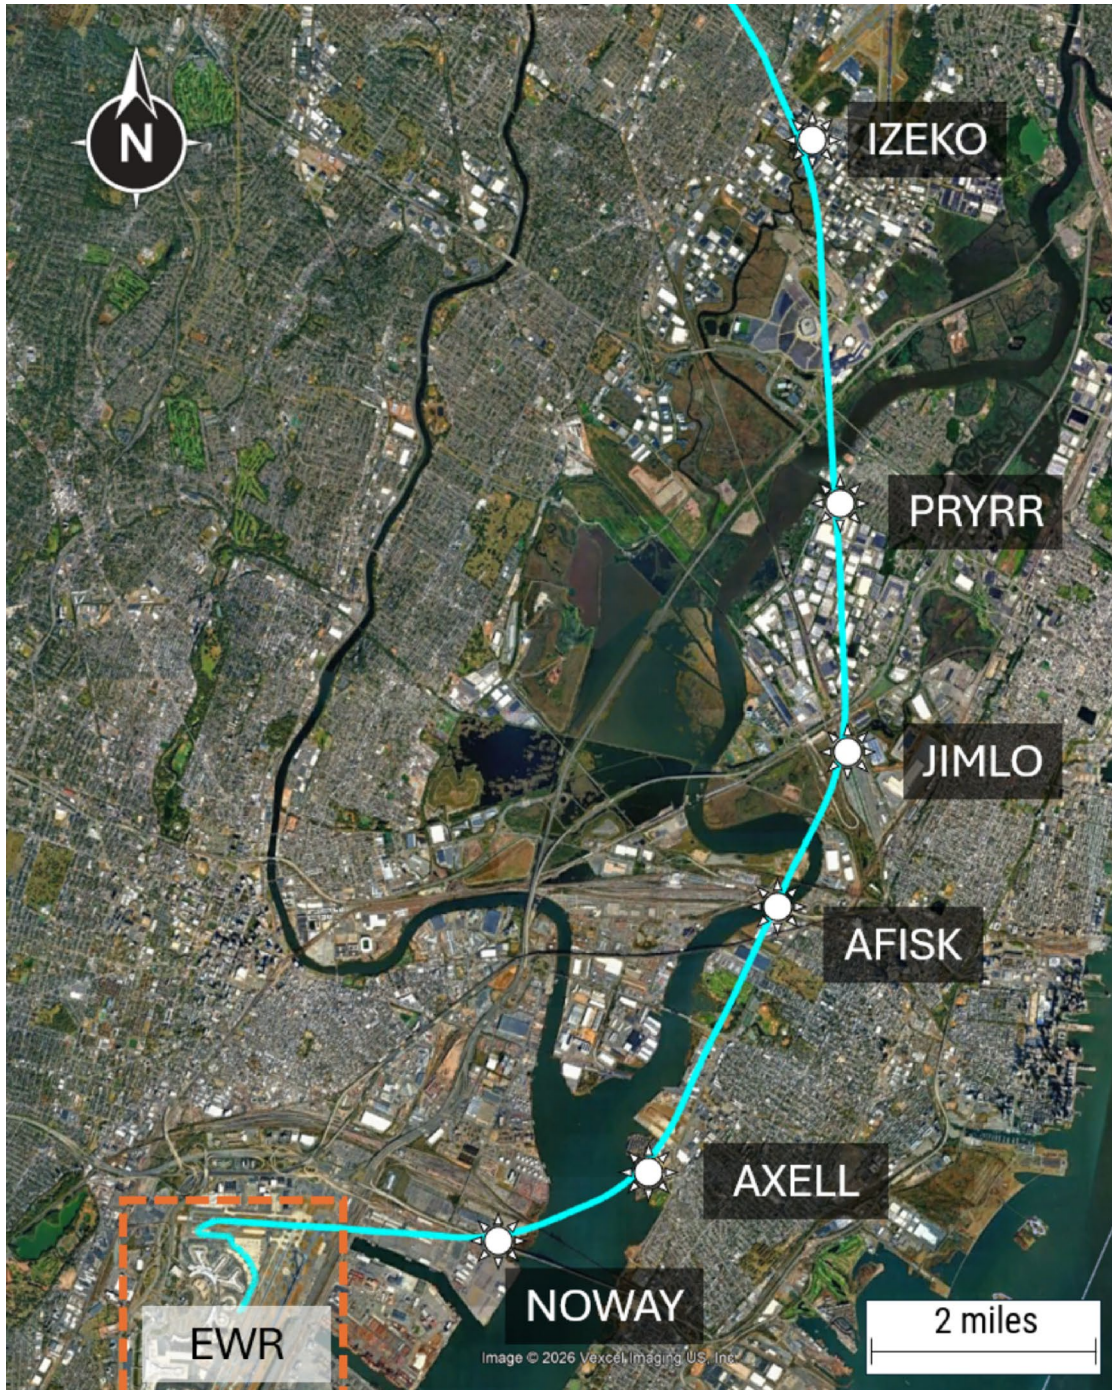
Figure 2. Google Earth image with accident airplane’s flight path overlaid.

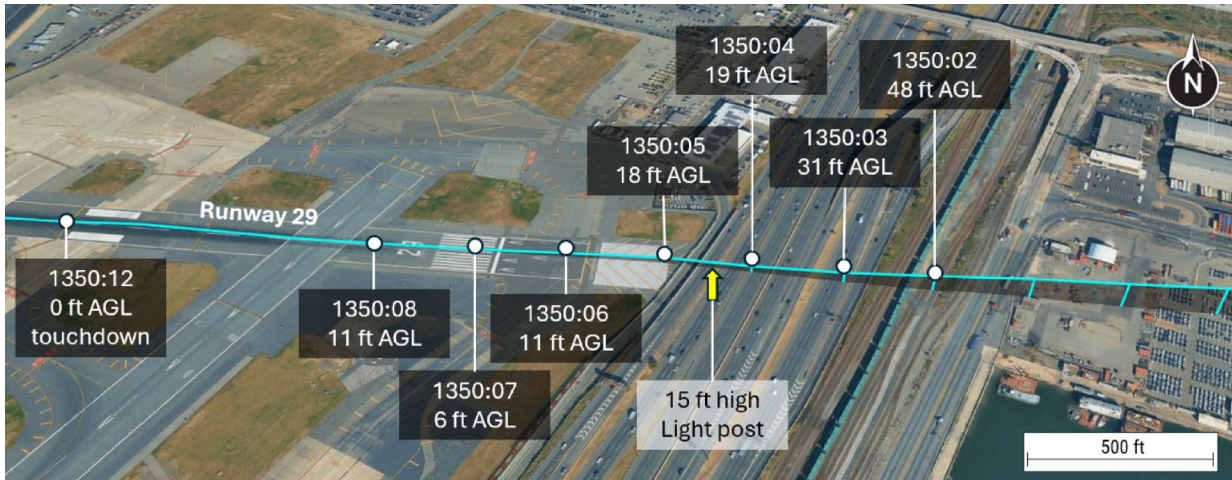
Figure 3. Google Earth image showing the New Jersey turnpike, light post and approach end of runway 29. Note: the turnpike is 5 ft higher than the runway and altitude is depicted as height above ground, so the airplane descended a total of 6 ft between 1350:04 and 1350:05.

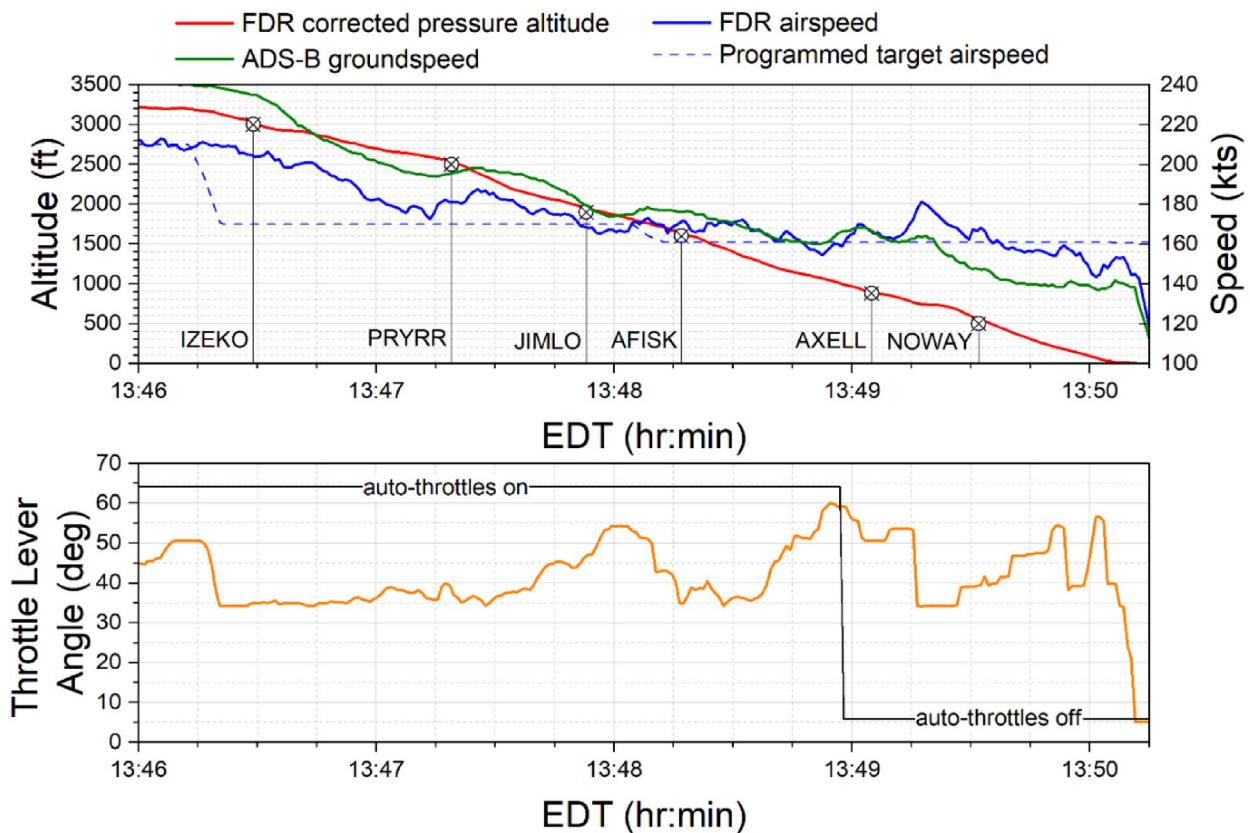
The captain stated that he turned off the autopilot and the auto-throttles at approximately 880 ft MSL or just around AXELL. He said that he “got fast” while he turned the airplane into the headwind and pulled the power levers back to compensate. The airplane shortly returned to a stable airspeed even though the wind gusts were producing “moderate turbulence.”

Figure 4. The upper plot depicts FDR pressure altitude corrected for the barometric setting, ADS-B groundspeed, FDR airspeed and the programmed target airspeed. The lower plot indicates when the auto-throttles were on/off and the throttle lever angle.

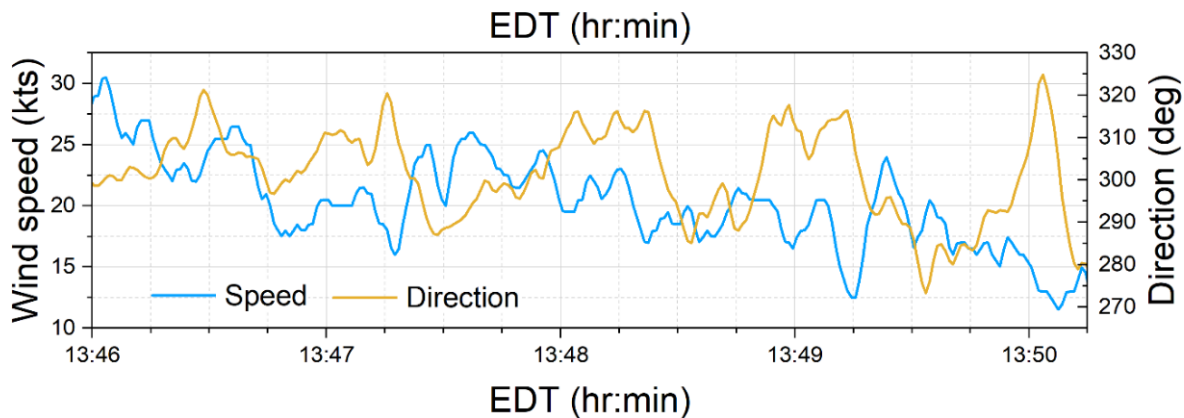
At the last Meteorological Aerodrome Report (METAR) prior to landing (16:51 UTC), the wind was at 290 degrees at 19 knots, gusting to 30 knots, visibility was 10 statute miles, and the altimeter was 29.88 inches of mercury. The Terminal Area Forecast (TAF) issued at 17:24 UTC forecasted gusts up to 30 knots. The TAF issued at 14:32 UTC forecasted gusts up to 28 knots. Figure 5 shows the wind speed and direction from the FDR.

Figure 5. Plot depicts wind speed (blue line) and direction (yellow line) from the FDR. There is a gust just prior to the airplane reaching NOWAY at 1349:25.

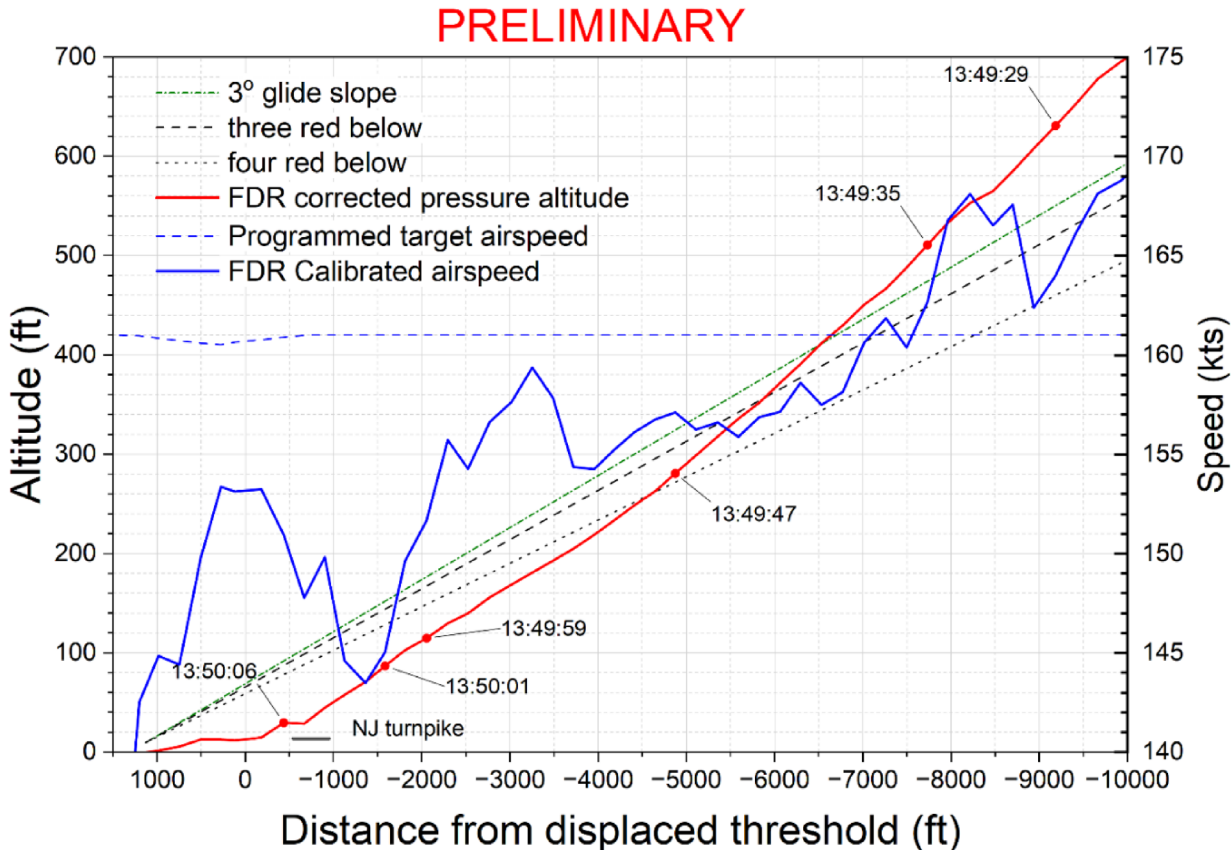
PAPIs are normally located on the left side of runways, however the PAPIs on runway 29 at EWR are located on the right side of the runway. Figure 6 depicts the glideslope for the

accident flight (red line). The green dotted line shows the altitude for a 3-degree glide slope path when the crew would see two red/two white on the PAPI. Altitudes below the grey dashed line would result in three red/one white on the PAPI. Altitudes below the grey dotted line would result in viewing four red lights on the PAPI.

Figure 6. Plot that depicts the altitude, speed and distance from the displaced threshold for runway 29. The red line is the FDR corrected pressure altitude; the blue line is the FDR calibrated airspeed; the dotted green line shows the altitude for a 3-degree glide slope path (crew would see two red/two white on PAPI) and altitudes below the dotted grey line would result in viewing four red lights on the PAPI.

After the accident, United Flight Operations issued an Ops Alert that applied to EWR arrivals specific to the RNAV vertical guidance for runway 29. It reminded pilots that the visual glideslope indicator (VGSI) was designed to provide safe obstruction clearance within 10 degrees of the runway centerline up to 4 NM. In addition, United Flight Operations issued Pilot Bulletin 26-069 revision 1 to all pilots that applied to short runway landing guidance. It mentioned that a hazard was identified through their Safety Management System (SMS) that the pilot technique of shifting the aimpoint of electronic or visual glide path indications, or “ducking under”, contributes to low approach altitudes during the visual segment into certain airports and runways. It emphasized that all approaches shall be conducted so that touchdown occurs 1500’ from the runway threshold, but not prior to 1000’ from the threshold, in accordance with their Flight Manual, Chapter 3.

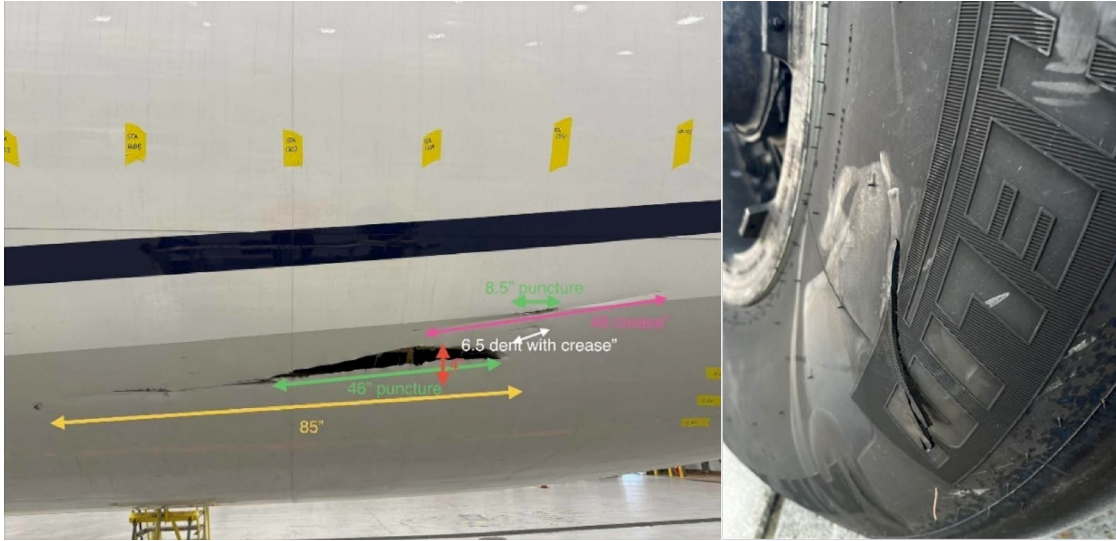
On site examination of the airplane revealed three punctures to the left lower aft fuselage. The damage runs from fuselage stations 1219 to 1373 and between stringers 27L and 31L. The forward puncture was about 6" long and 1" wide, the middle puncture was about 46" long and 4" wide and the aft puncture was about 8.5" long and 1" wide. Between the damaged areas there were also dents and creases on the skin. The total size of the holes was larger than the outflow valve and the damage affected all 3 elements of the fuselage structure making the damage to the airplane substantial. The #1 tire on the left main landing gear (MLG) had evidence of slash marks. See figure 7 for pictures of airplane and tire damage.

Figure 7. Right photo shows the left lower aft fuselage damage, and the left photo shows the damage to the #1 left MLG tire. (Source: United Airlines)

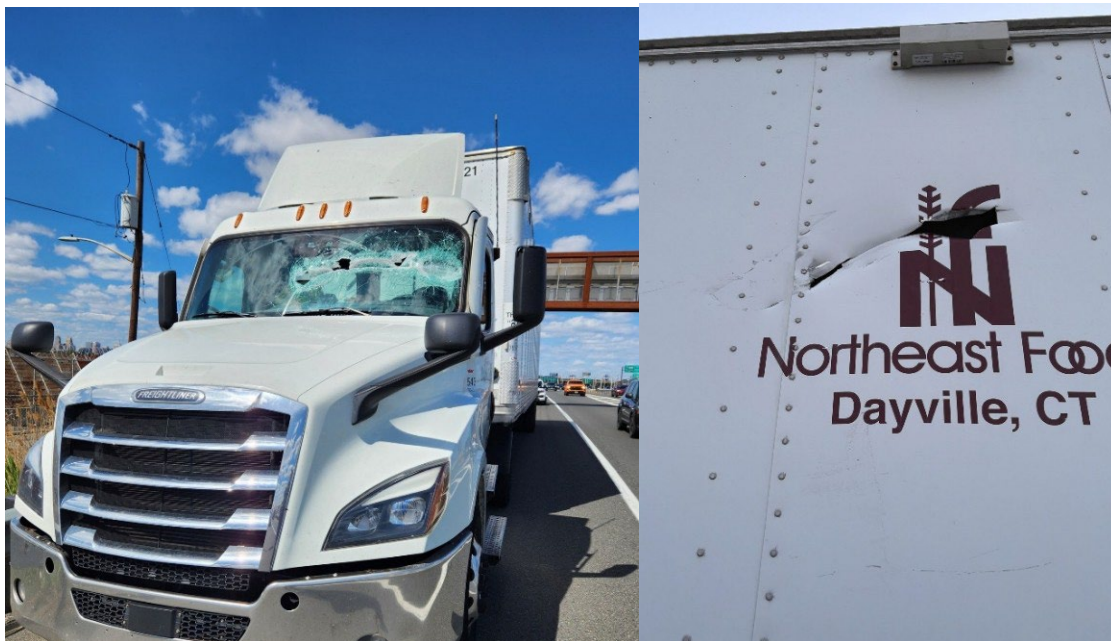
The tractor-trailer that was struck by the light pole had damage to the windshield and the side of the trailer, see figure 8. The windshield appeared to have impact damage and there were impact marks on the forward upper left corner of the trailer, and punctures in the aluminum siding. One major puncture was on the front face of the trailer, and the second puncture was minor and on the forward left side of the trailer. There was no evidence of tire marks on either the tractor cab or trailer.

Figure 8. Left photo shows the damage to the tractor cab's windshield, and the right photo is front face of the trailer. (Source: left photo Port Authority, right photo NTSB)
