## AIRCRAFT INCIDENT REPORT

EASTERN AIRLINES, INC.,  
BOEING 727-25 N8139  
ATLANTA HARTSFIELD INTERNATIONAL AIRPORT,  
ATLANTA, GEORGIA

AUGUST 22, 1979

NTSB-AAR-80-8

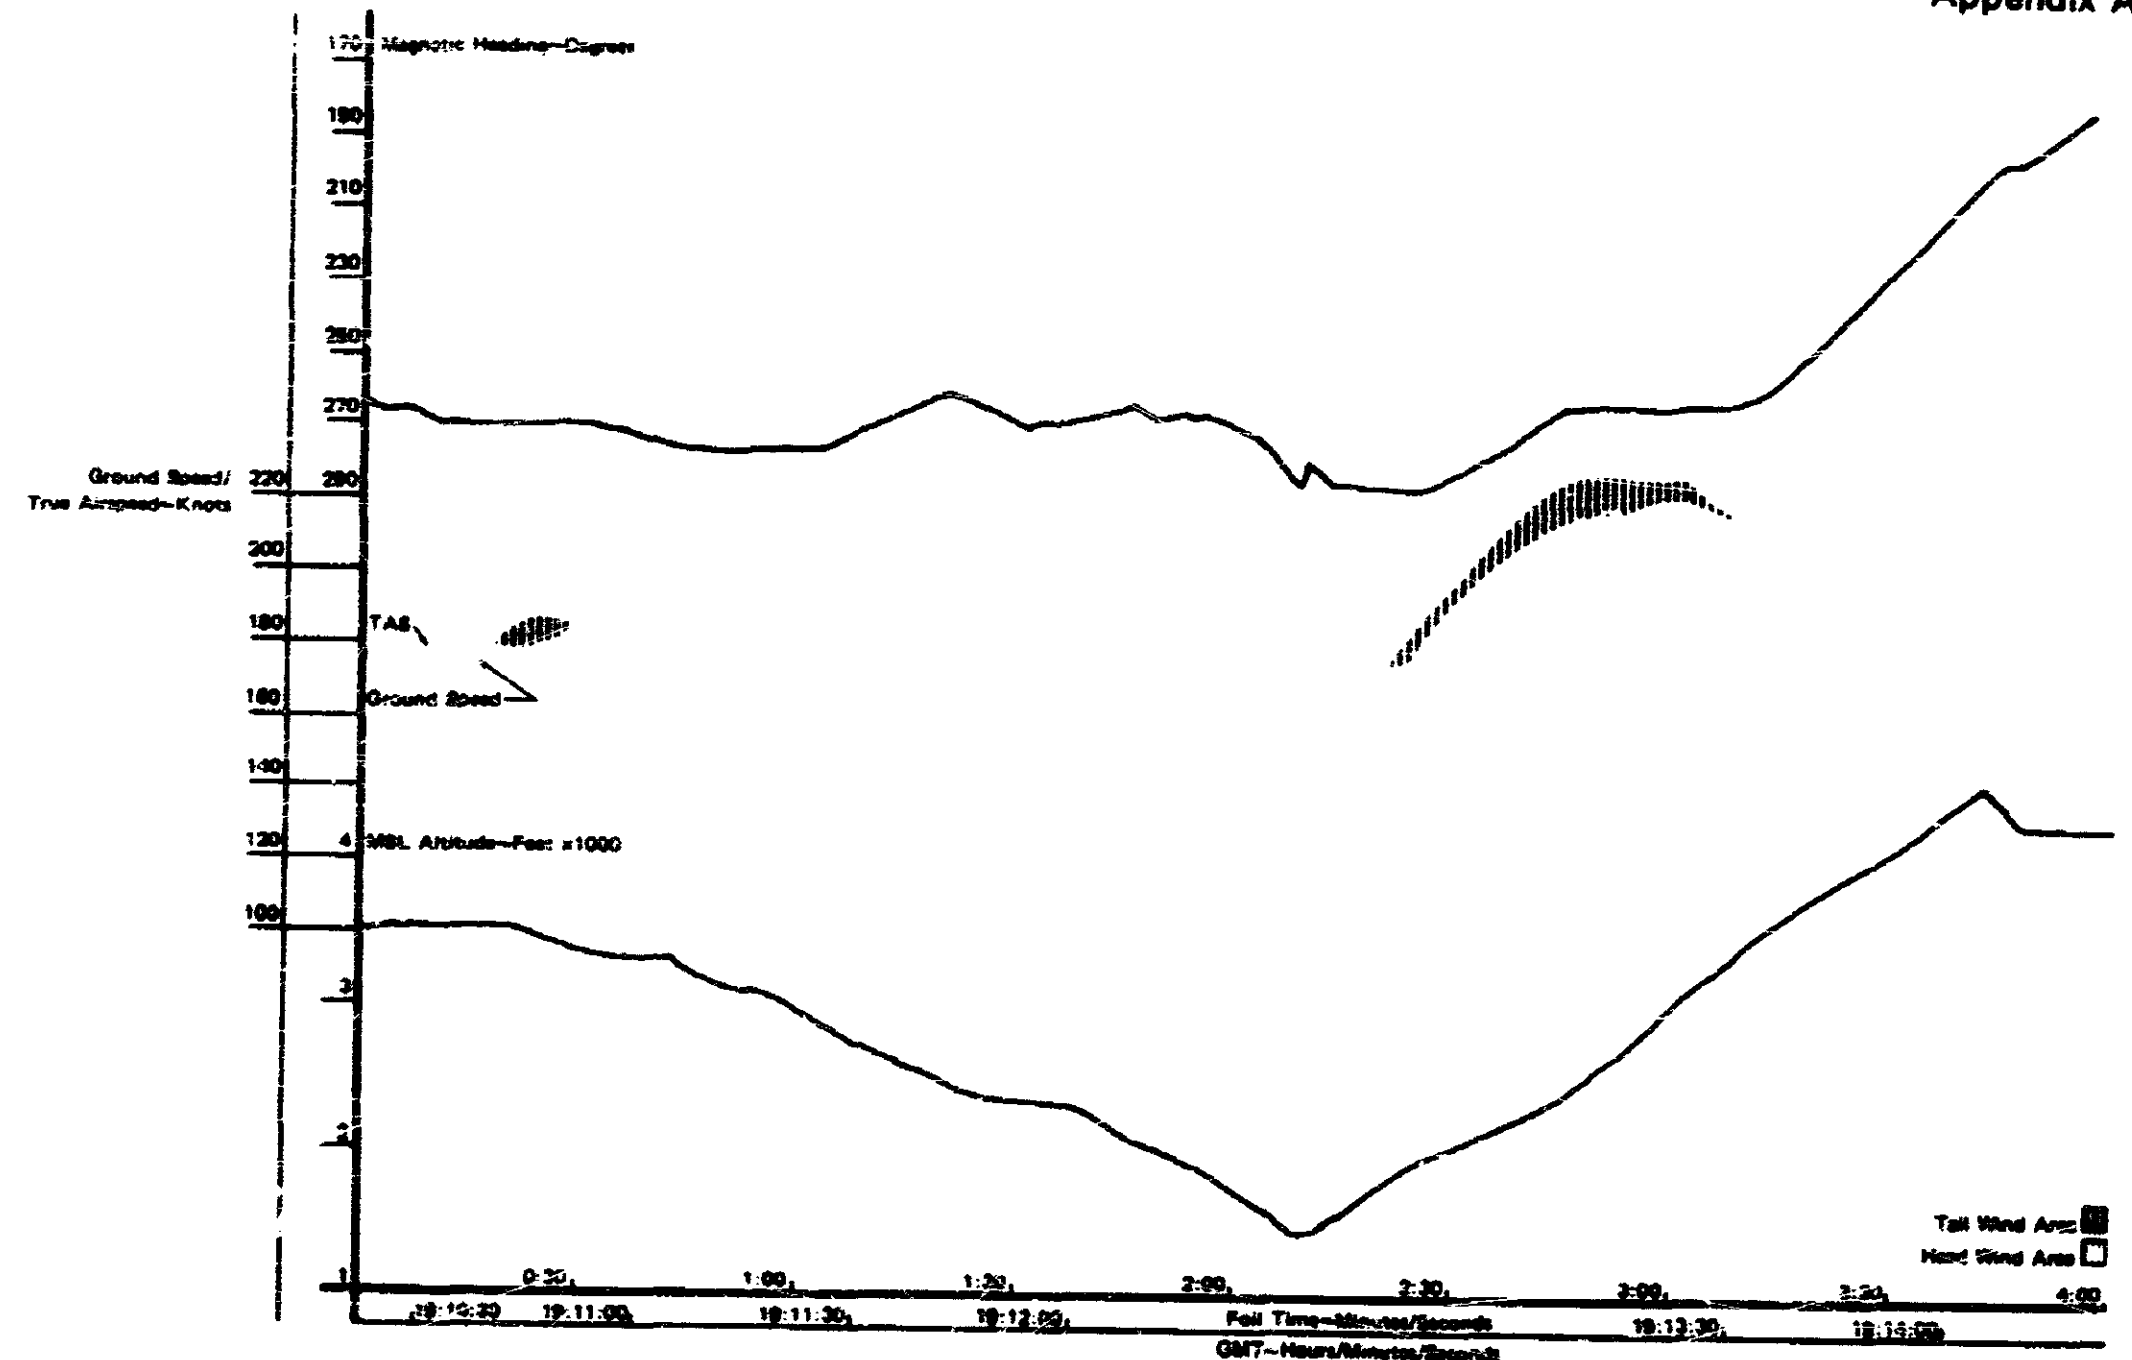
Appendix A

NTSB Washington, D.C. FOR Heading & Altitude True Airspeed & ARTS III Groundspeed  
 EAL, Boeing B-727, N8138 FLT 892, Atlanta, Georgia  
 August 25, 1978

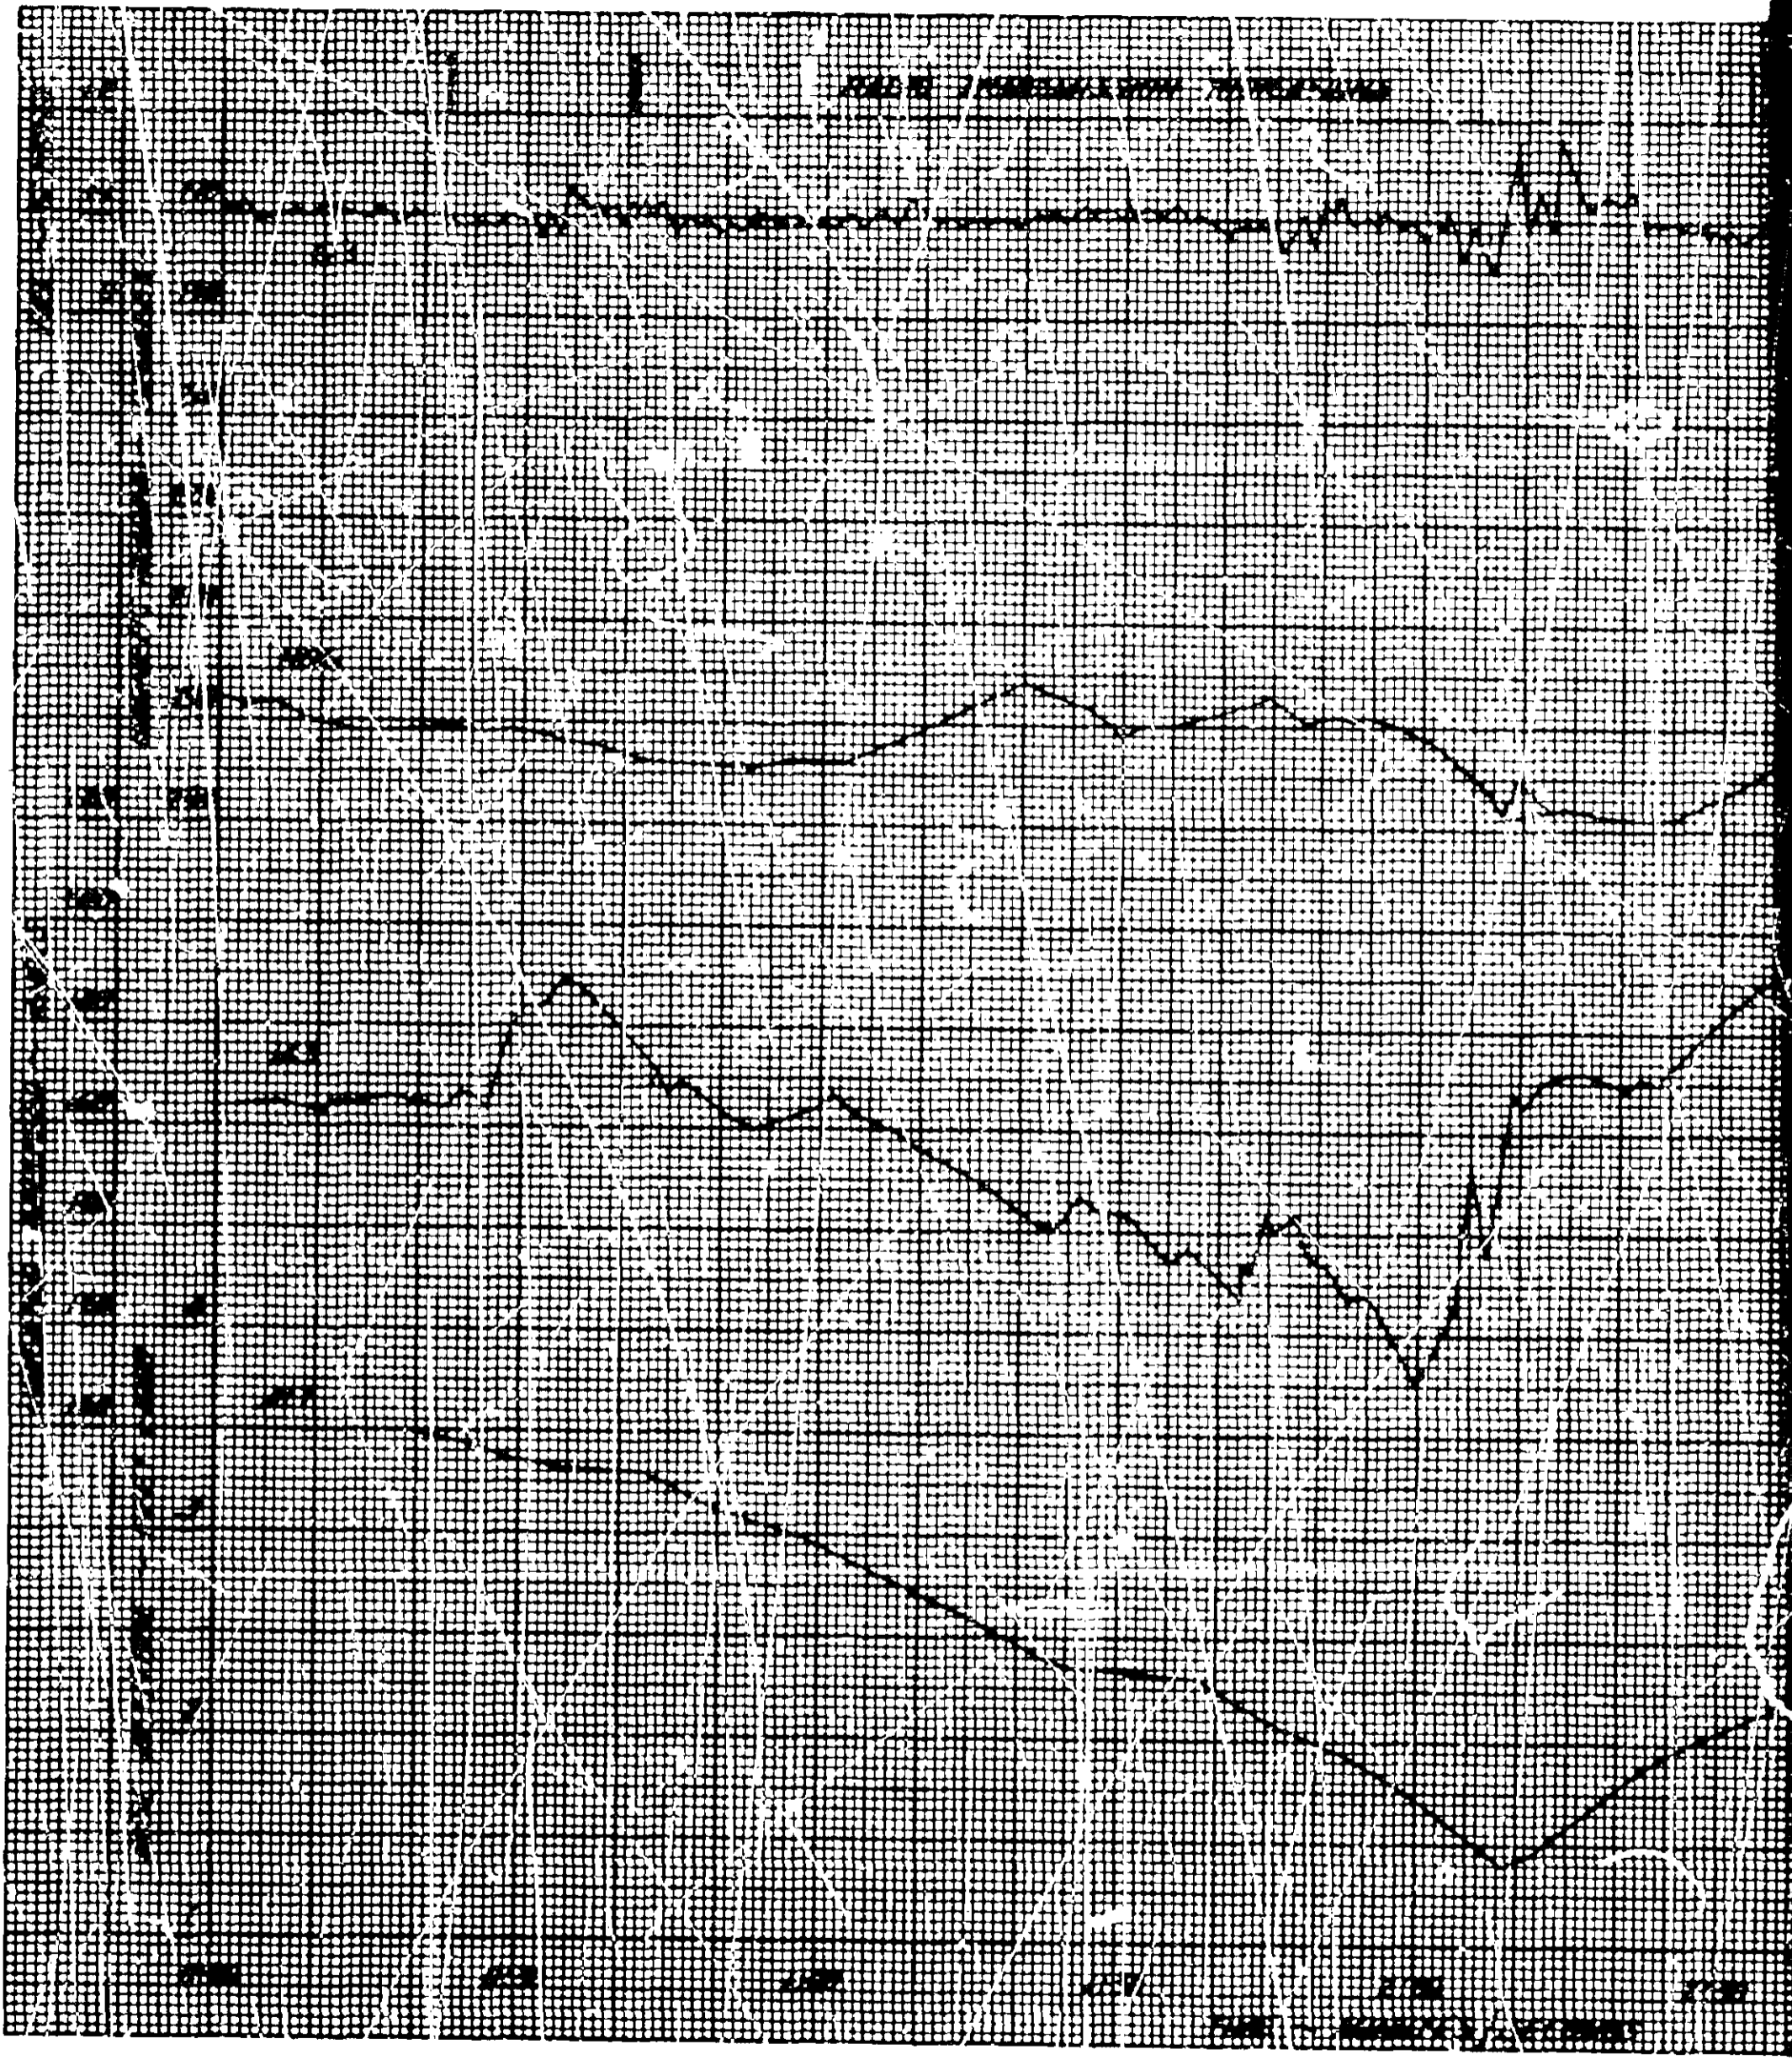
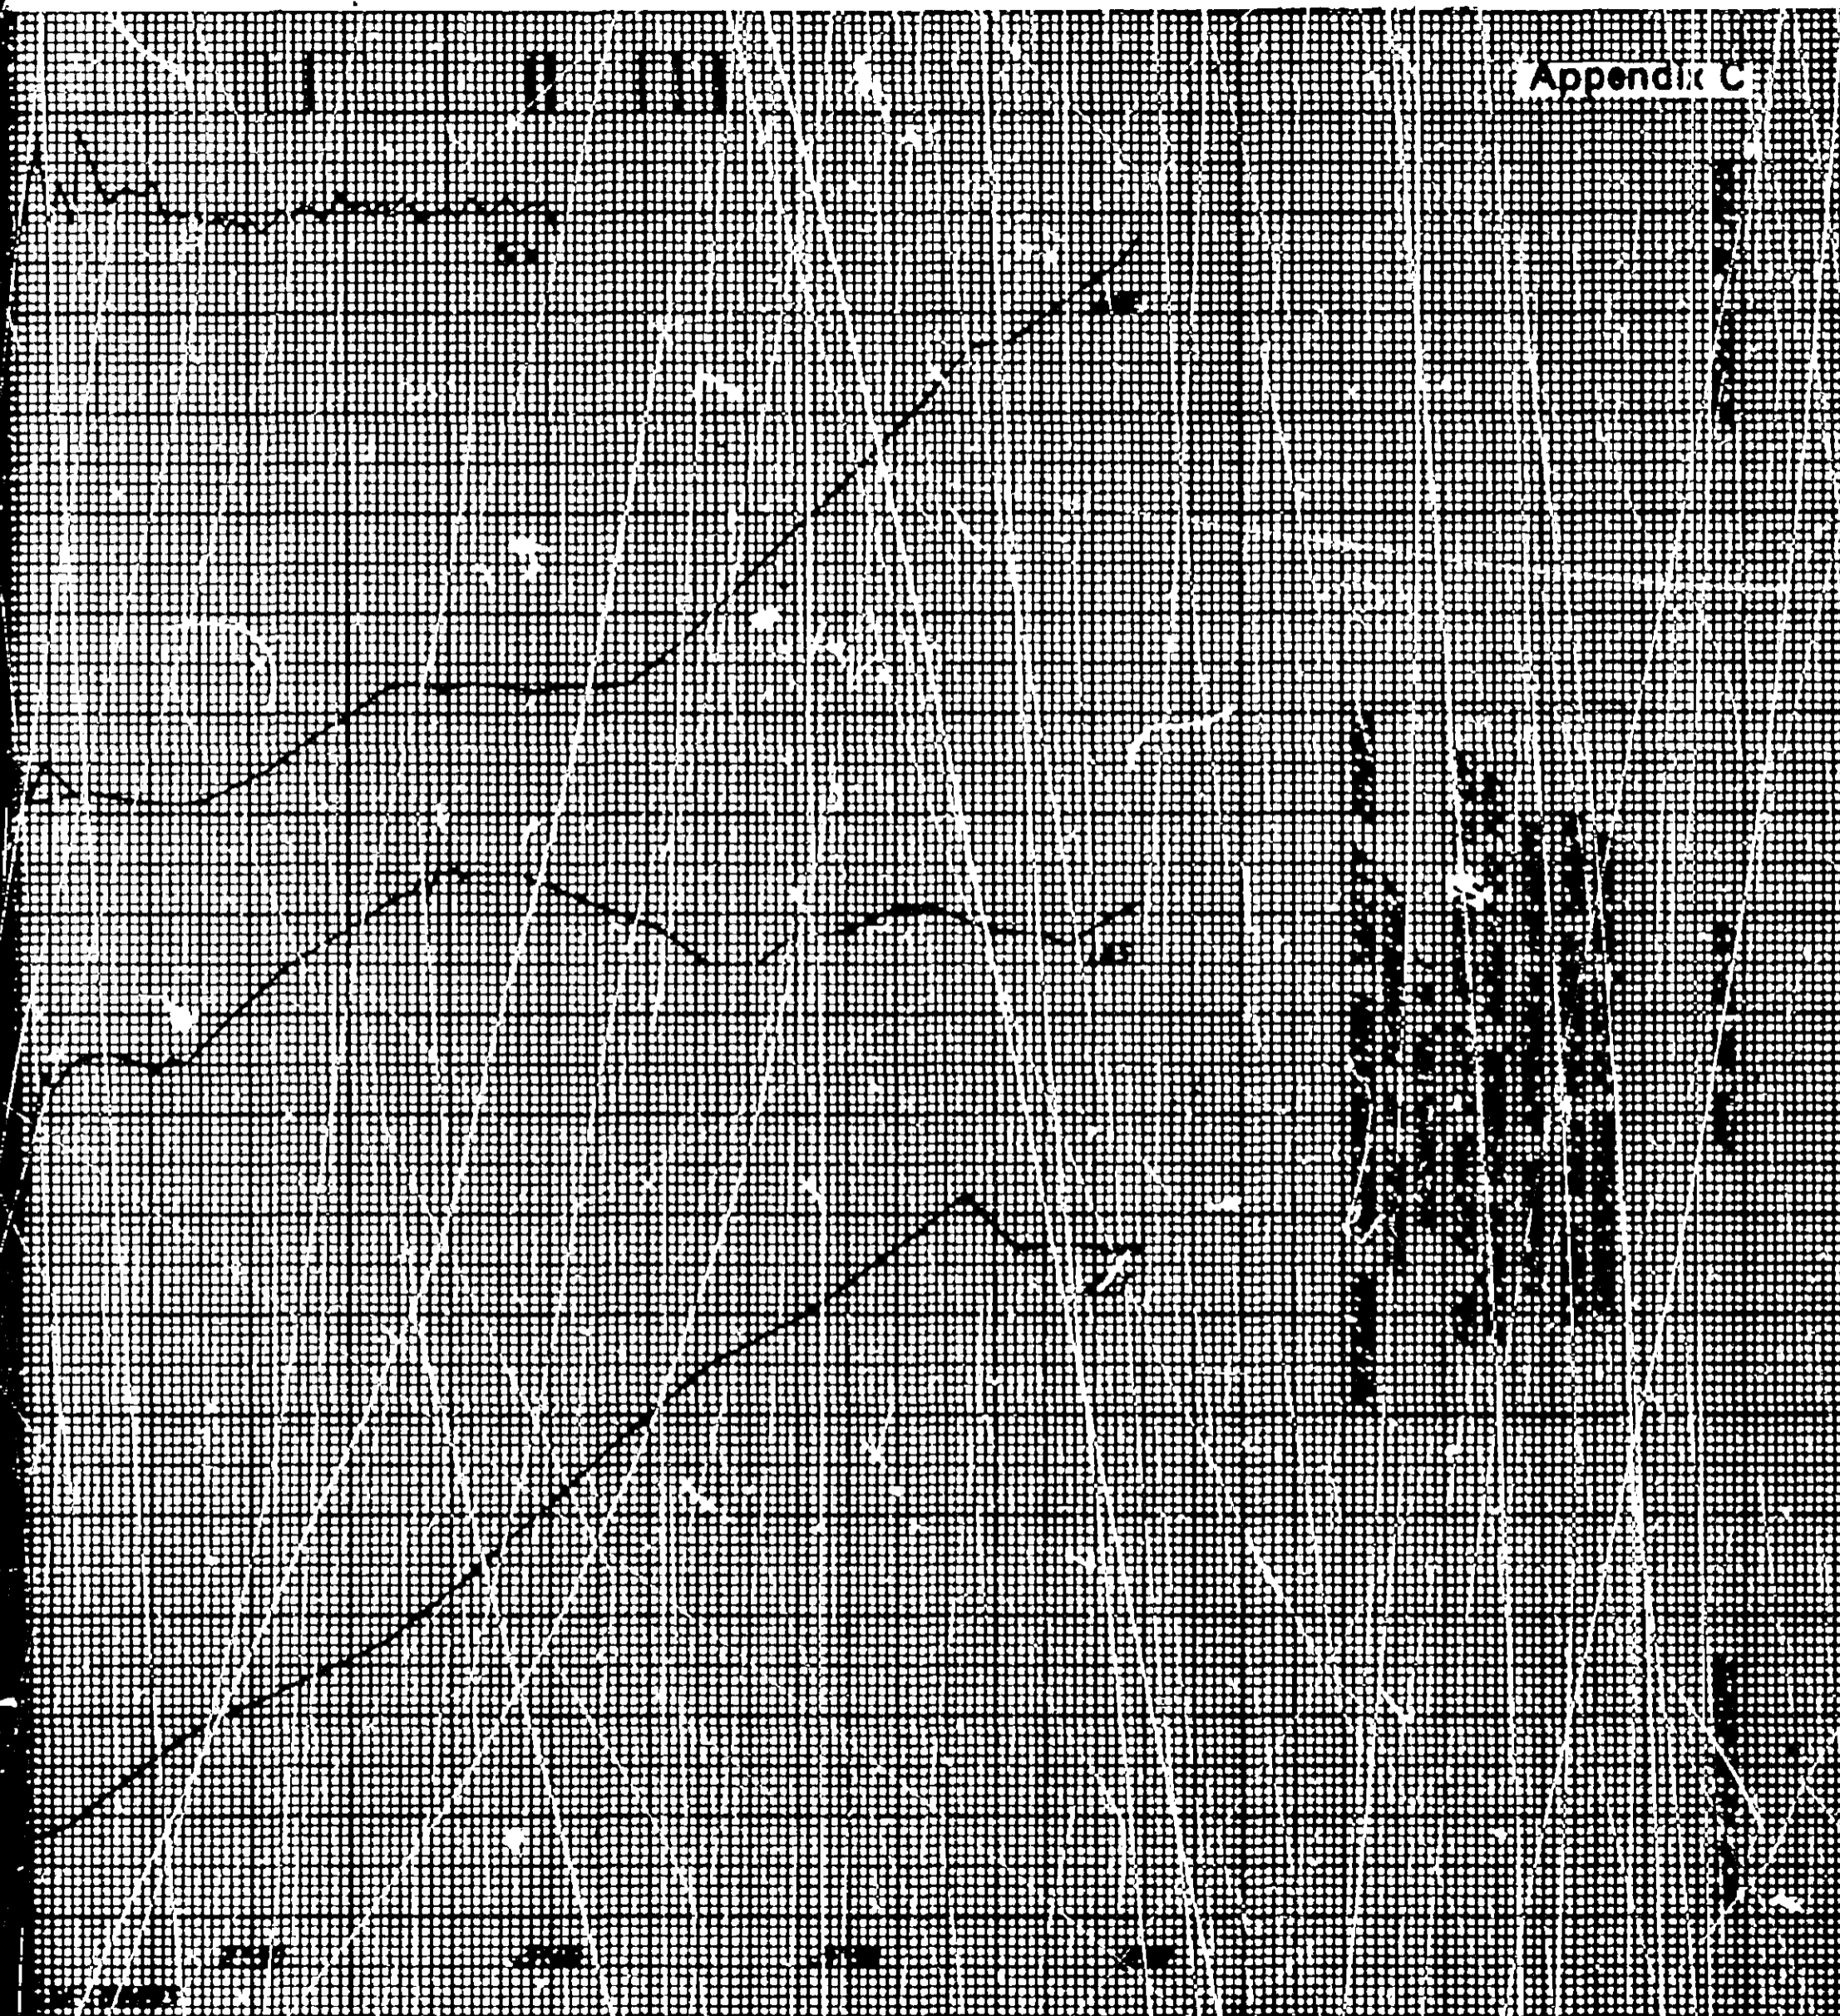
Flight 693's FDR foil was undamaged and a readout of the 2 min before and the 2 min after the indicated low point of the altitude trace was made. (See appendix C.) The OM, which is 5 nmi from the threshold of runway 27L, was passed about 58 sec on the readout's time baseline; the lowest altitude—1,400 ft (about 375 ft a.g.l.)—occurred at 2 min 9 sec.

Twenty seconds after the start of the readout, the pilot began to descend from 3,500 ft. Between 20 sec and 98 sec, the aircraft descended at an average rate of 923 fpm to 2,300 ft. Between 98 sec and 113 sec, the aircraft descended at an average 1,500 fpm to 1,925 ft, and between 113 sec and 129 sec, it descended at an average 1,969 fpm to 1,400 ft. Thereafter, the aircraft began to climb and achieved a rate of climb of about 2,004 fpm.

During the first 27 sec of the readout, the airspeed was stabilized at 162 KIAS. About 30 sec before crossing the OM, the airspeed began to increase, reaching 184 KIAS within 8 sec and then restablilizing about 162 KIAS as the OM was crossed. Between 70 sec and 100 sec, while the aircraft was descending at 923 fpm to 2,300 ft, the airspeed decreased to 128 KIAS. Over the next 5 sec, the airspeed increased to 144 KIAS and then decreased. The lowest airspeed--110 KIAS--was recorded 9 sec before the lowest altitude was recorded. Beginning at 120 sec, the airspeed began to increase and reached 209 KIAS at 170 sec. The most erratic movements and maximum variations of the airspeed trace occurred between 102 sec and 130 sec. These coincided with the maximum descent rates noted on the altitude trace and the largest excursions noted on the vertical acceleration trace.
