Highway–Railroad Grade Crossing Collision  
US Highway 95  
Miriam, Nevada  
June 24, 2011

NTSB/HAR-12/03  
PB2013-103891

# Highway Accident Report

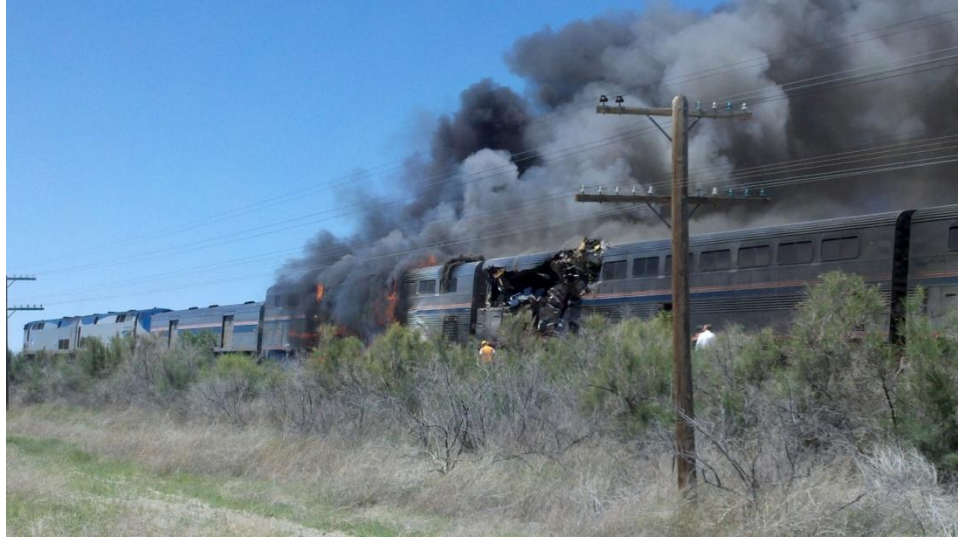
**Figure 3.** From left to right, photograph showing two locomotives, baggage railcar, burning crew sleeper railcar, first coach railcar with large opening where penetrated by first side-dump trailer, and front of second coach railcar. (Courtesy of rail passenger)

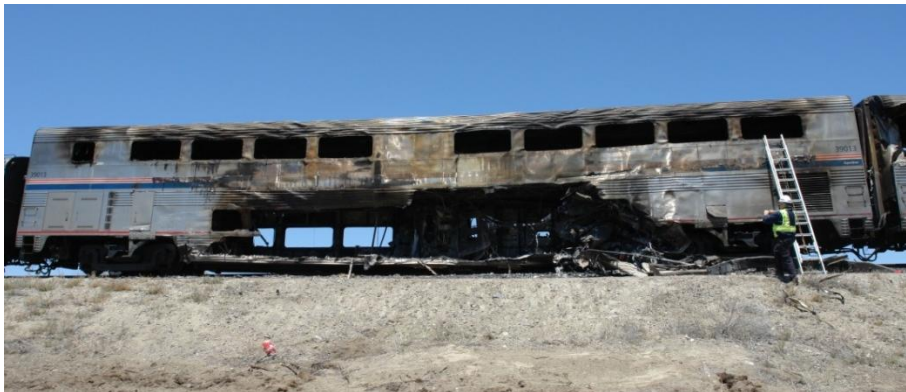
**1.5.1.1 Crew Sleeper Railcar 39013.** During the accident sequence, the left front of the truck-tractor struck the bilevel crew sleeper railcar near the midpoint of its forward wheel assembly. (See figure 5.) Postrecovery examination showed that the railcar roof had a wavy appearance consistent with distortion due to high temperatures. All the railcar windows had melted. The outer surfaces of the stainless-steel side panels had pronounced thermal discoloration, as evidenced by blue- and straw-colored hues. On the forward end of the railcar, the rubber diaphragm that surrounded the car-to-car door opening was intact. On the aft end of the railcar, the fire had consumed the rubber diaphragm on the car-to-car door leading to the trailing coach railcar. The interior compartment of the lower level was destroyed, rendering it substantially a continuous open space. The fire consumed all combustible materials in the lower level and destroyed the upper level of the railcar.

**Figure 5.** Photograph of crew sleeper railcar 39013, with front of railcar at left, showing where accident truck-tractor penetrated lower level and ensuing fire engulfed railcar.

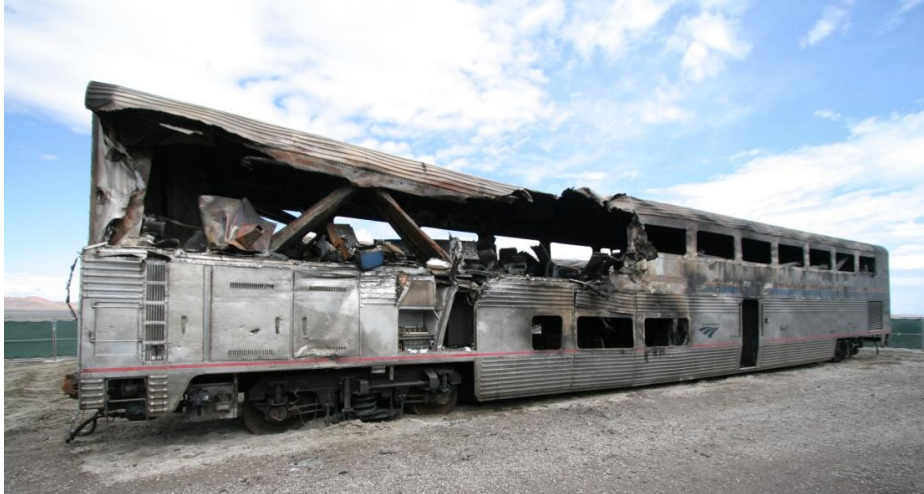
**1.5.1.2 First Coach Railcar 34033.** The coach railcar behind the crew sleeper railcar also sustained impact and subsequent fire damage, as shown in figures 6 and 7. This bilevel railcar had passenger seating on the upper level, and lavatories and a smaller passenger compartment on the lower level. During the accident sequence, the first trailer of the accident truck penetrated the upper level sidewall panel of the railcar, and the impact damage continued longitudinally toward the aft end. This damage resulted in an opening in the left sidewall panel, extending horizontally from the forward corner-post of the upper level passenger compartment and progressing aft about 33 feet (which is about 40 percent of the length of the railcar). The seating area at the forward end of the upper level passenger compartment also showed signs of impact damage.

**Figure 6.** Photograph of first coach railcar 34033 at impound lot, with front of railcar at left, showing extent of damage caused by collision with first side-dump trailer and fire damage throughout railcar.

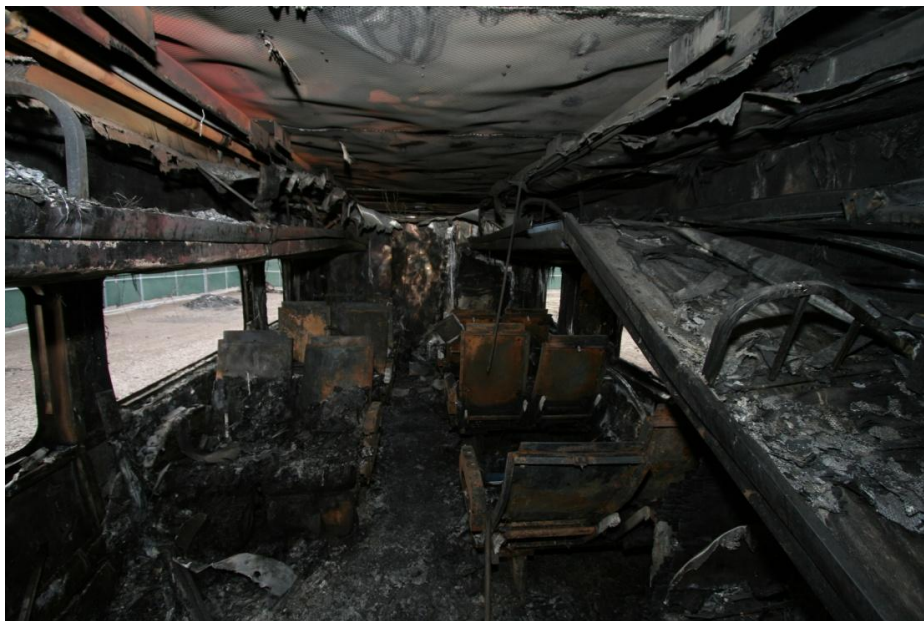
**Figure 7.** Photograph of interior of lower level of first coach railcar 34033, showing extensive structural and fire damage.

The fire consumed the passenger compartment on the lower level of the first coach railcar, leaving only small scraps of charred materials. The fire also consumed the passenger compartment on the upper level. All the windows of this coach railcar had melted or were missing, with the exception of two on the lower right-hand side, which were charred but remained in position. The fire had destroyed the rubber diaphragm surrounding the car-to-car door at the forward end of the railcar. The outer door mode control switch was found to be in the

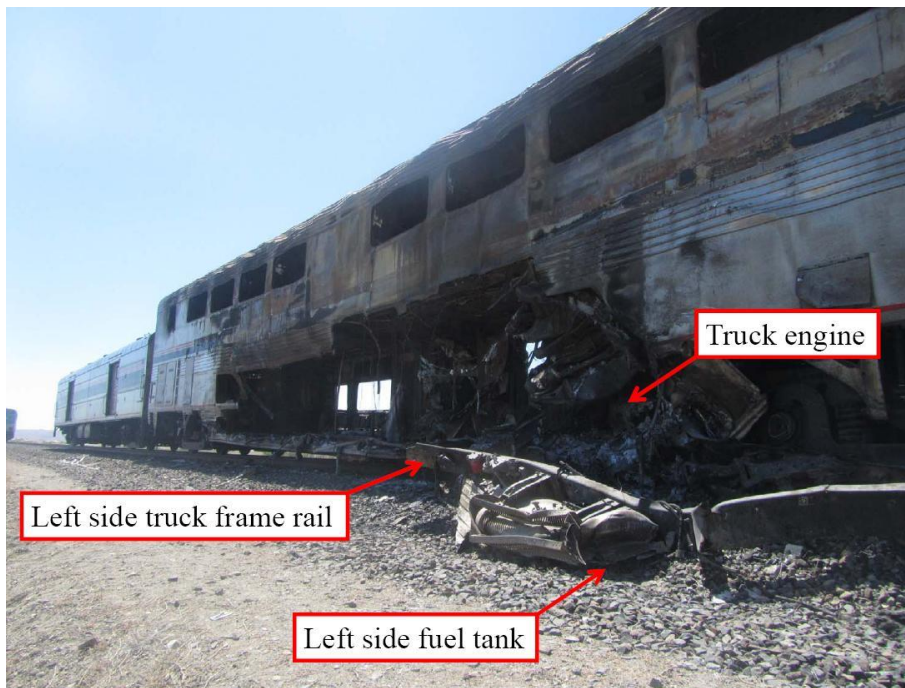
**Figure 12.** Photograph of portion of damaged train, showing frame-rail elements and engine of accident truck embedded within and extending from side of crew sleeper railcar.

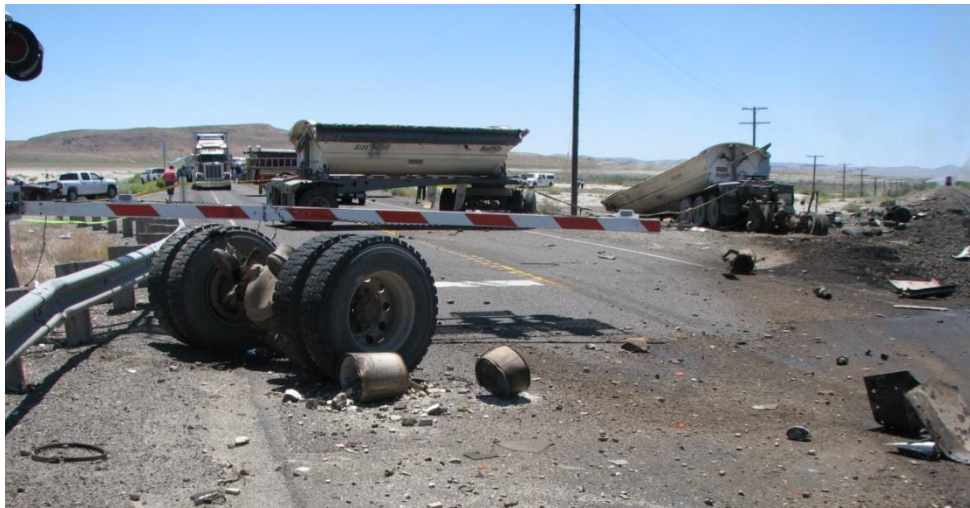
The first trailer in the combination unit came to rest near the southwest corner of the grade crossing. The second trailer came to rest south of the grade crossing, across both lanes of US 95. (See figure 13.) The first trailer sustained impact damage at its left front corner in the area of its hydraulic side-dump motor and fittings, and at its front underside in the area of its fifth wheel attachment.<sup>17</sup> The fifth wheel from the truck remained attached to the underside of the first trailer but torn away from the truck frame rails. Material from the left top corner of the accident truck (interior and exterior roof) was found embedded along the left front corner of the first trailer. Fire damage and black soot were present along the left side of the first trailer. The front side of the second trailer was also damaged, with its drawbar attachment rails to the first trailer torn off. The second trailer showed no fire damage. All trailer axles remained attached to the trailers.

**Figure 13.** Photograph showing grade crossing, at-rest location of side-dump trailers (located at center and right), and fourth axle of accident truck (left foreground). (Courtesy of Nevada Highway Patrol)

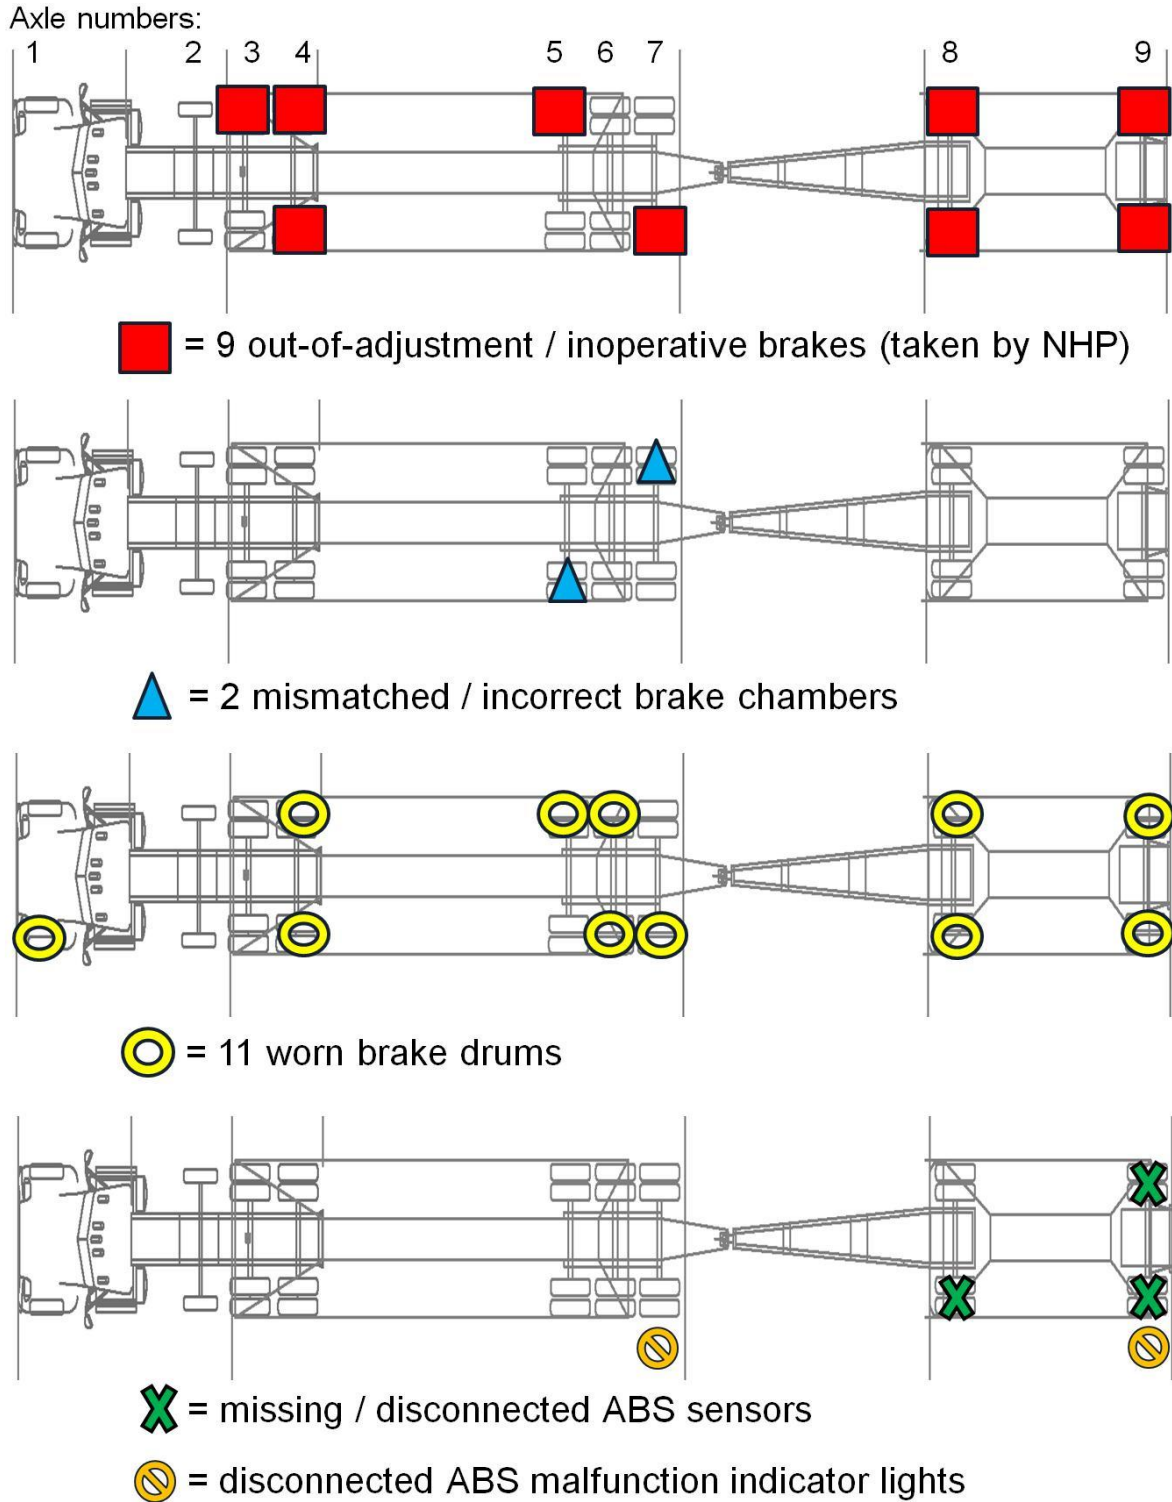
- **Commercial vehicle brake maintenance:** The brakes of the accident truck were improperly maintained, and their poor condition increased the stopping distance of the truck. This factor—in addition to the driver’s delayed braking—led to the collision with the train.

**Figure 15.** Depiction of brake issues identified on accident truck.

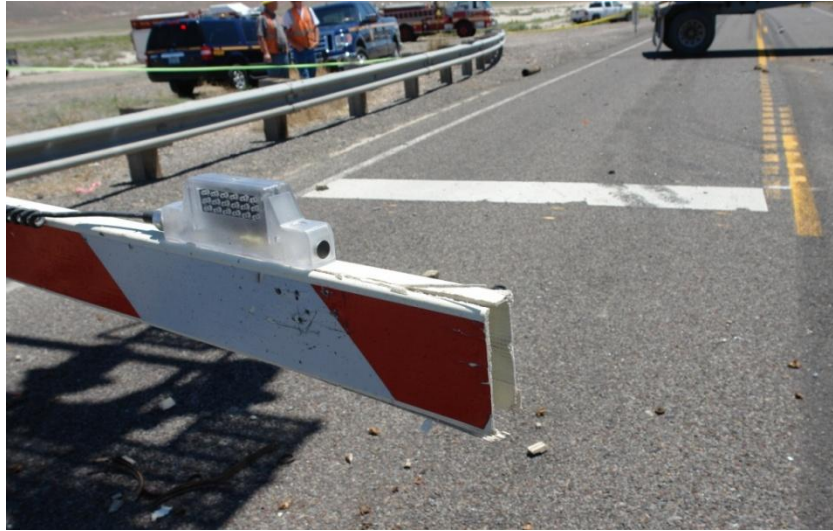
**Figure 17.** Photograph showing damage to tip of crossing gate arm in northbound lane of US 95. (Courtesy of Nevada Highway Patrol)

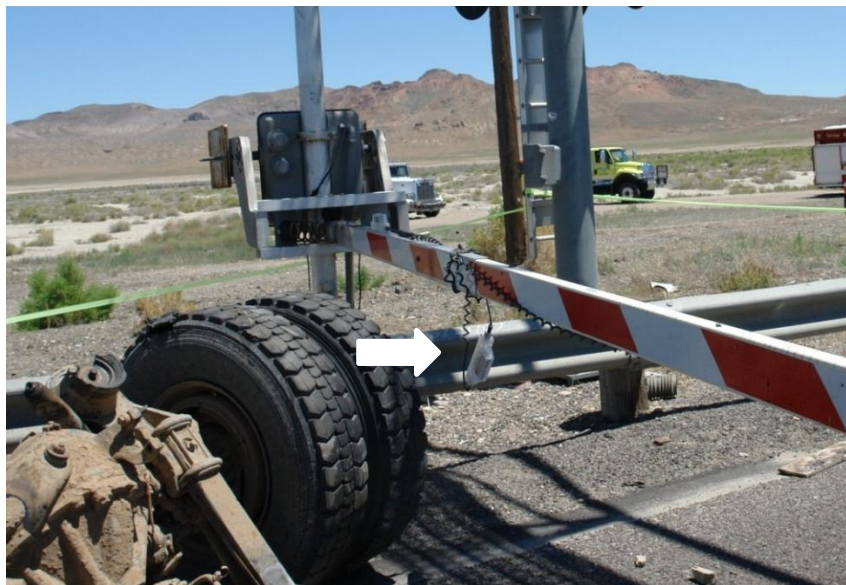
**Figure 18.** Photograph showing detached center light of crossing gate arm hanging from its power cord and fourth axle from accident truck at bottom left. (Courtesy of Nevada Highway Patrol)

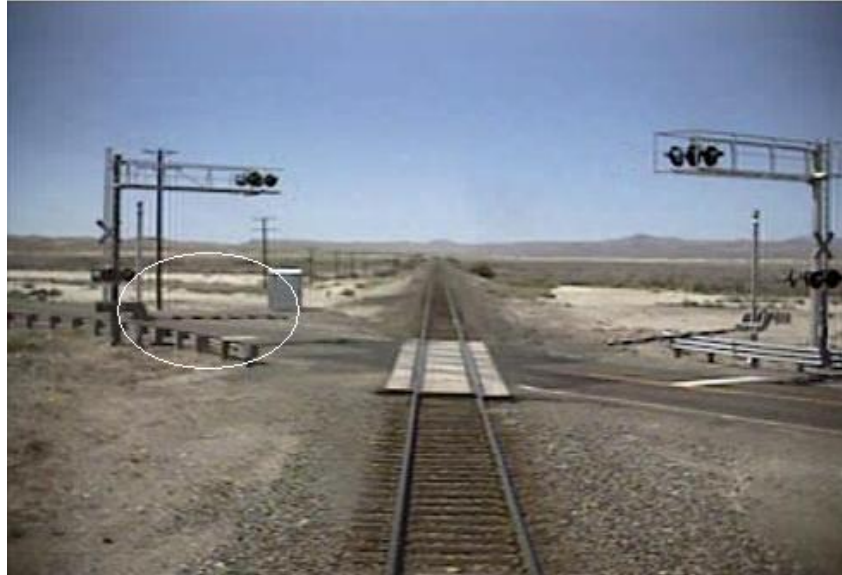
NTSB investigators extracted a still image from the video captured by the lead locomotive's front-mounted camera. Figure 19 shows the image taken at 11:19:24 a.m. with the crossing gate arms in the descended position in the northbound and southbound lanes of US 95 about 1 second prior to arrival of the lead locomotive. Witness statements also indicate that the grade crossing flashing lights on the northbound side of US 95 were operational.

**Figure 19.** Video frame capture from Amtrak train no. 5 at 11:19:24 a.m., about 4 seconds prior to accident truck collision, showing crossing gate arms in descended position on northbound (circled) and southbound sides of US 95. At point of image capture, accident truck is approaching grade crossing but outside video camera field of view.

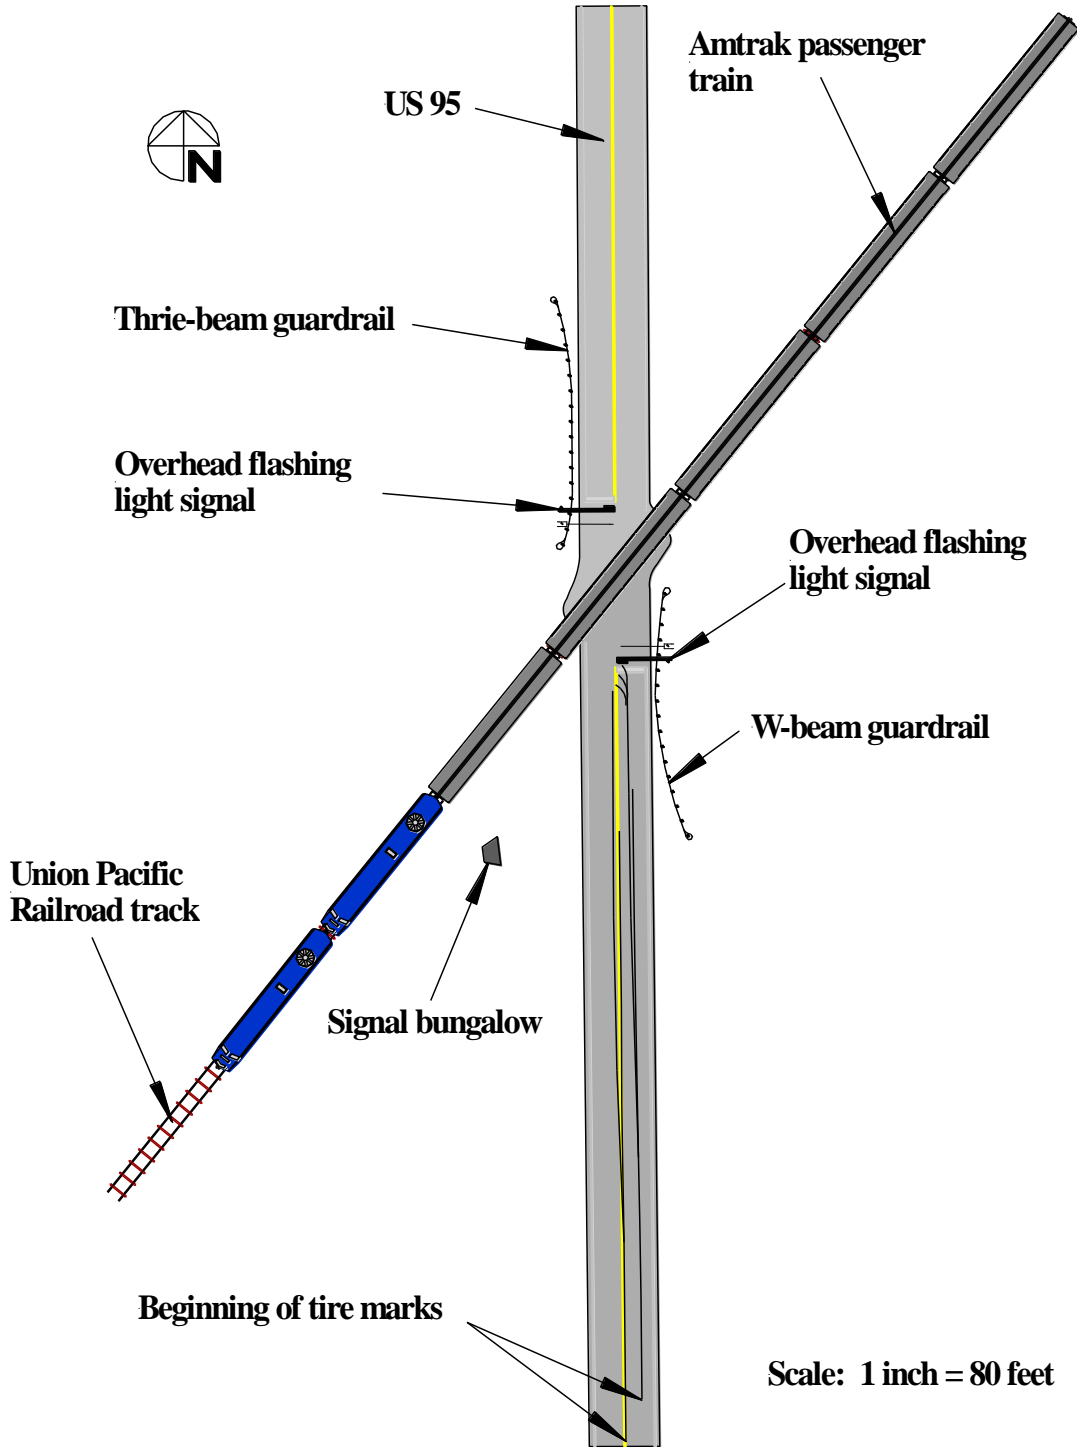
Figure 22. Diagram depicting tire marks left by accident truck in northbound lane of US 95.
