# National Transportation Safety Board

## Union Pacific Railroad, Derailment with Hazardous Materials Release March 10, 2017

Michael Hiller, IIC

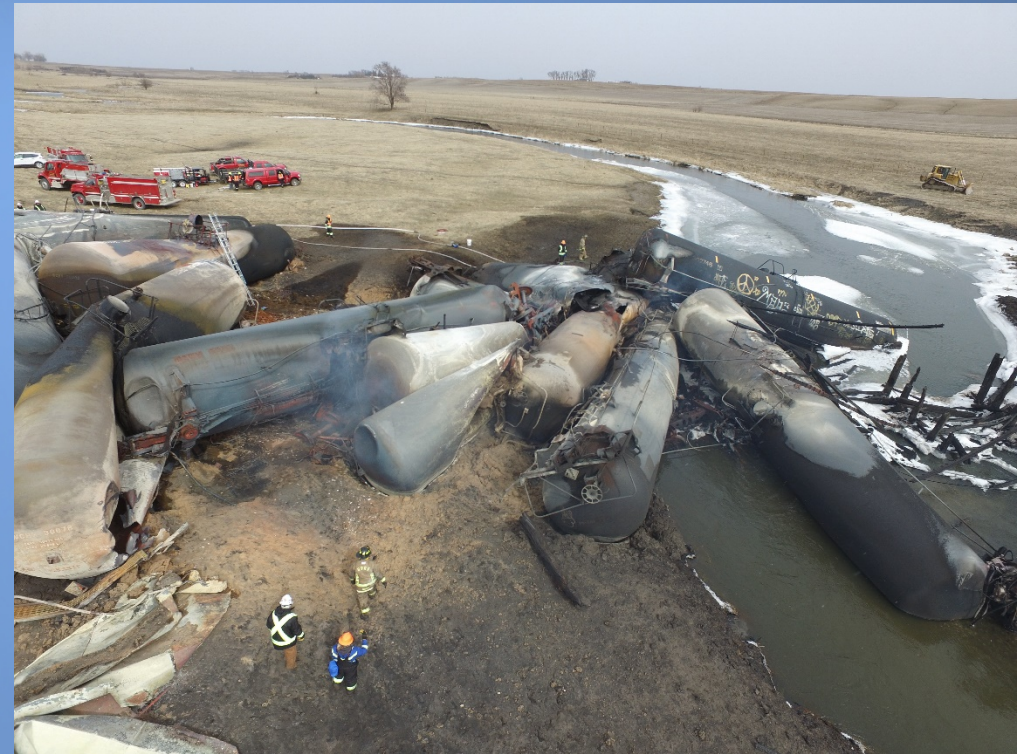
- Legacy DOT-111
- 10 tank cars mechanically breached
- PHMSA developed new standard, DOT-117
- DOT-111 retrofitted or removed from ethanol service by May 1, 2023

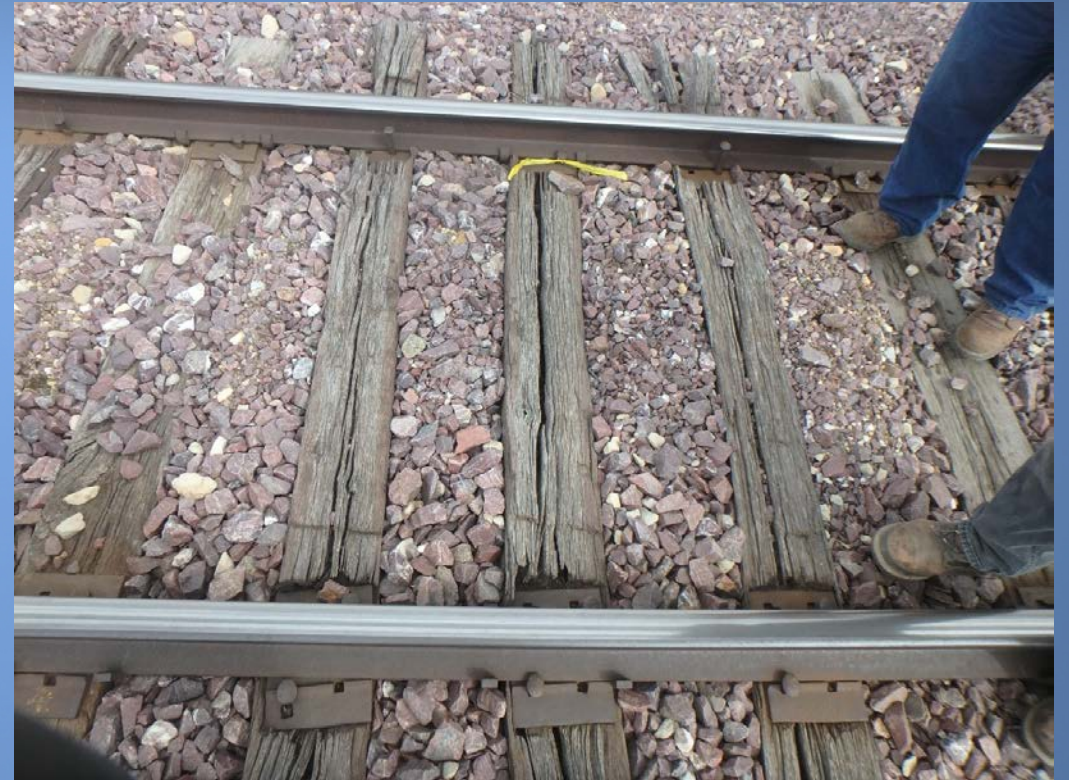
- 7 track defects found
- May 2017, FRA found 78 defective conditions
  - 51 defective crossties
- No civil penalties recommended

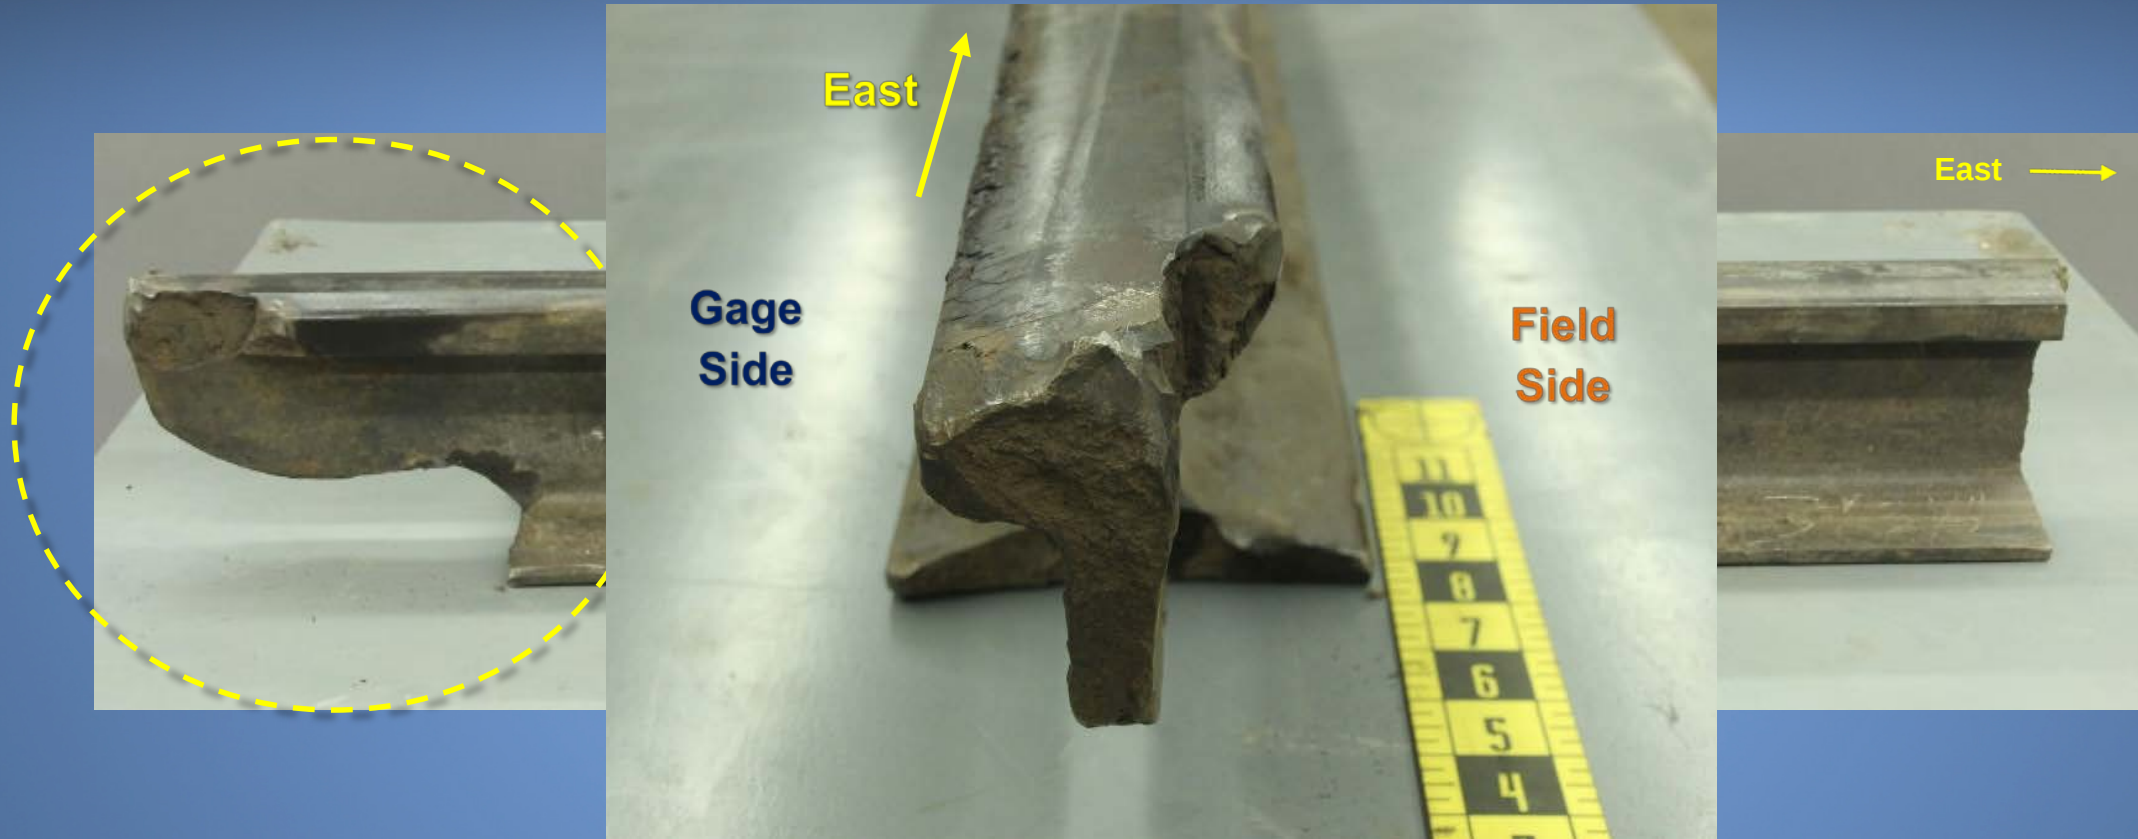
# Probable Point of Derailment

- The train derailed at a broken south rail on the west approach prior to the timber bridge
  - Rail fragment recovered was most damaged
  - Located adjacent to largest missing rail section
- Finite element modeling performed on worn 90-lb. rail with varying track support
  - Worn rail with degraded supports leads to higher stress
  - Could increase risk of rail head failure

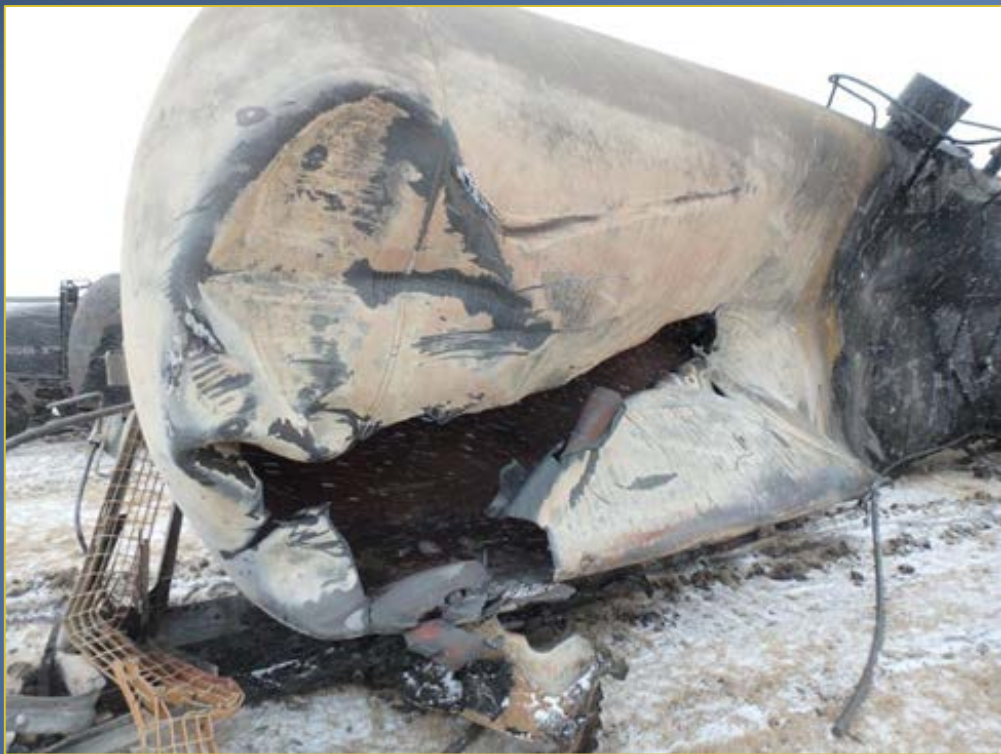
Punctured DOT-111 Tank Car, Graettinger, Iowa

- Typical poor DOT-111 lading-retention performance
- Must be replaced or retrofitted by May 1, 2023
- All tank cars in the accident train were specification DOT-111
