# International Investigations

*Global Collaboration with Domestic Impact*

**Materials Laboratory**

**Michael Budinski**

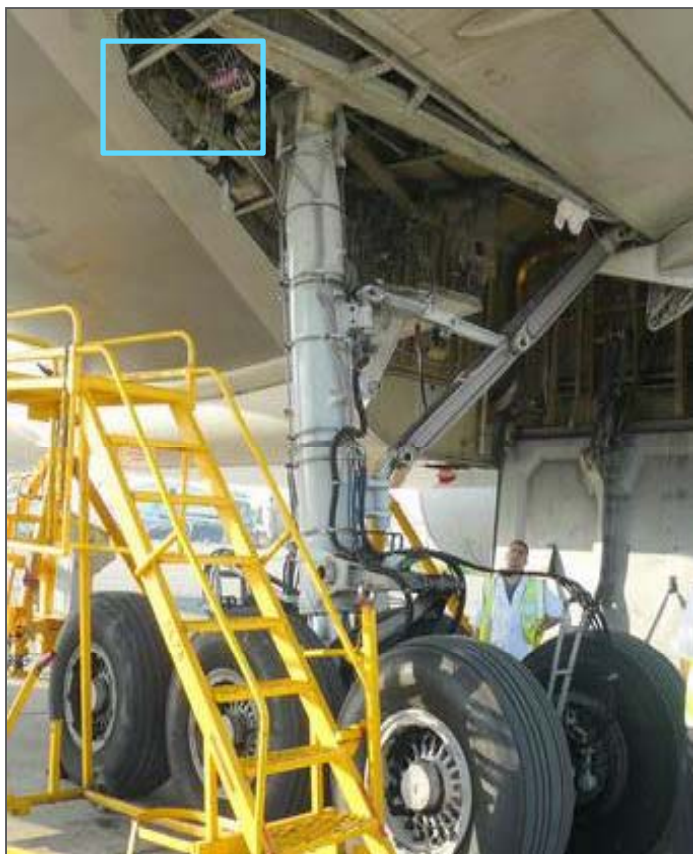
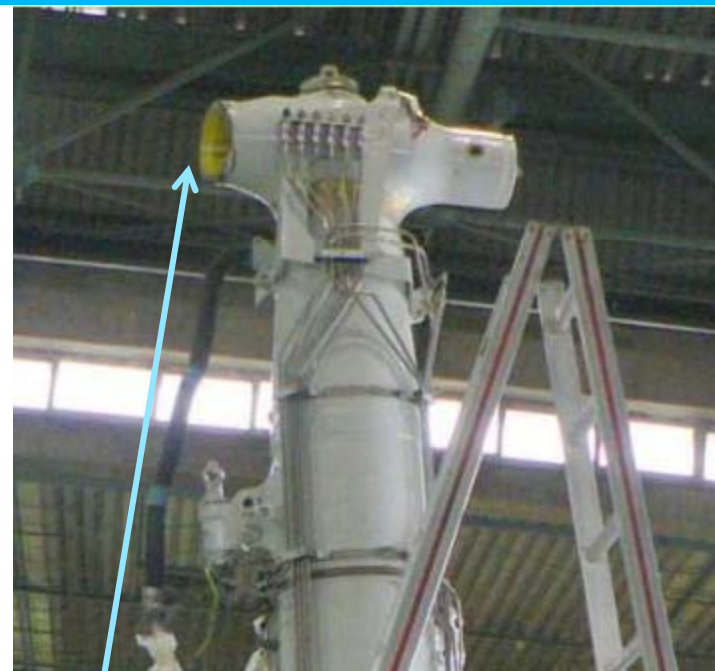
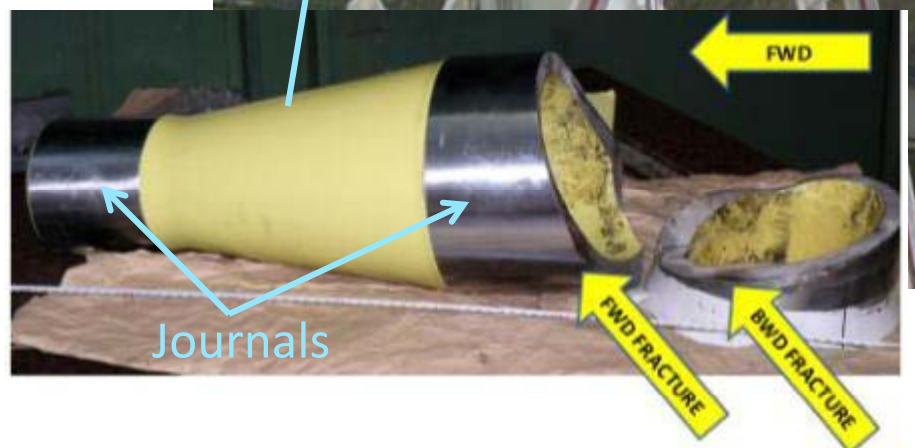
- Post-flight inspection revealed fractured left MLG forward trunnion

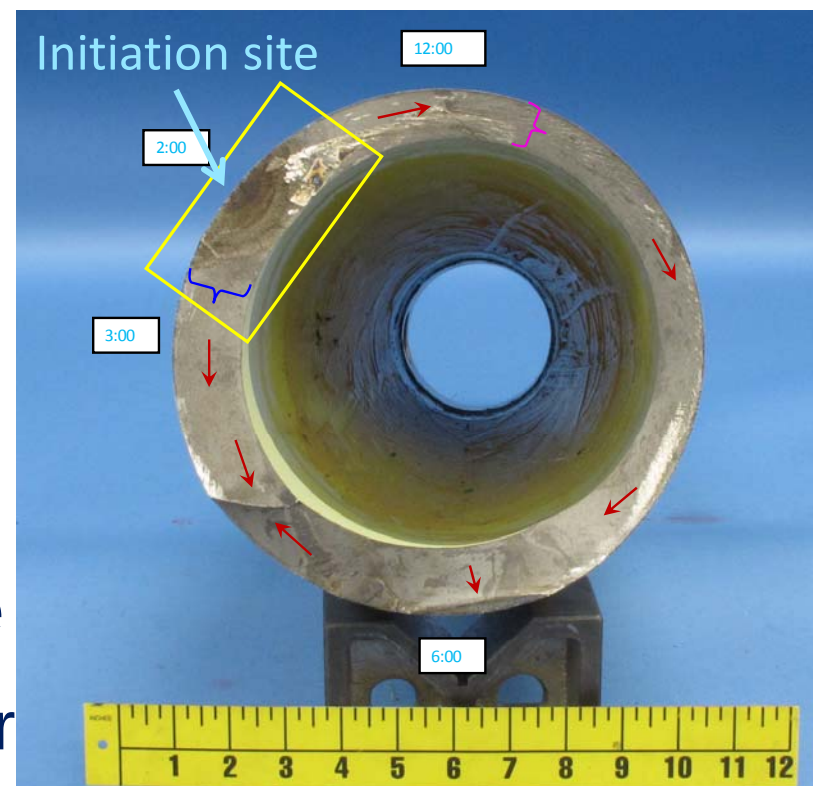
- Metallurgical analysis of the fractures, materials and specialized crack inspection
- Failure from fatigue at grinding burn cracks
- Examination of MLG steps at the overhaul shop in Singapore
- Opportunities identified to lower the probability of recurrence

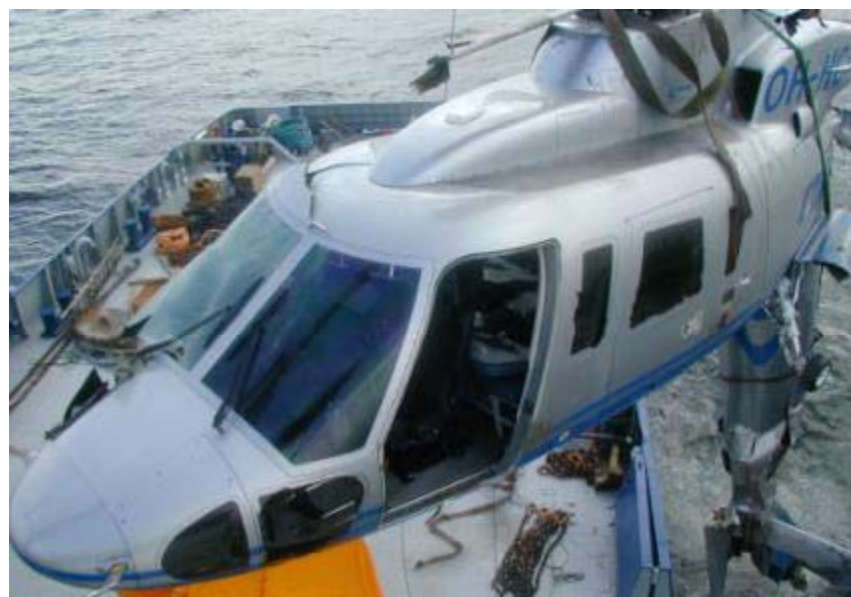
- Copterline Sikorsky S-76C+ helicopter (OH-HCI Finland), crashed into the Baltic Sea shortly after takeoff from Tallinn, Estonia
- The investigation revealed the failure of the forward main rotor actuator

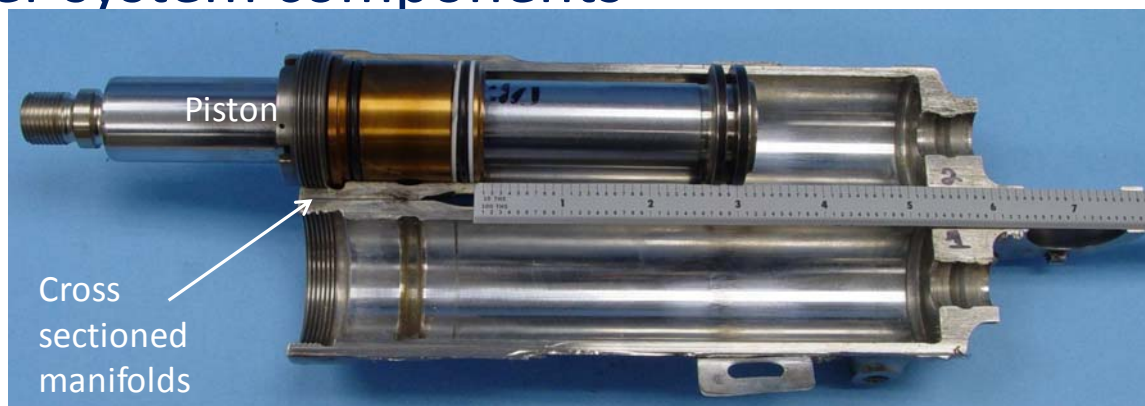
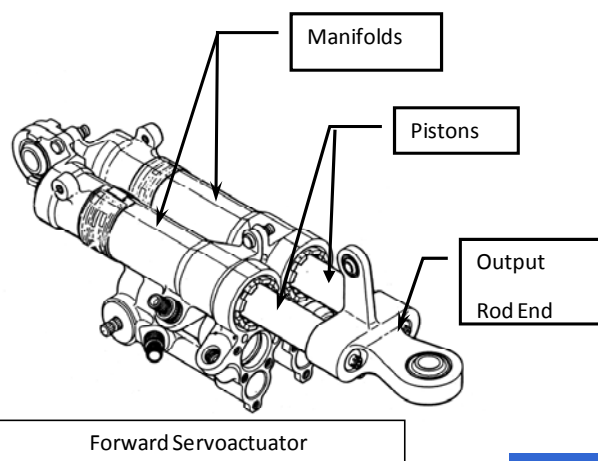
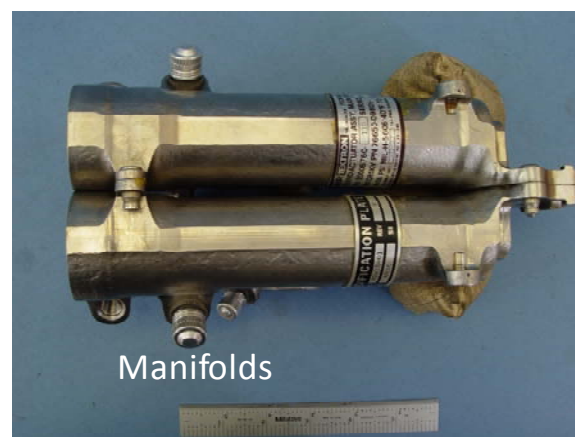
The NTSB conducted a metallurgical evaluation of the main rotor forward actuator components, exemplar actuator pistons, and other system components

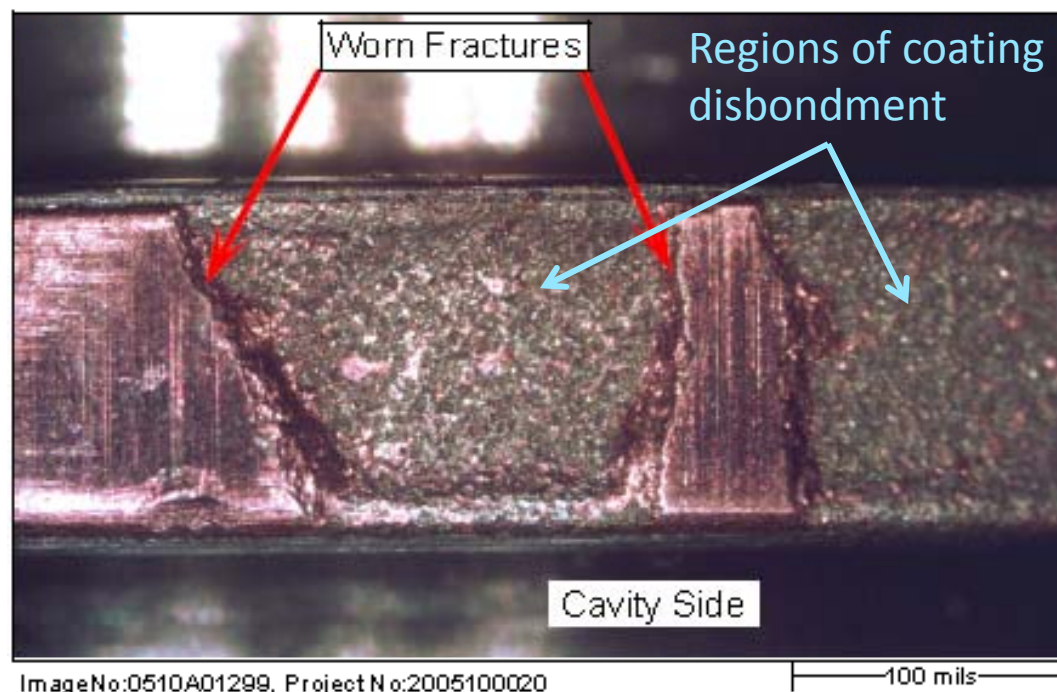
Metallurgical evaluation revealed failure of the coating system on the actuator pistons

- Excessive wear of components
- Hydraulic fluid leakage
- Blockage of a fluid return port

NTSB Safety Recommendations A-05-33 through -35 issued, which ask for:

- Immediate leakage testing of in-service actuators
- Visual and laboratory examination of hydraulic fluid filters
- Preflight check of flight control “stick jump” and control movement smoothness

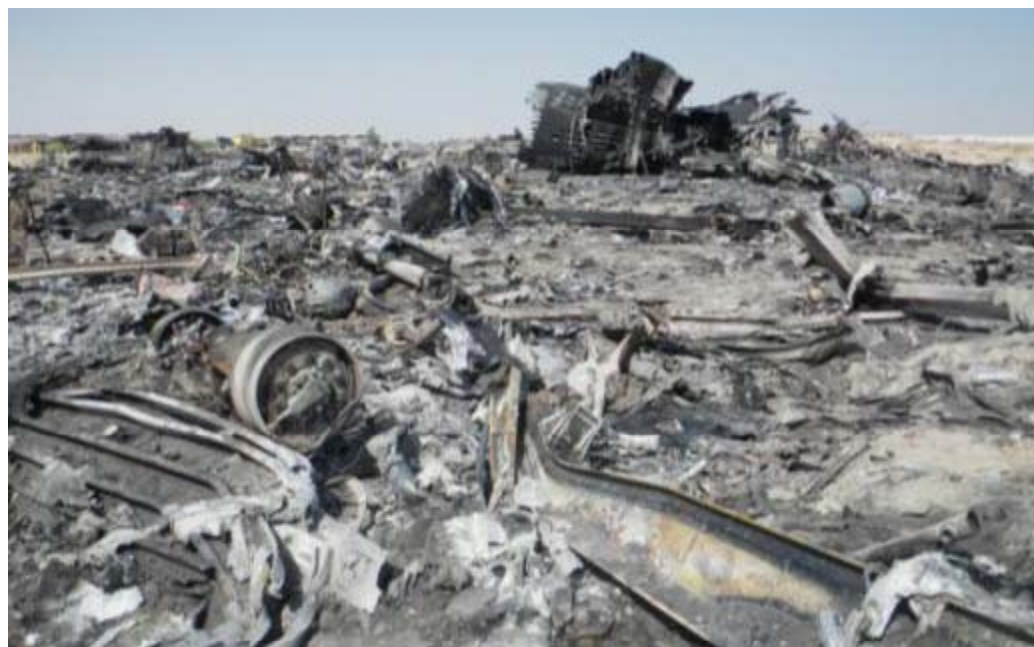
- NTSB Materials Laboratory fire investigator on scene
- Developed a fire test program to understand cargo fires:
  - Quantify the fire load posed by lithium-ion batteries relative to ordinary combustibles
  - Quantify the size and growth rate of a cargo container fire
