# National Transportation Safety Board

## Operational Issues

Operational Factors

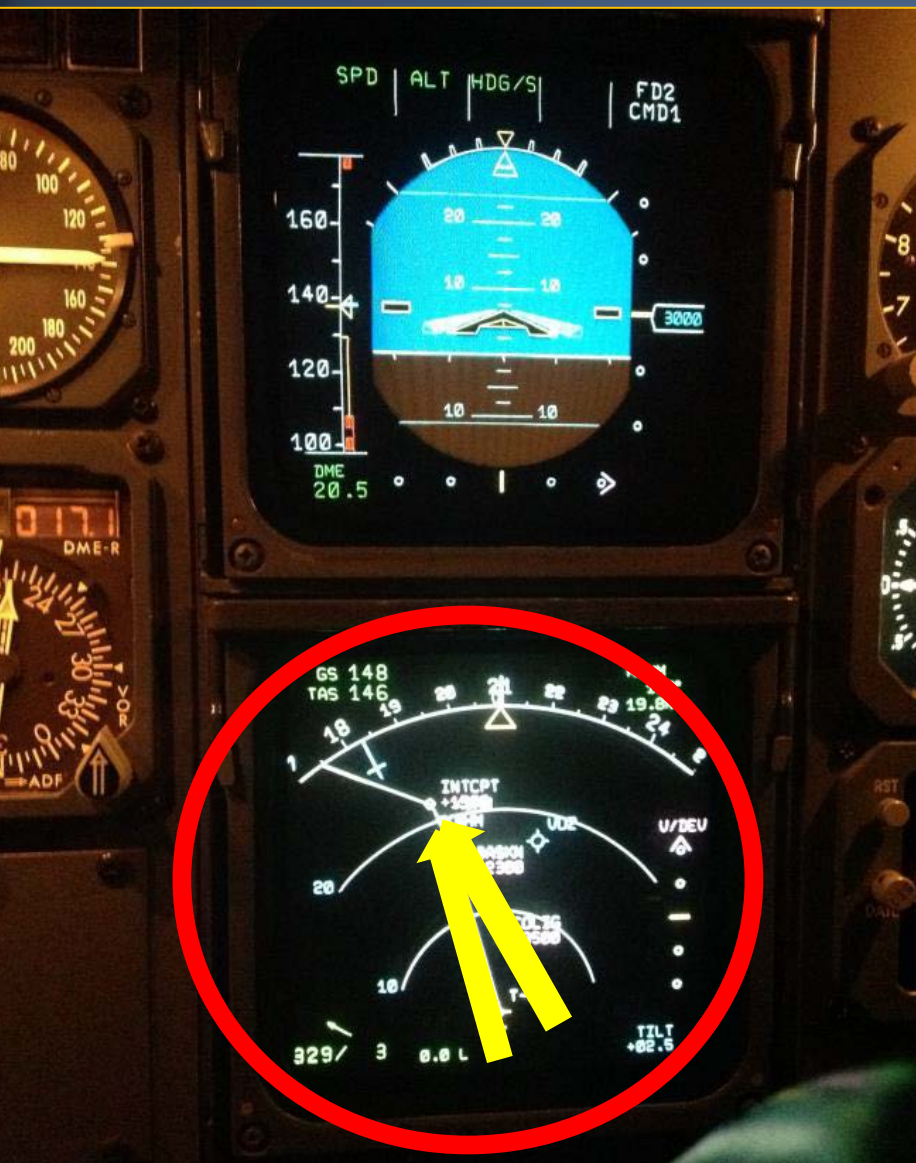
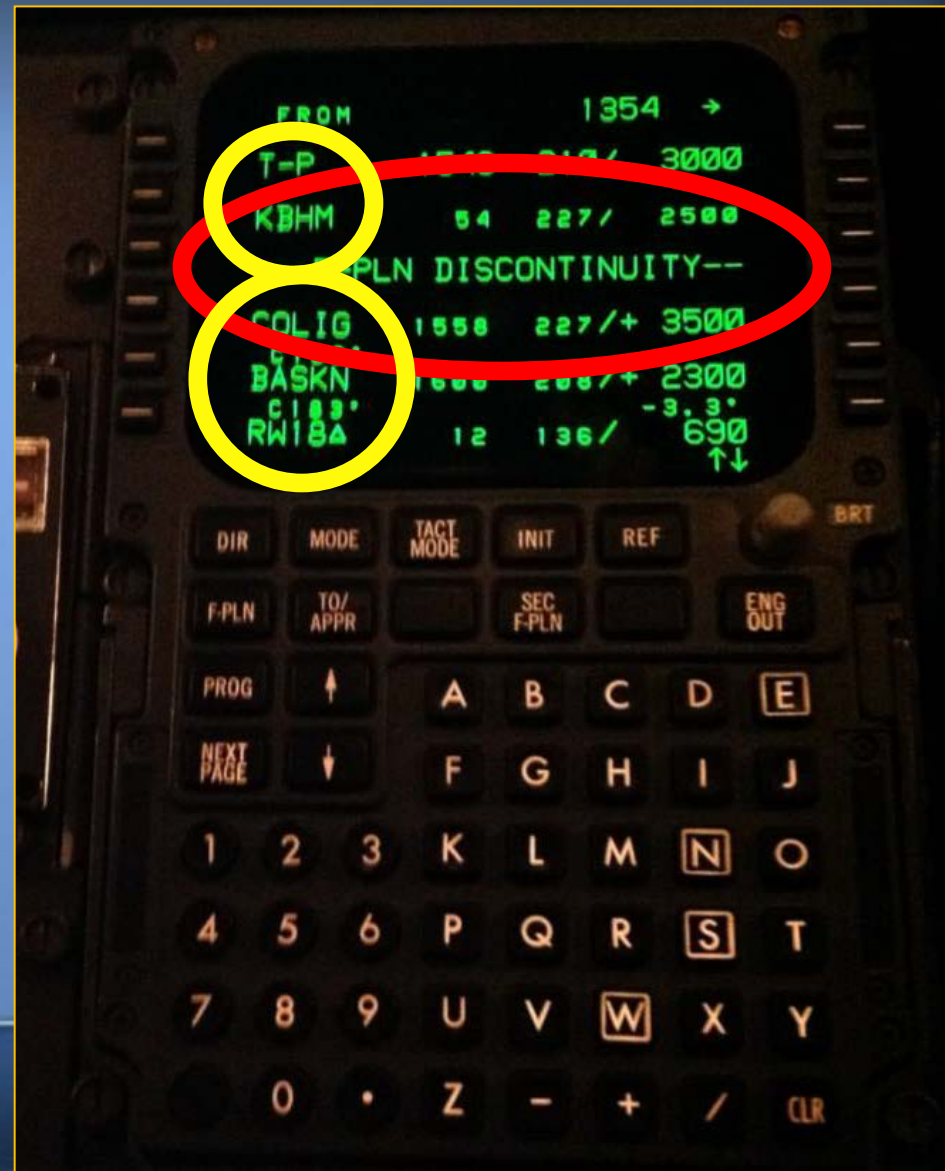
# Approach Setup

- Runway 18 served by 2 nonprecision approaches
- Published error in localizer approach chart
- Weather forecast 400-foot ceiling at arrival

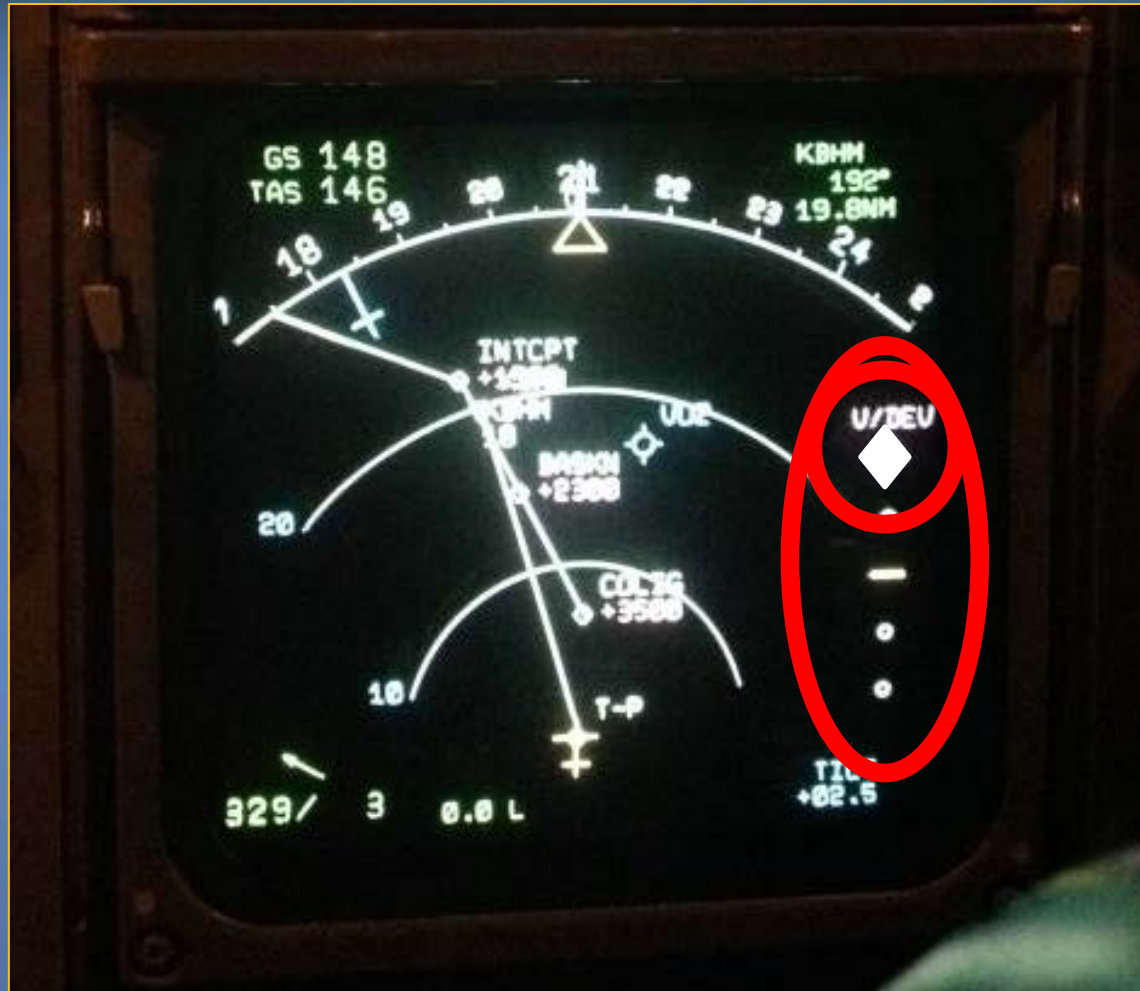
# Navigation Display

- As flight approached Birmingham, ATC gave vector to join localizer course
- Flight plan not sequenced and verified by flight crew
