NTSB National Transportation Safety Board

*Office of Railroad, Pipeline &
Hazardous Materials Investigations*

Track & Structures

Postaccident Investigation

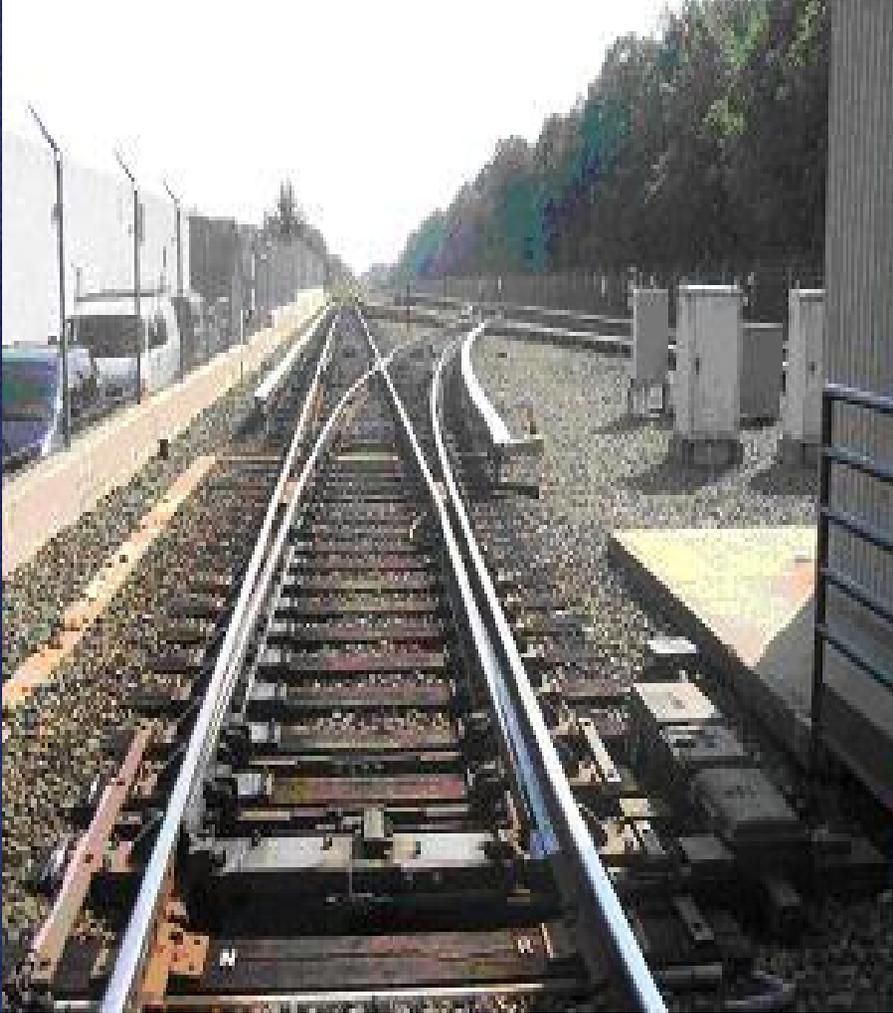
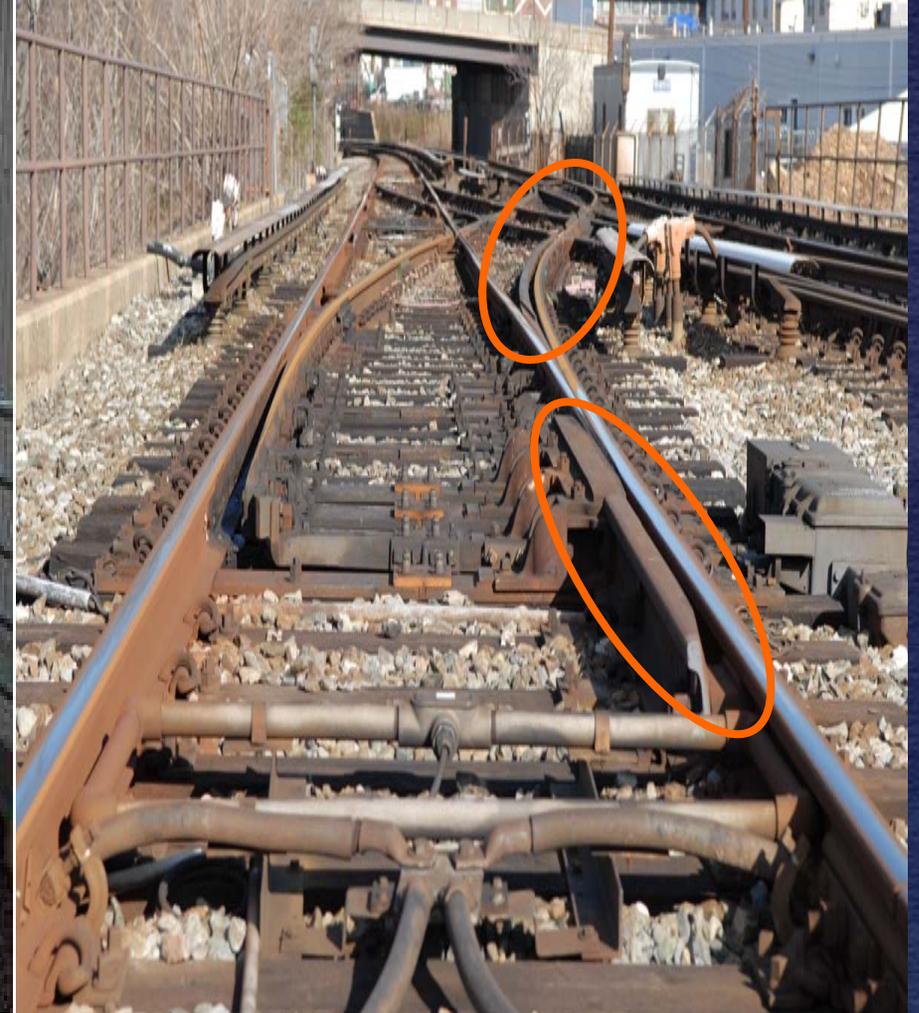
5000-Series Derailment History

- WMATA experienced 7 yard derailments, beginning in 2003
 - Involving empty trains
 - Traveling at low speeds
 - Traversing unguarded No. 8 turnouts or curves with a radius of less than 500 feet
- Some involved cars with recently trued wheels

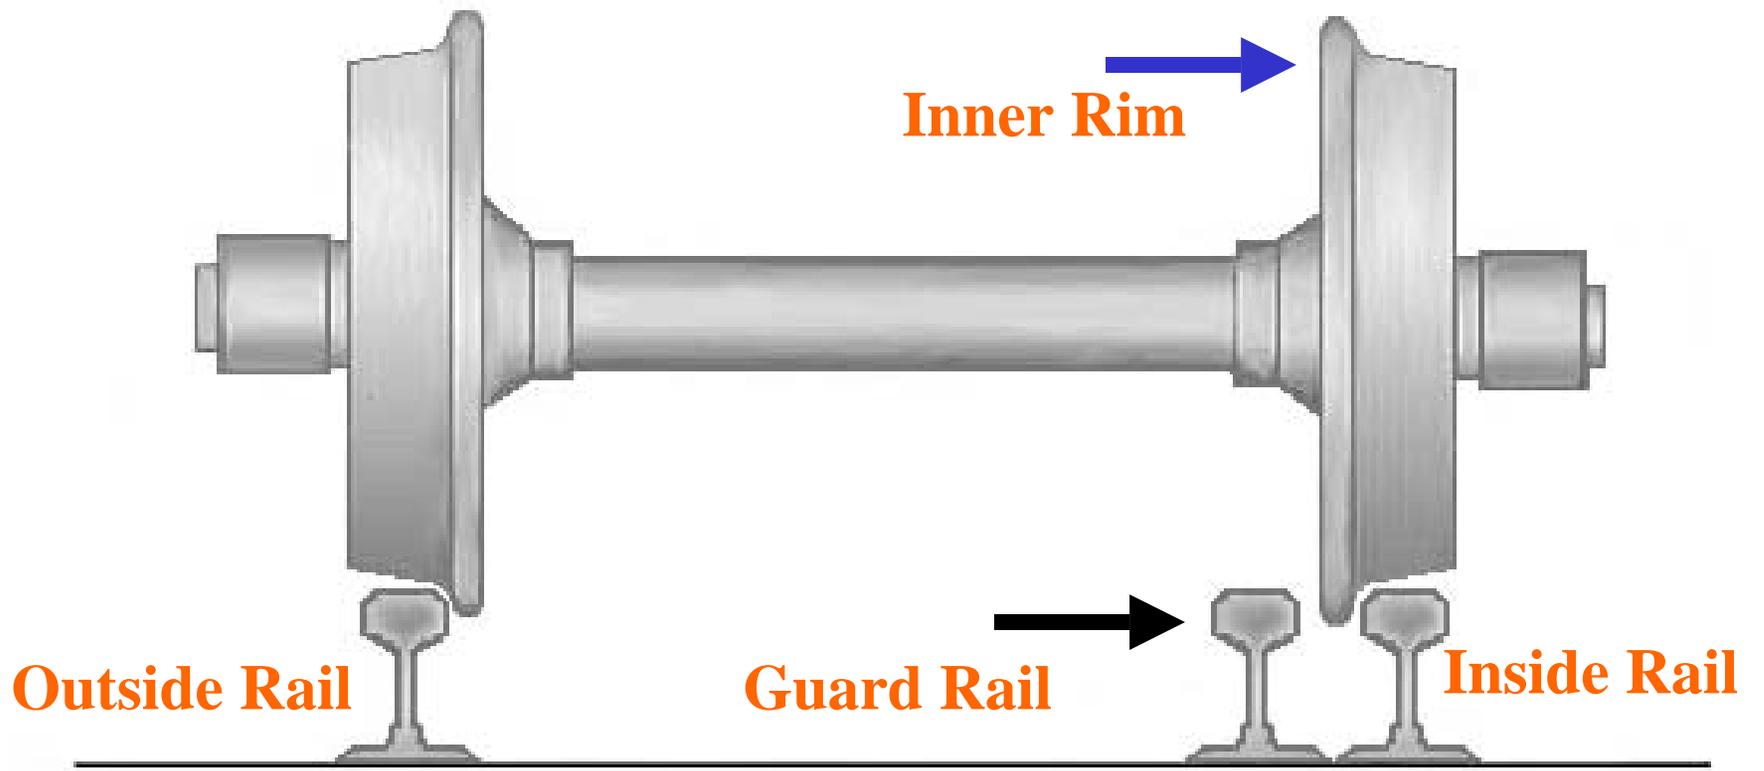
Had a guarded turnout been installed, it would have prevented the wheel climb and derailment of the fifth car as the accident train traversed the curved track.
