NTSB ***SAFETY ALERT***

Take Time to Torque

Apply proper torque to prevent accidents

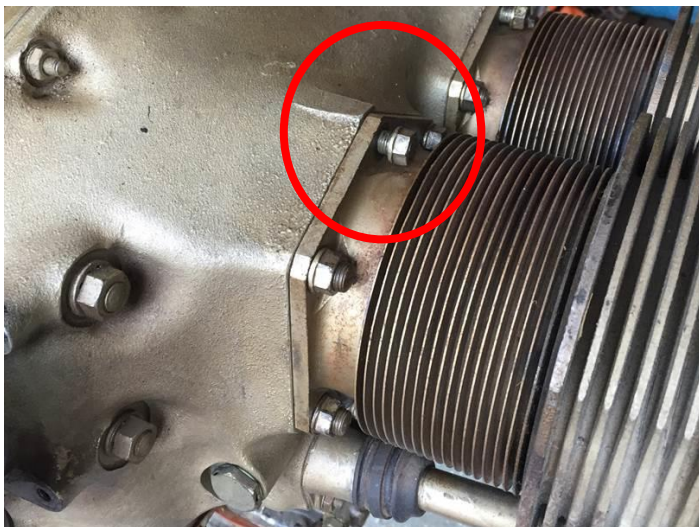
- From 2009 to 2015, over 45 accidents and incidents have occurred that resulted from maintenance personnel applying improper torque to engine fasteners (bolts and nuts) during engine maintenance activities. The application of improper torque led to internal engine damage and subsequent engine failures and accidents or incidents (see figures 1 and 2).
- Applying too little or too much torque can cause a bolt to fail and/or the nut and bolt threads to become stripped, which allows the fastening hardware to loosen.

Figure 1. Cylinder with a finger-tightened nut that is not properly torqued.

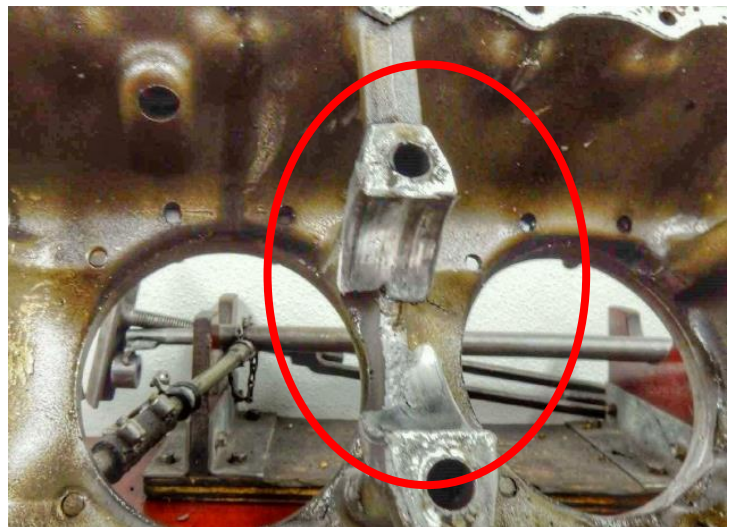
Figure 2. Internal damage to another engine resulting from the application of improper torque.

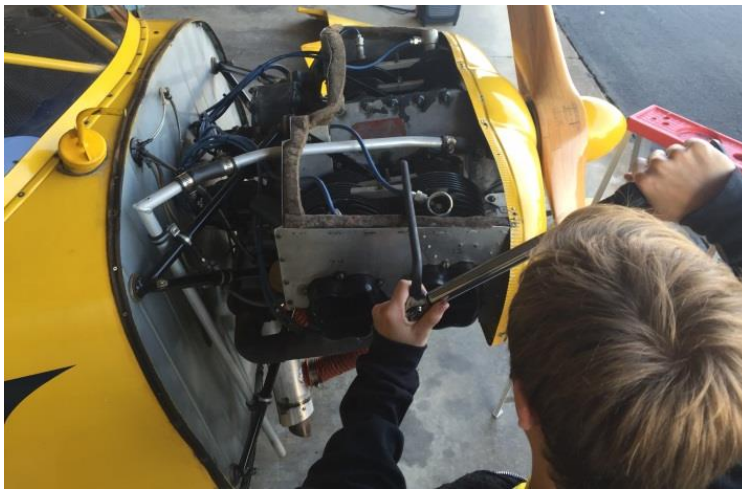
Figure 3. Mechanic applying torque to through bolts.

- Use a calibrated torque wrench to measure the amount of twisting force applied to a nut or bolt (see figure 3). Verify that your wrench is calibrated and check that the wrench is not damaged to ensure continued accuracy.

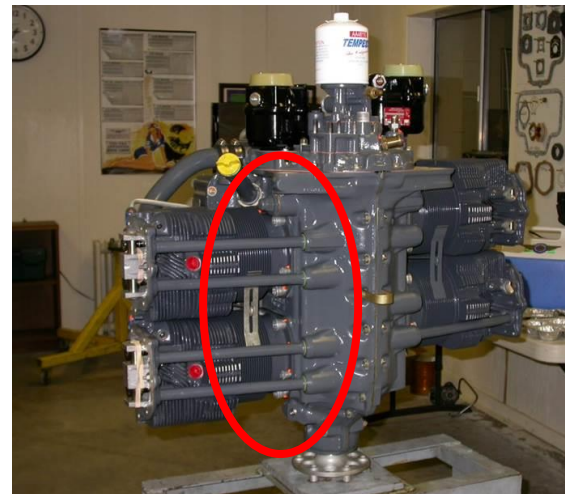
Figure 4. Engine on stand showing torque seal on fasteners.

- Also use torque seal to verify that the applied torque has not changed and to visually confirm which fasteners have been torqued (see figure 4).
- Beware of leaving hardware that has been only finger tightened. Once you start the process, make sure you complete it. Set a reminder if you need to step away before completing the torqueing process.
