NATIONAL TRANSPORTATION SAFETY BOARD

AIRCRAFT ACCIDENT REPORT

TRANS INTERNATIONAL AIRLINES CORP.
FERRY FLIGHT 863, DOUGLAS DC-8-63F, N4863T
J. F. KENNEDY INTERNATIONAL AIRPORT,
NEW YORK

REPORT NUMBER: NTSB-AAR-71-12

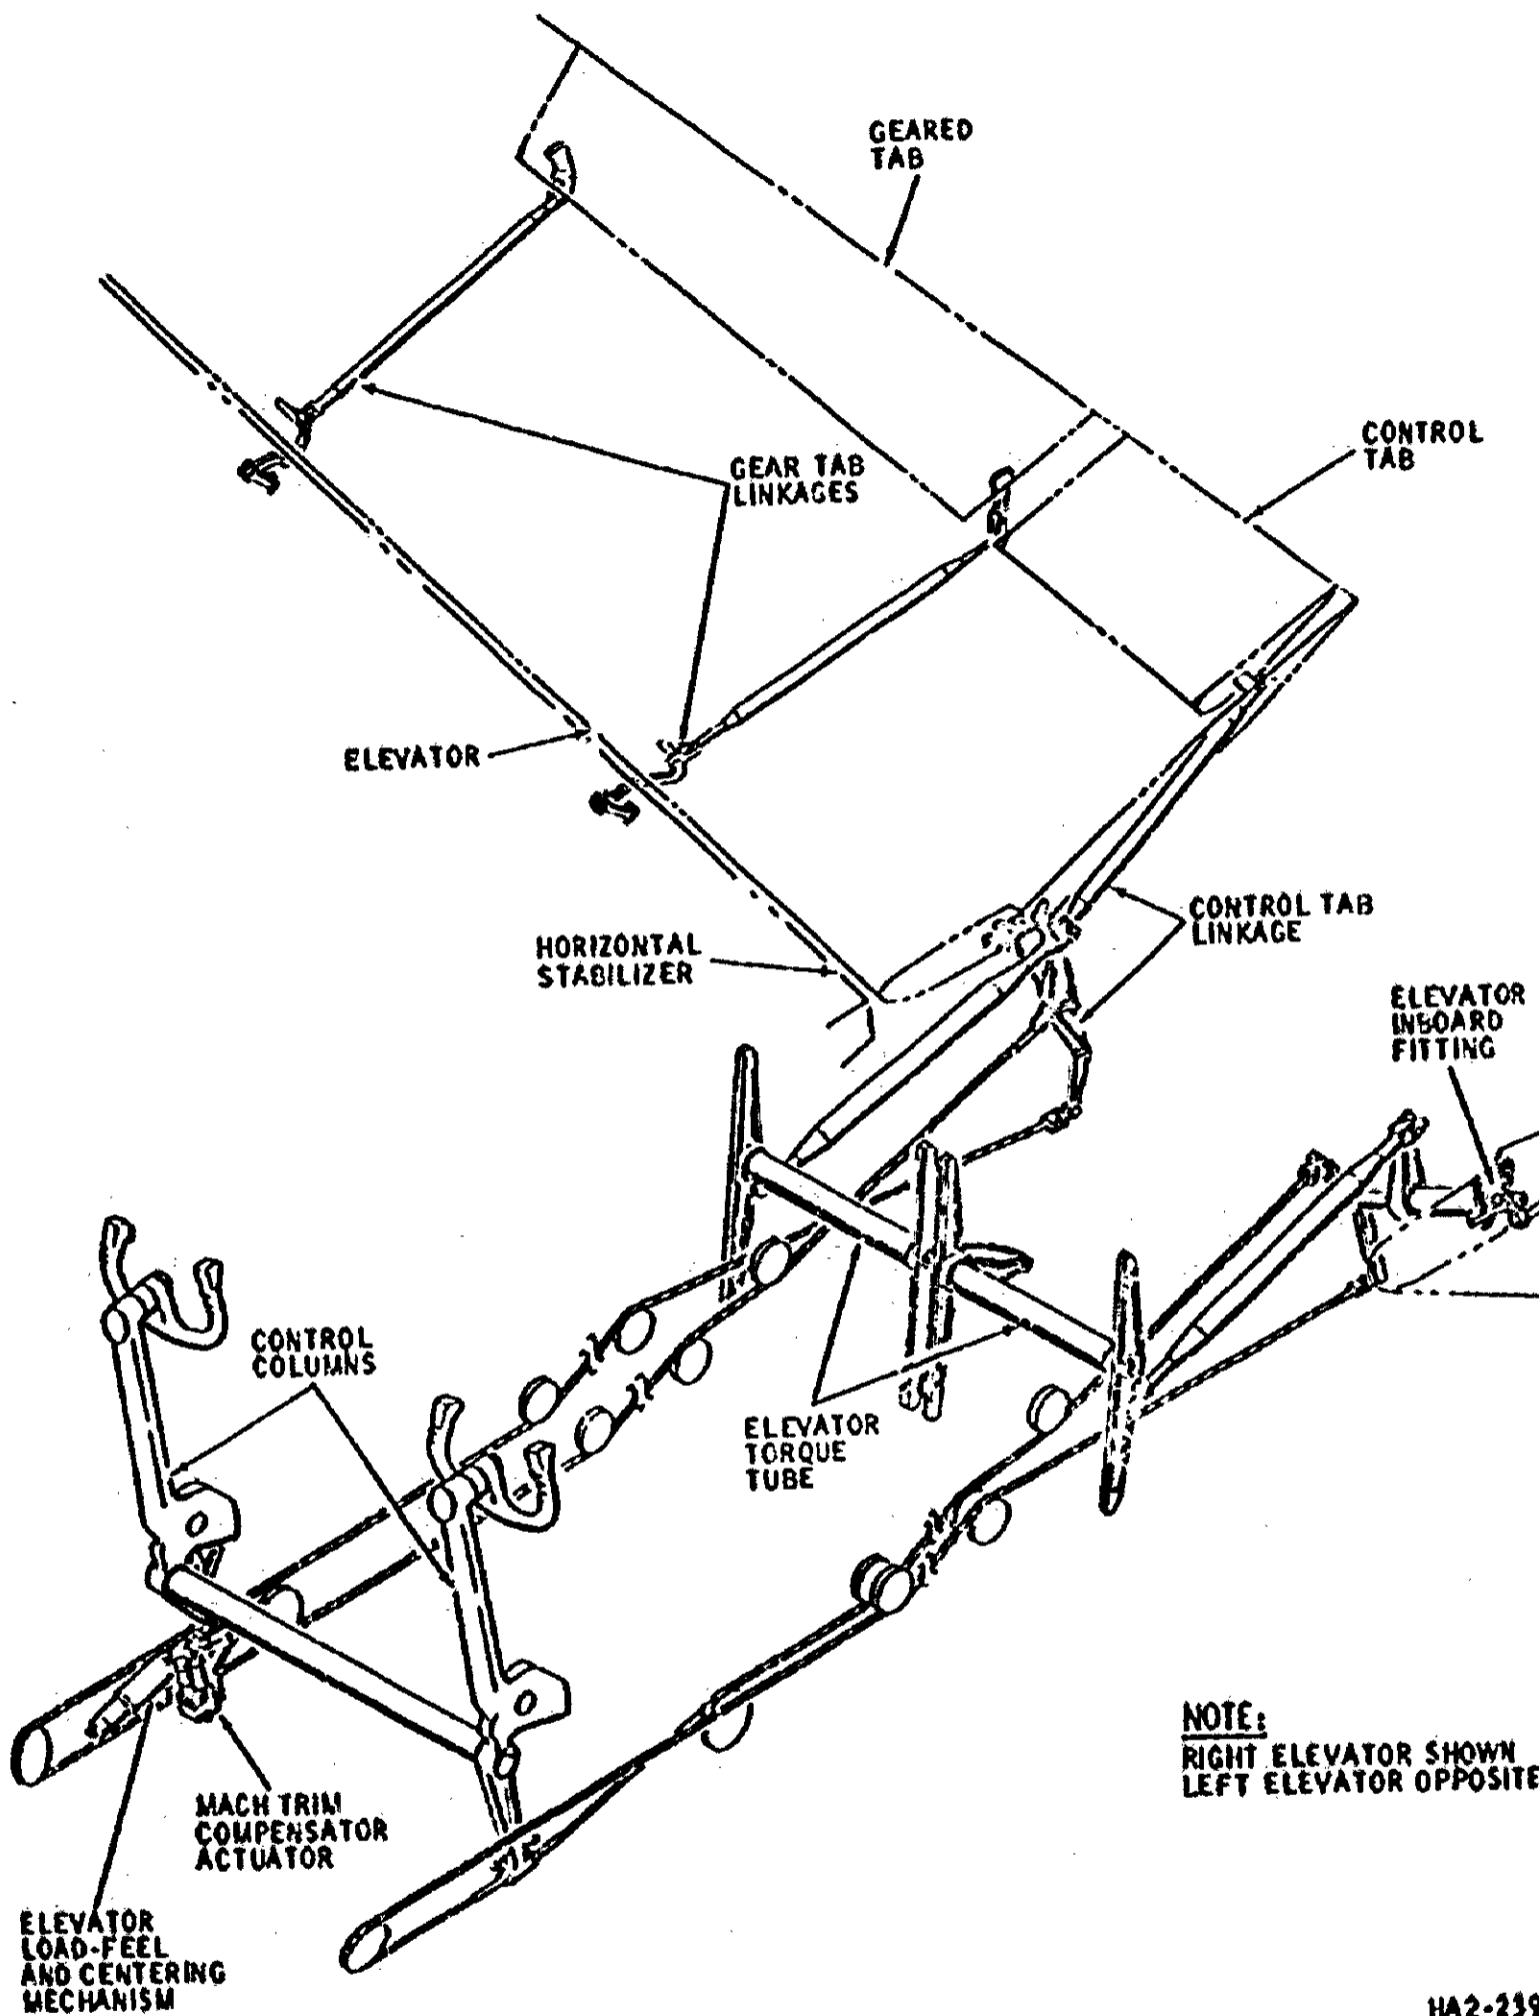
Elevator Control System -- Schematic
Figure 1

The elevators are operated aerodynamically by the tabs which are controlled by a cable system from the control column. The geared tab on each elevator is linked mechanically to the stabilizer so that as the elevator moves, the geared tab moves in the same direction as the control tab to provide additional aerodynamic control surface. (See Attachment 1.)
