AIRCRAFT ACCIDENT REPORT

HUGHES AIR WEST DC-9, N9345,
AND U.S. MARINE CORPS F-4B, 151458
NEAR DUARTE, CALIFORNIA

JUNE 6, 1971

NATIONAL TRANSPORTATION SAFETY BOARD
Washington, D. C. 20591
REPORT NUMBER: NTSB-AAR-72-26

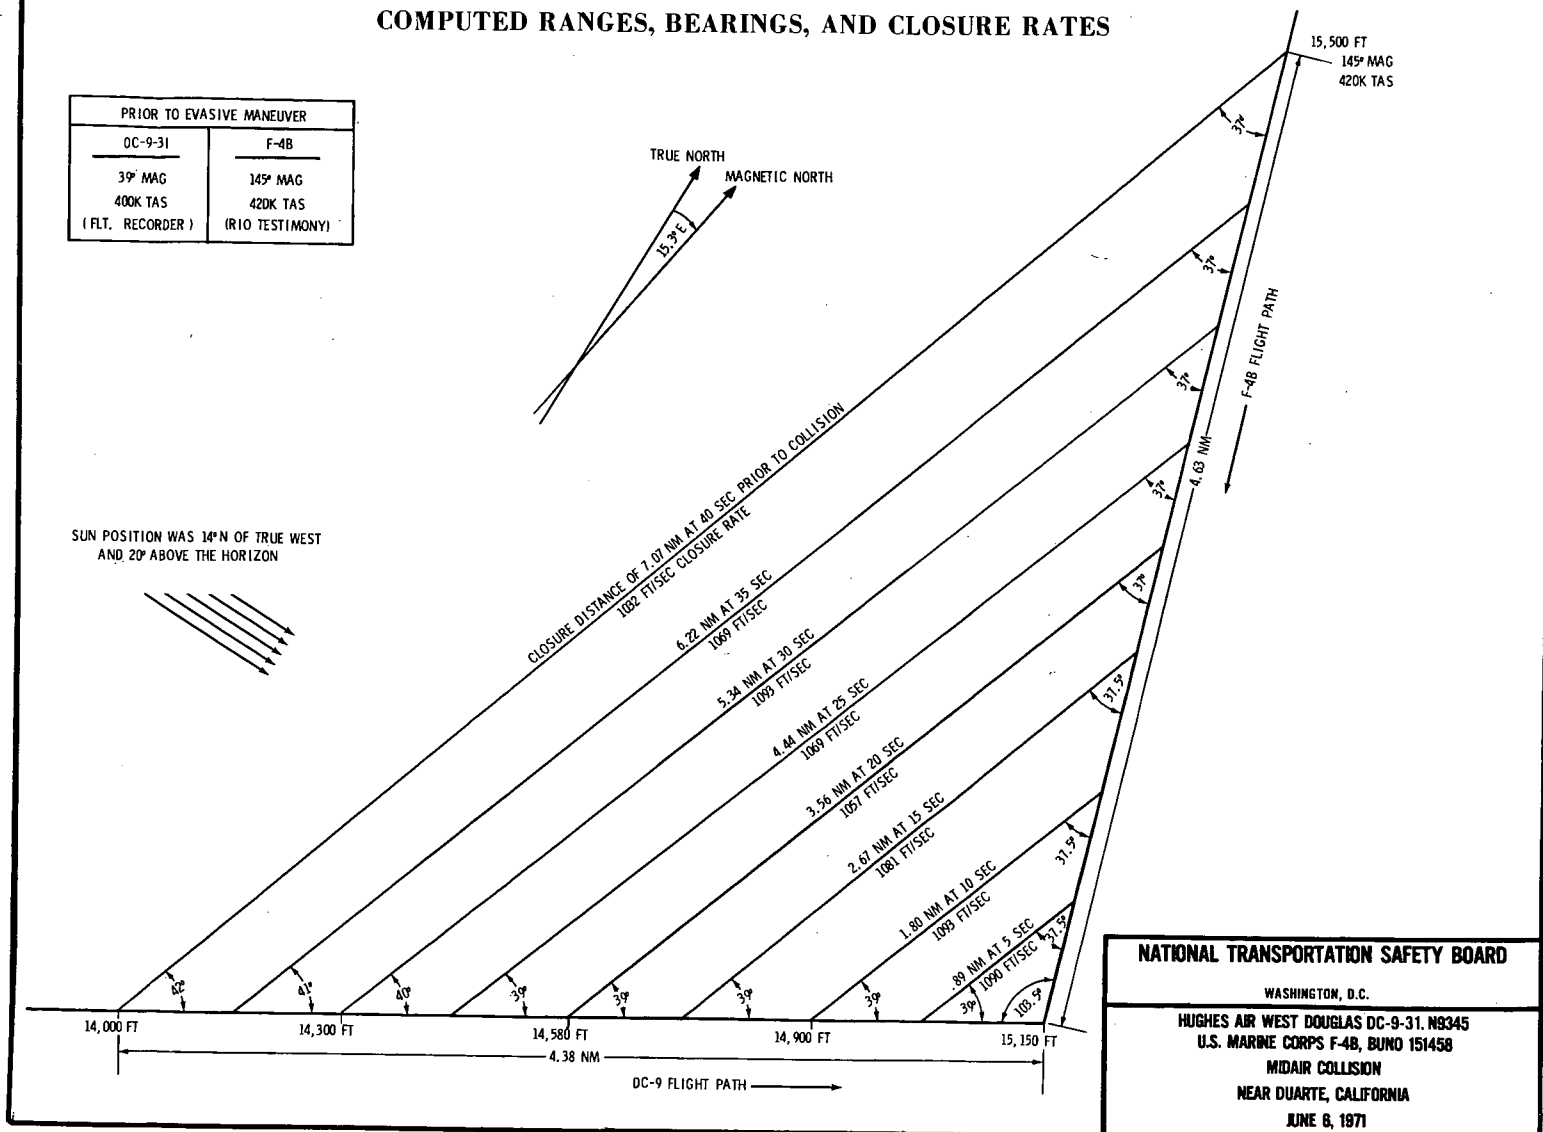
COMPUTED RANGES, BEARINGS, AND CLOSURE RATES

PRIOR TO EVASIVE MANEUVER	
DC-9-31	F-4B
39° MAG	149° MAG
400K TAS	420K TAS
(FLT. RECORDER)	(RIO TESTIMONY)
