| 4. Title and Subtitle Aircraft Accident Report - Eastern Air Lines, Inc., Douglas DC-9-31, N8984E, Charlotte, North Carolina, September 11, 1974 | | 5. Report Date May 23, 1975 | |

AIRCRAFT ACCIDENT REPORT

EASTERN AIR LINES, INC.
DOUGLAS DC-9-31, N8984E
CHARLOTTE, NORTH CAROLINA
SEPTEMBER 11, 1974

NATIONAL TRANSPORTATION SAFETY BOARD
Washington, D. C. 20594
REPORT NUMBER: NTSB-AAR-75-9

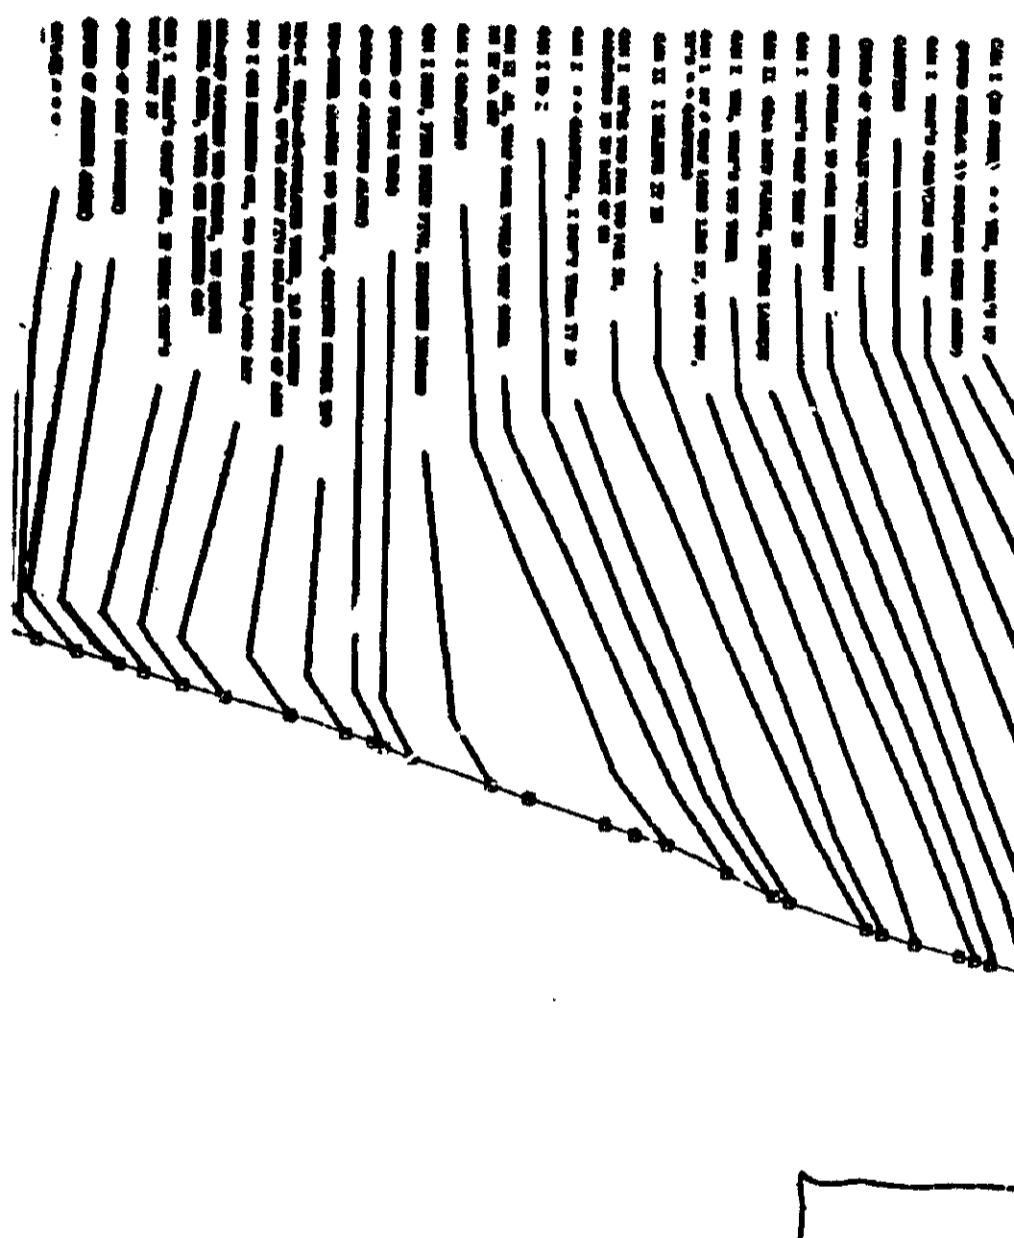
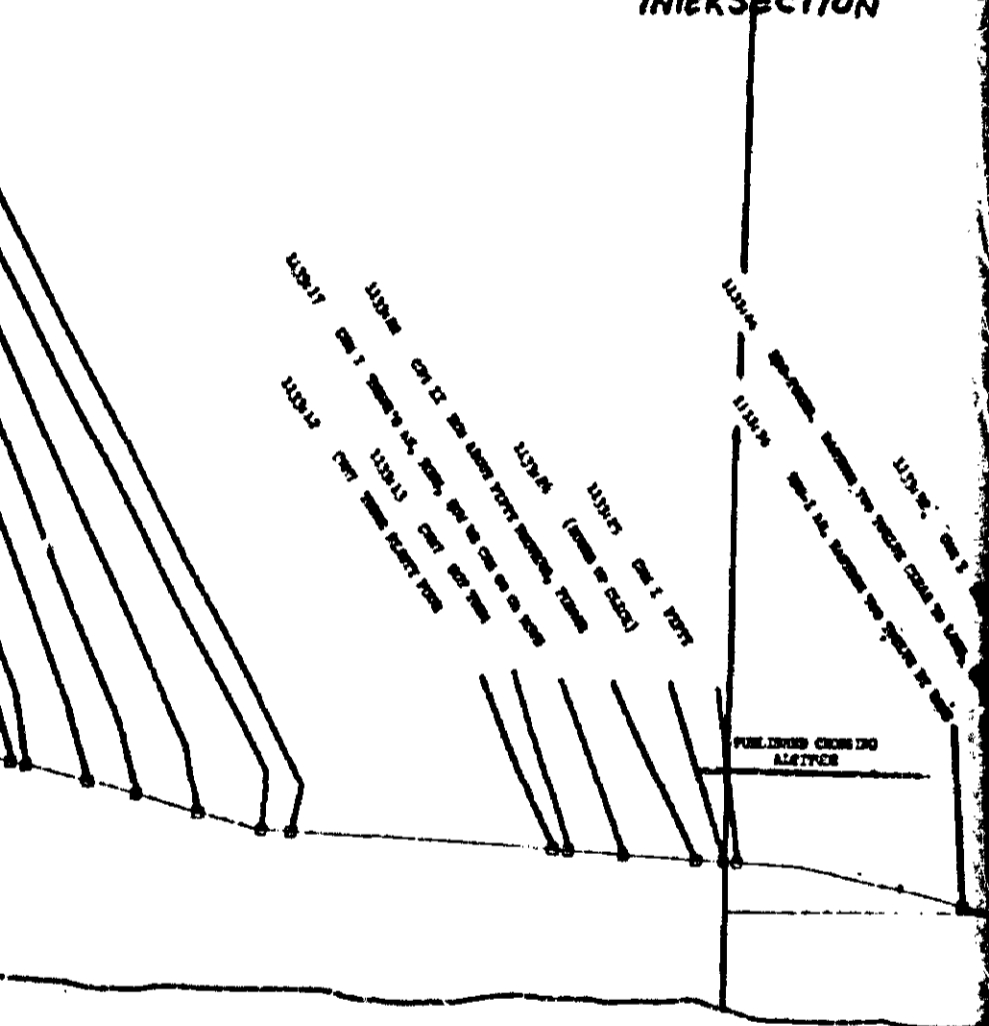
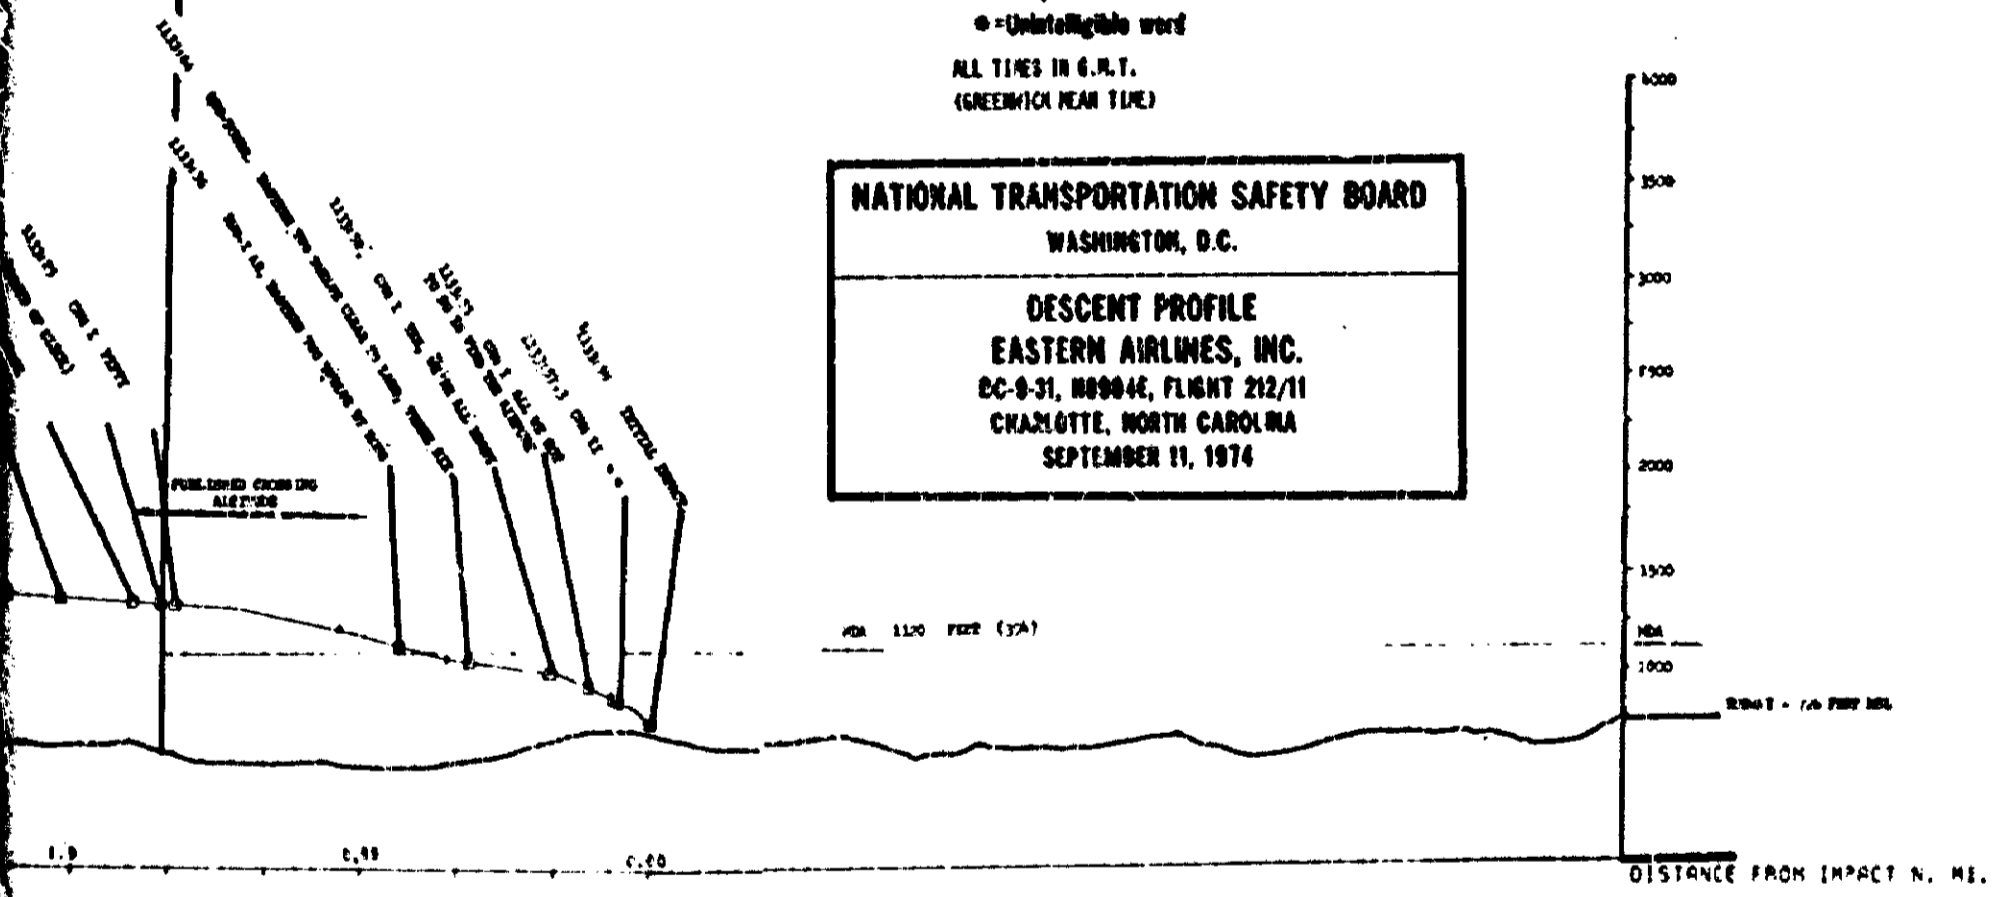
NATIONAL TRANSPORTATION SAFETY BOARD
 WASHINGTON, D.C.
DESCENT PROFILE
 EASTERN AIRLINES, INC.
 EC-8-31, N8904E, FLIGHT 212/11
 CHARLOTTE, NORTH CAROLINA
 SEPTEMBER 11, 1974

At 0733:17, the captain said, "There's ah, Ross. Now we can go down." The first officer then requested, "How about 50°, please." The captain replied, "50." Clicks heard on the CVR indicate that the flap handle was moved. At that time, the FDR showed the aircraft's altitude was about 1,480 feet.

aircraft still had almost 1,300 feet to lose prior to reaching MDA, and he conducted the remainder of the approach accordingly. The captain may likewise have believed the aircraft was 1,000 feet higher above the field elevation than it actually was, which would mean that, in his mind, the plane never reached MDA or 100 feet above MDA, which would further explain why these callouts were never made. Additionally, the captain may have failed to detect the discrepancy between the prescribed and actual altitudes because of his preoccupation with the checklist and with looking outside the cockpit.

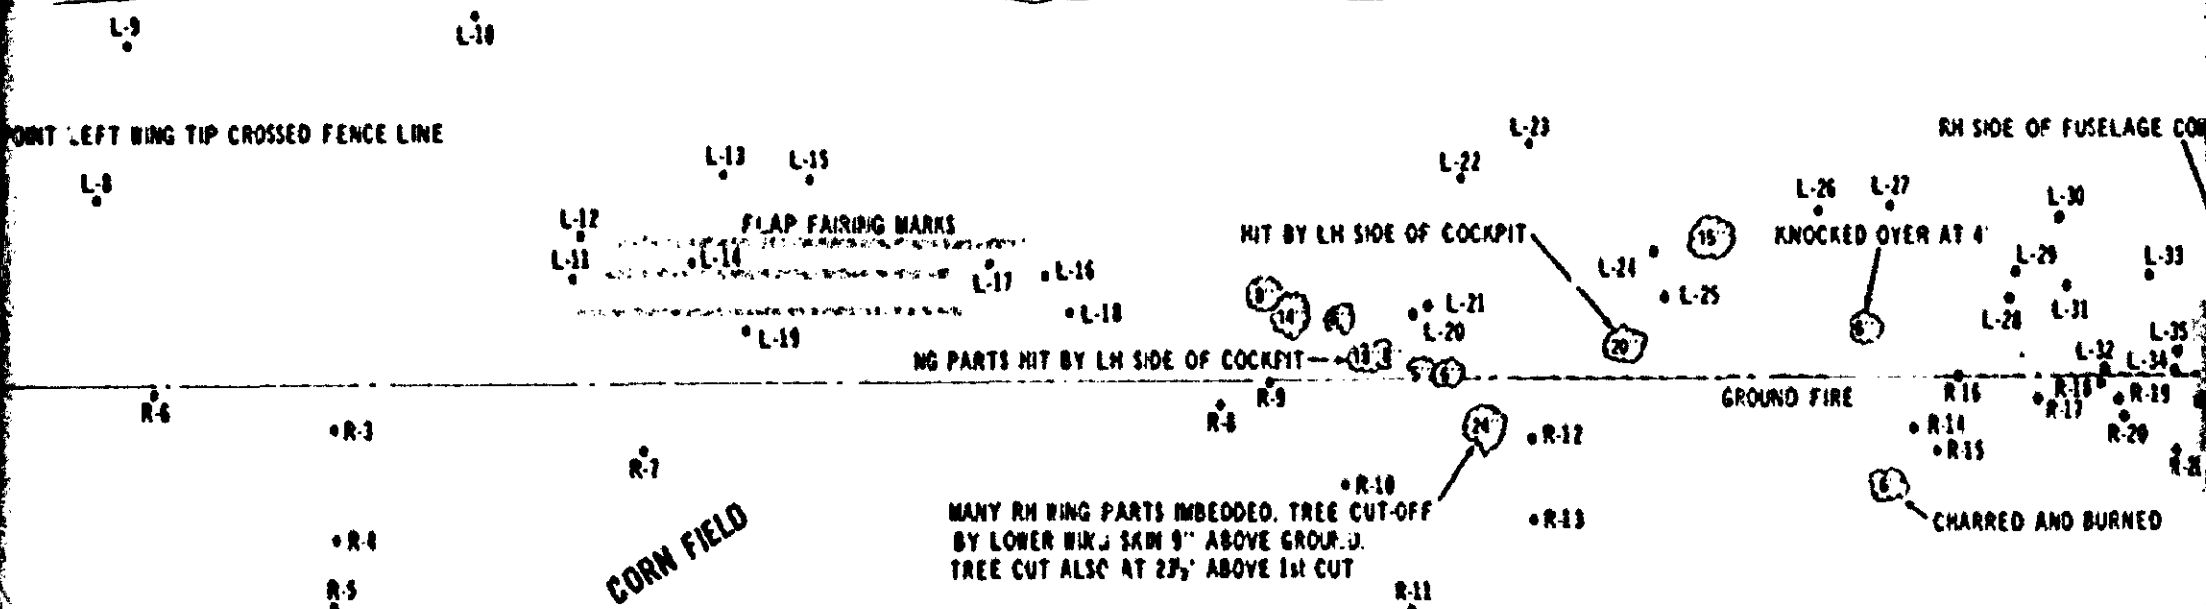
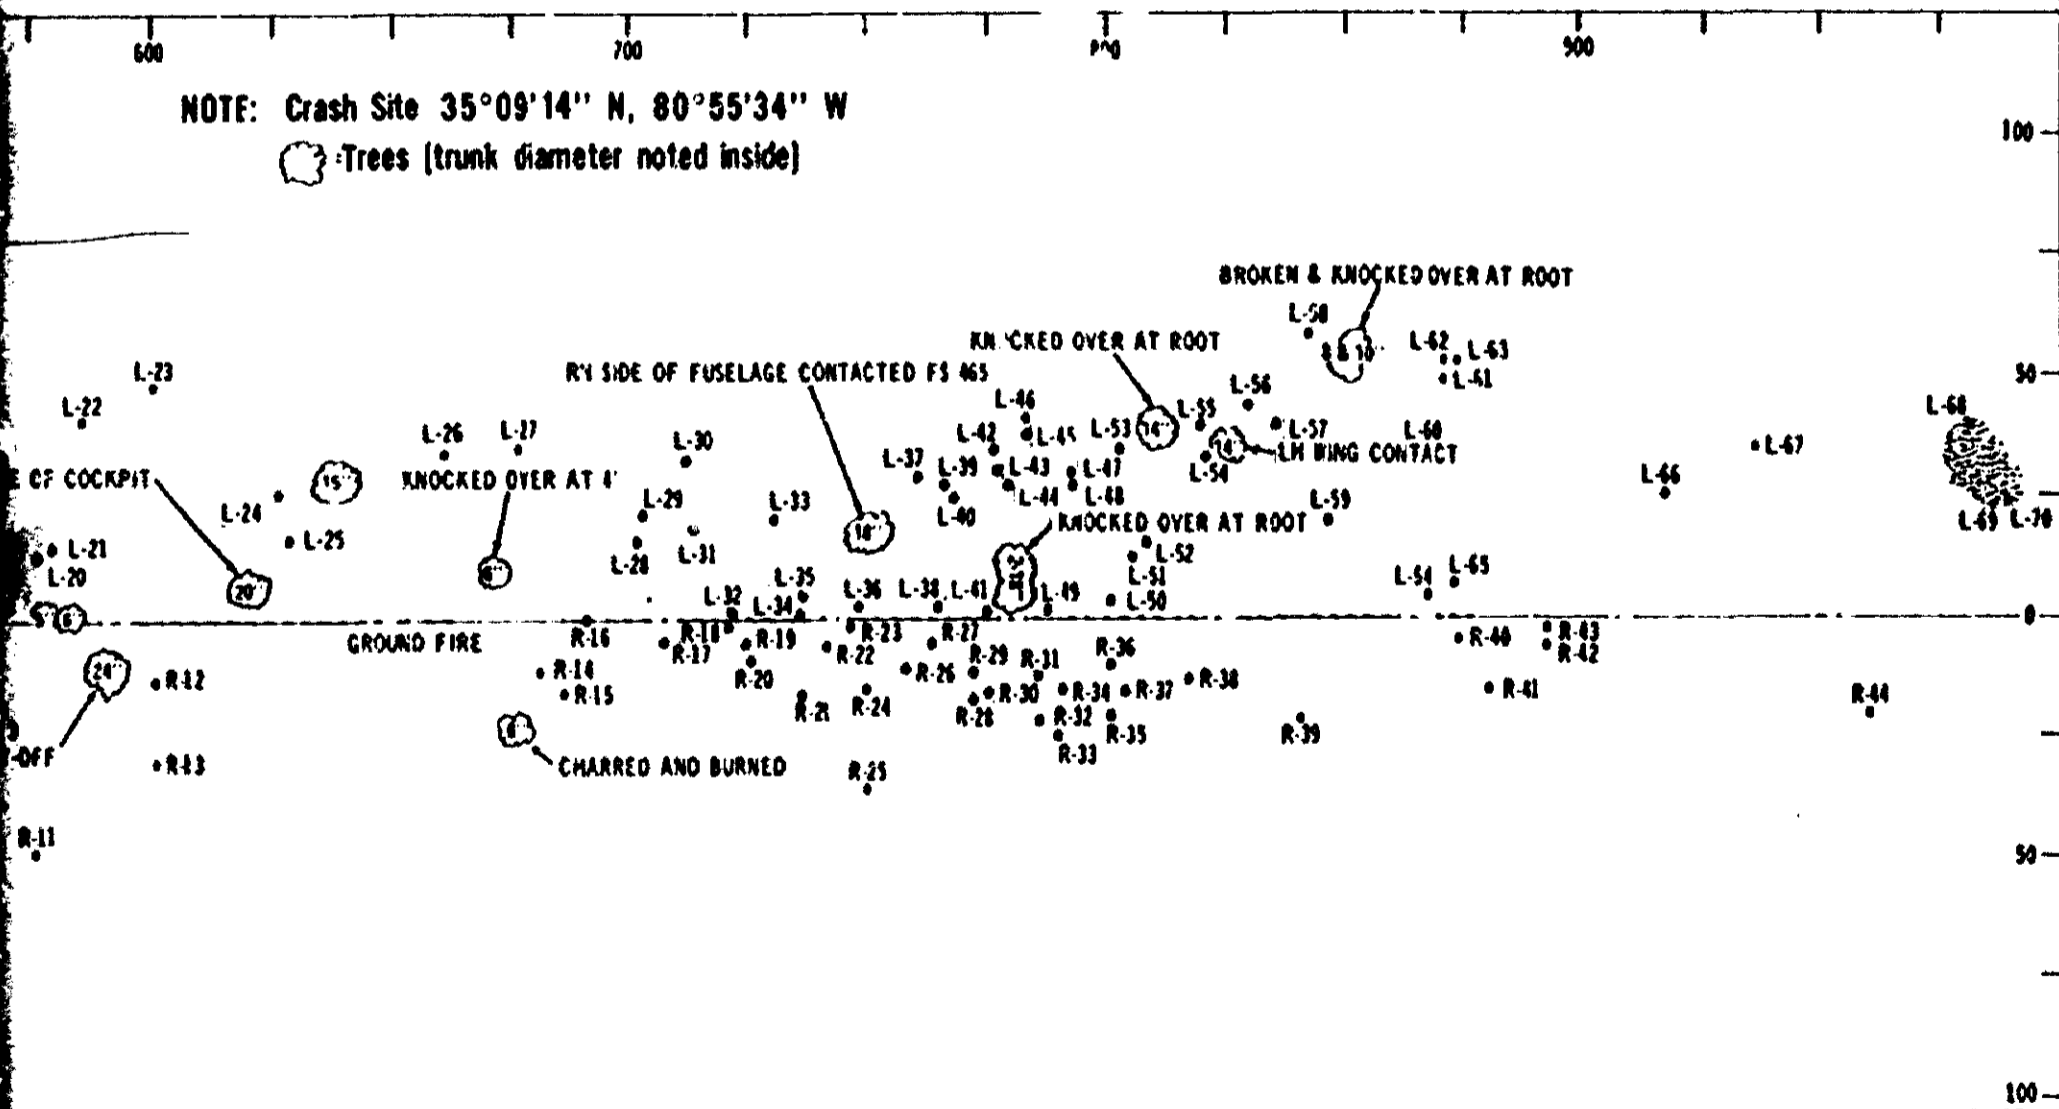
WRECKAGE DISTRIBUTION CHART
EASTERN AIRLINES, INC., DOUGLAS DC-9-31, N-8984E
3.3 STATUTE MILES SOUTH OF RUNWAY 36
DOUGLAS AIRPORT, CHARLOTTE, N.C.
SEPTEMBER 11, 1974

Broken red glass from the lower fuselage rotating beacon was found within the tail skid and aft fuselage ground marks.

The aircraft wreckage came to rest in a ravine 995 feet from the initial impact point. The cockpit section came to rest on a magnetic heading of 310° ; the aft fuselage section came to rest on a magnetic heading of 290° . The wreckage area was 995 feet long and 110 feet wide. No parts of the aircraft were found outside the main wreckage area. (See Appendix G.)
