AIRCRAFT ACCIDENT REPORT

**NATIONAL JET SERVICES, INC.,
DOUGLAS DC-3, N51071**

**EVANSVILLE DRESS REGIONAL AIRPORT, INDIANA
DECEMBER 13, 1977**

REPORT NUMBER: NTSB-AAR-78-10

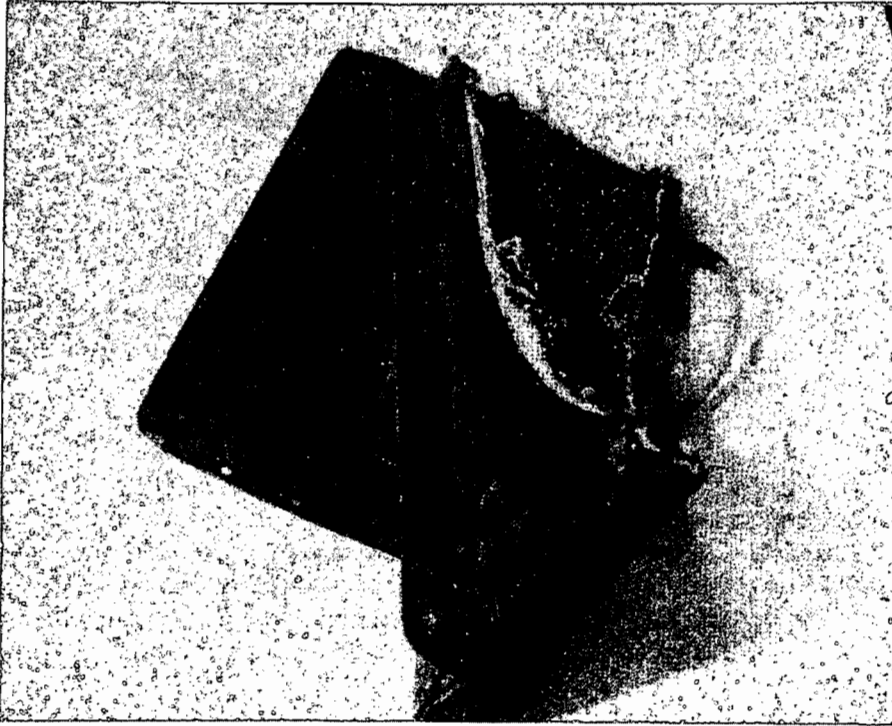
Figure 4. The right (outboard) side of the right aileron control lock showing the vertical member of the lock and the upper and lower horizontal members which hold the inboard end of the aileron.

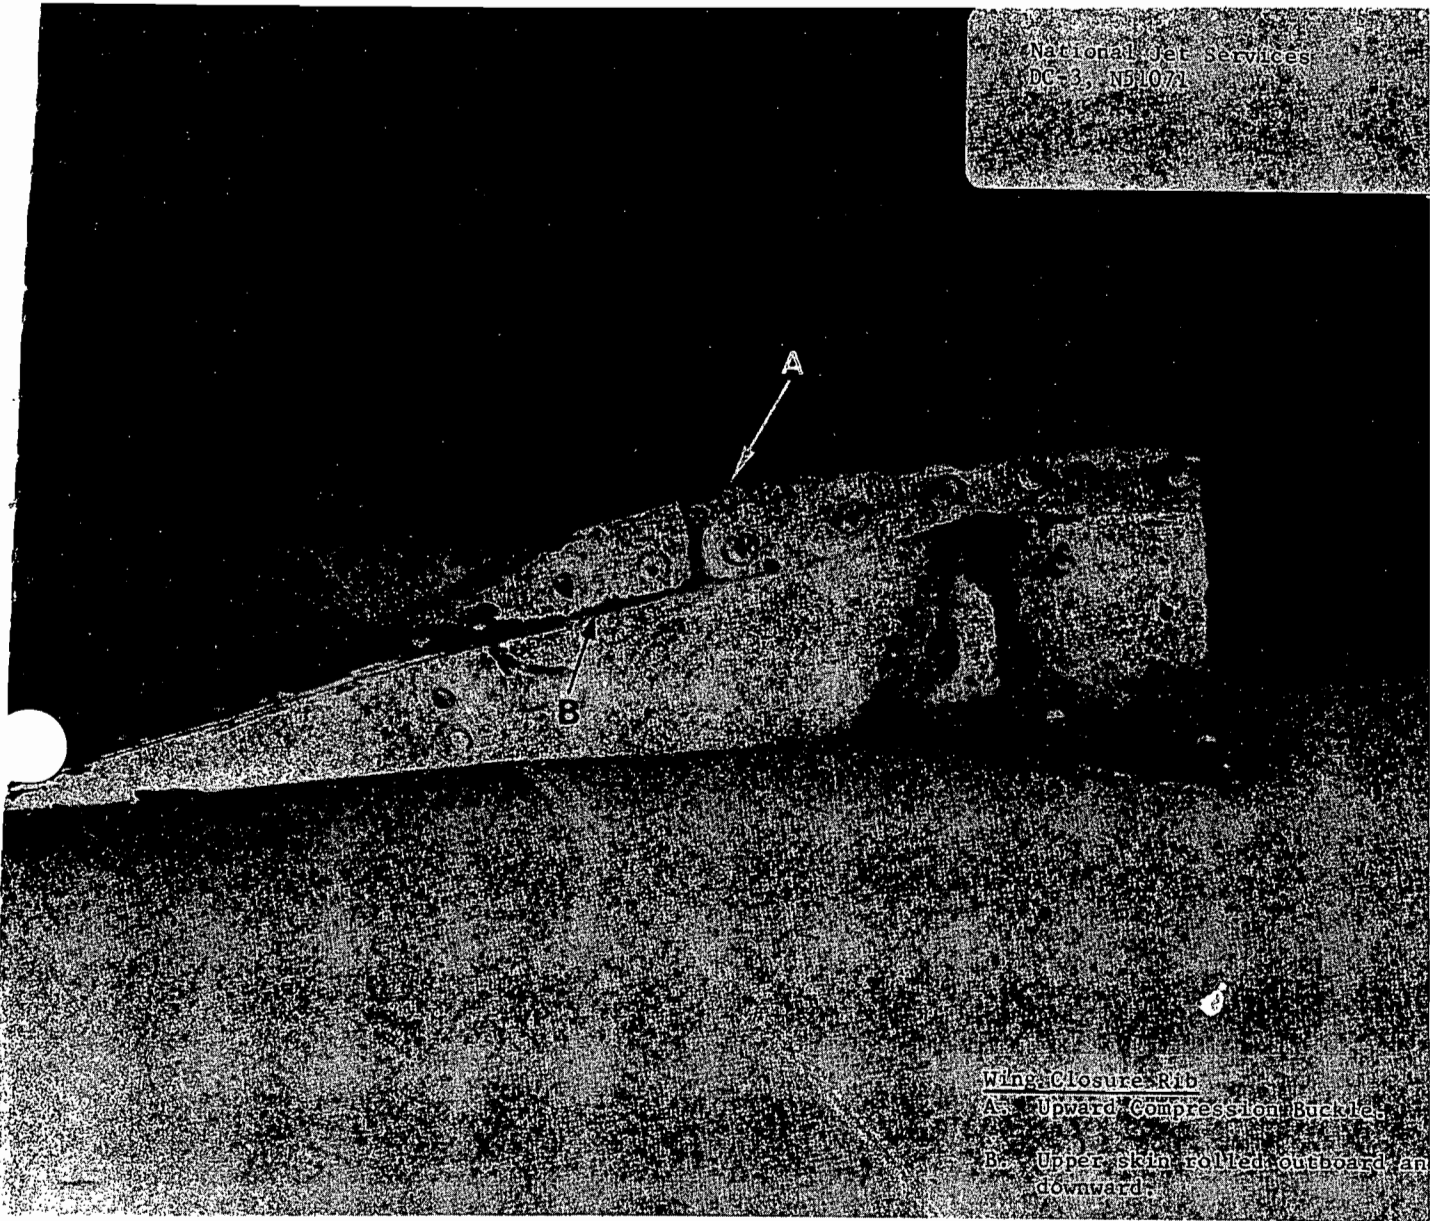
Wing Closure Rib

A. Upward Compression Buckle.

B. Upper skin rolled outboard and downward.

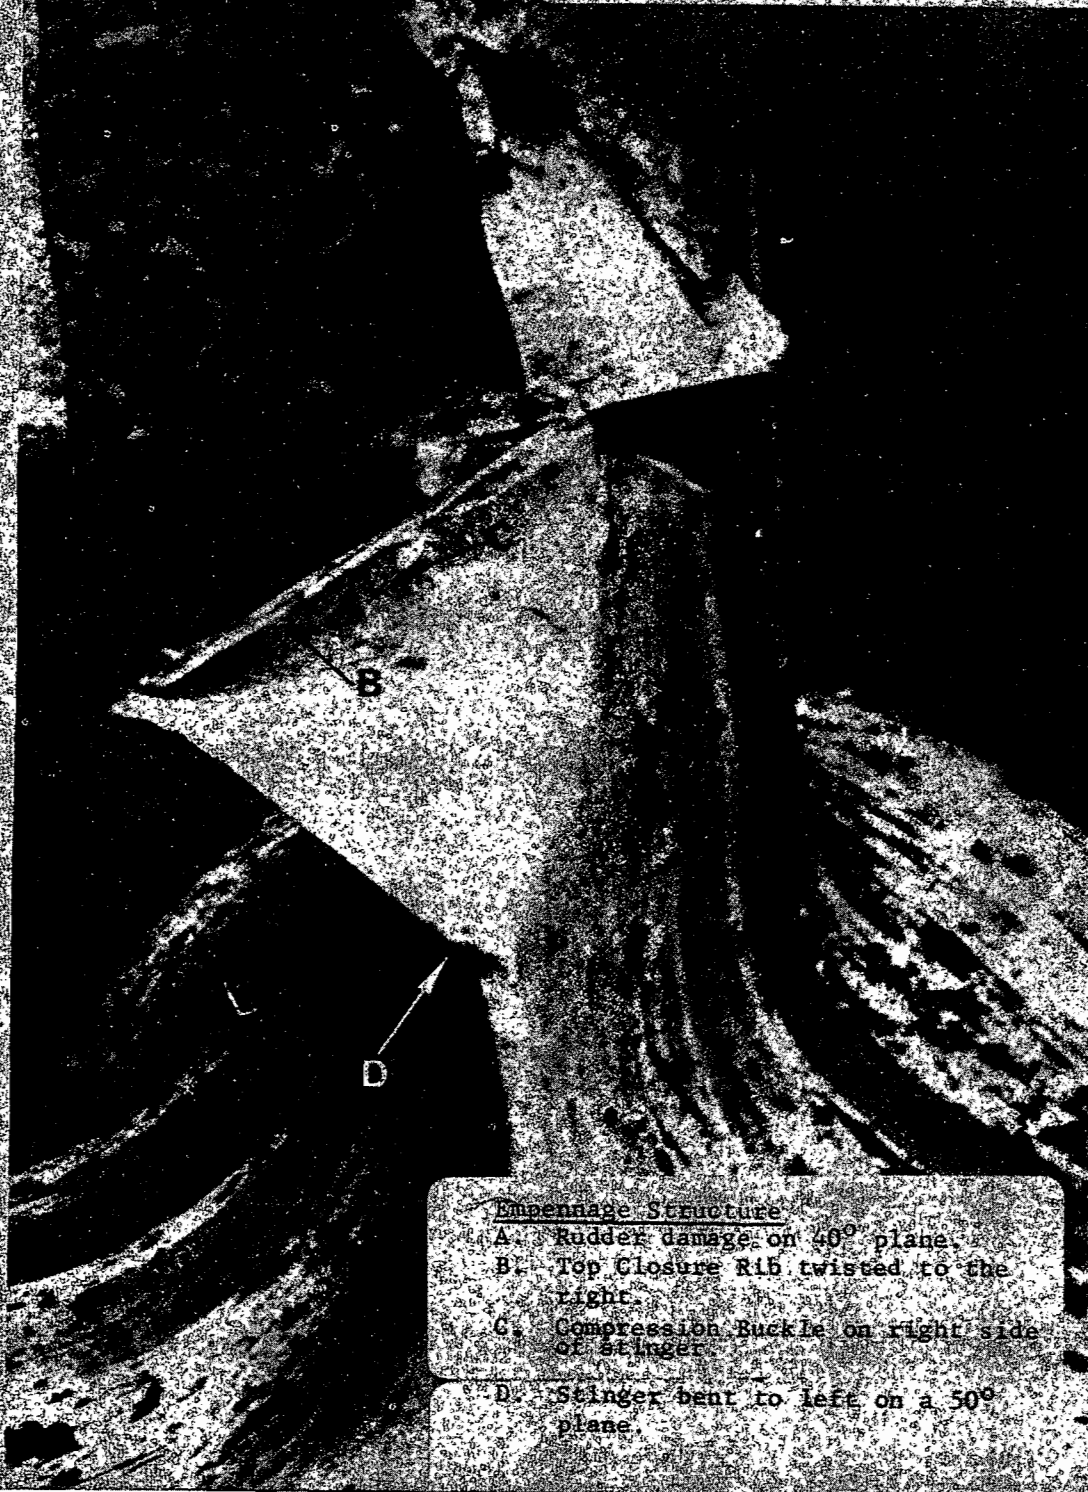
Fig 8

The fuselage tail cone assembly remained attached to the aft fuselage structure. The vertical trailing edge of the tail cone from a point 10 ins. down from the top rib had been bent to the left on about a 50° plane. The uppermost rib of the cone had been twisted to the right with a severe buckle at the rib and right skin juncture. The top rib also had been torn and buckled on the left side at the left side skin to rib juncture 12 ins. forward of the vertical trailing edge. Similar damage was also noted on the right side of the rib about 1 in. forward of the rib damage on the left side. (See Appendix G, figures 8 through 11.)

Empennage Structure
A. Rudder damage on 40° plane.
B. Top Closure Rib twisted to the right.
C. Compression Buckle on right side of stringer.

D. Stinger bent to left on a 50° plane.

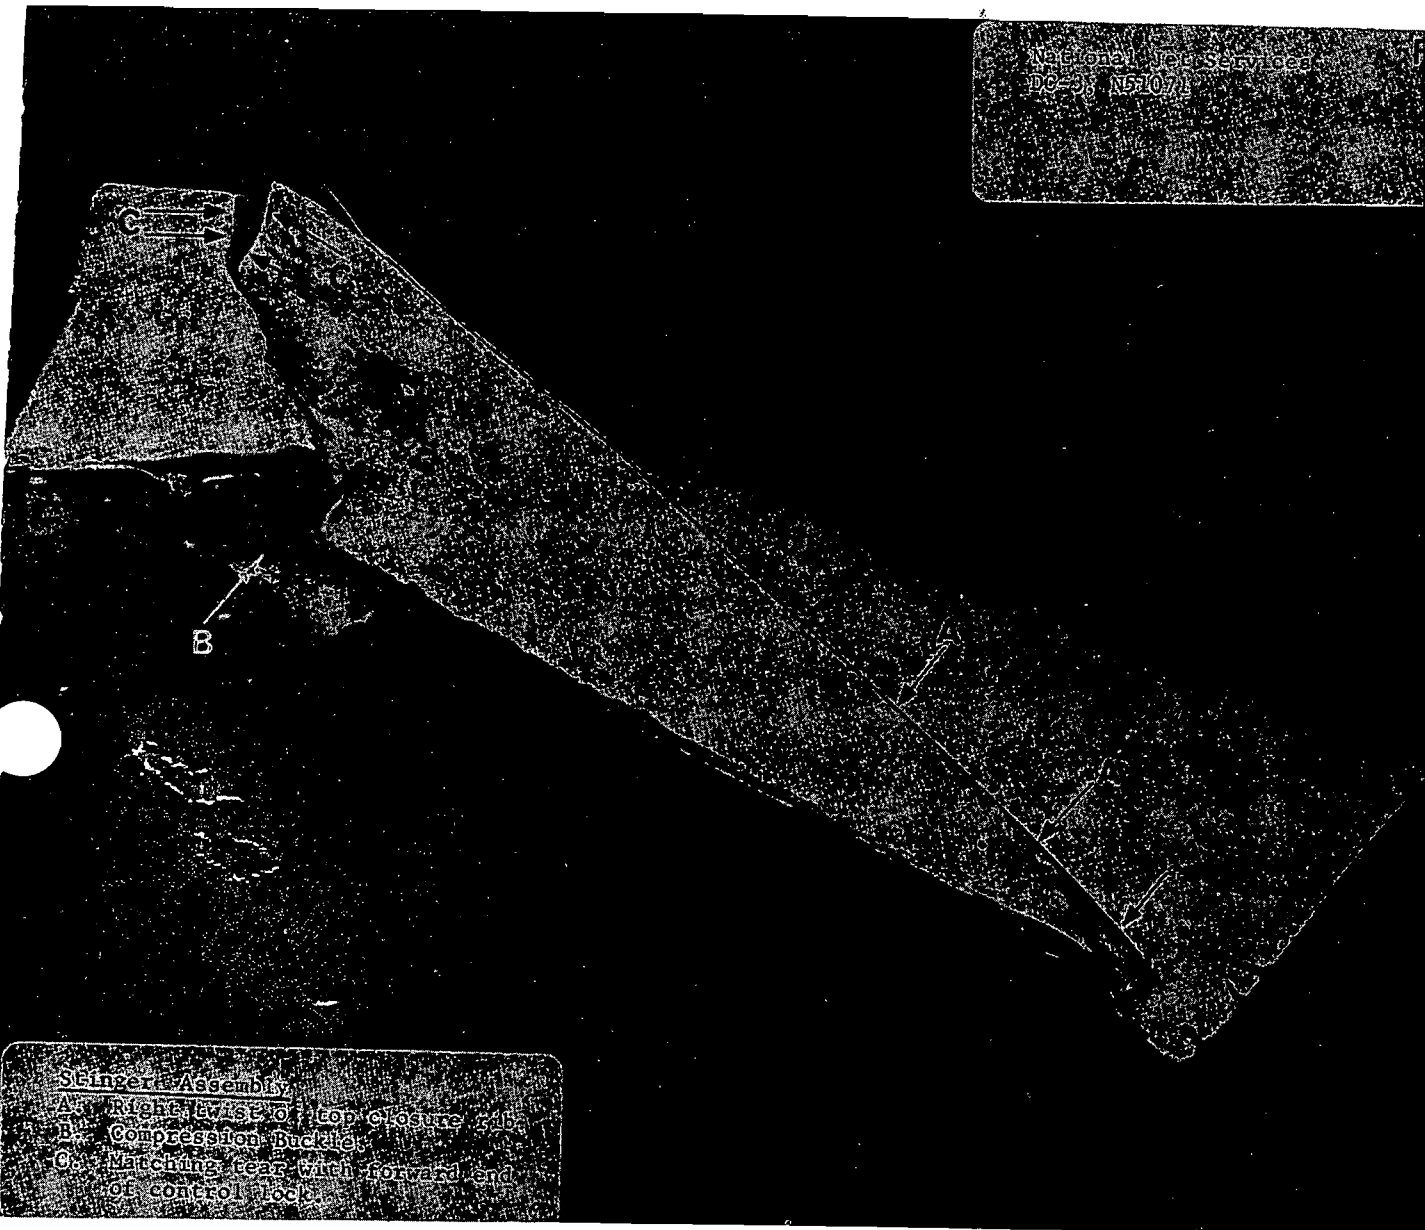
Since there was no impact damage to the tail cone assembly, the external rudder control lock was in place at impact. Although the sturdily constructed lock protected the tail cone from direct impact by wing structure, it also transmitted the impact forces to it. This is substantiated by the cone's rotation to the left.

Sinker Assembly
A. Right side of top closure and
Compression Buckle.
B. Compression Buckle.
C. Matching rear with forward end
of control lock.
