AIRCRAFT ACCIDENT REPORT

NATIONAL AIRLINES, INC.,
BOEING 727-235, N4744NA
ESCAMBIA BAY
PENSACOLA, FLORIDA

MAY 8, 1978

1. Report No. NTSB-AAR-78-13		2. Government Accession No.		3. Recipient's Catalog No.	
4. Title and Subtitle Aircraft Accident Report -- National Airlines, Inc., Boeing 727-235, N4744NA, Escambia Bay, Pensacola, Florida, May 8, 1978		5. Report Date November 9, 1978		6. Performing Organization Code

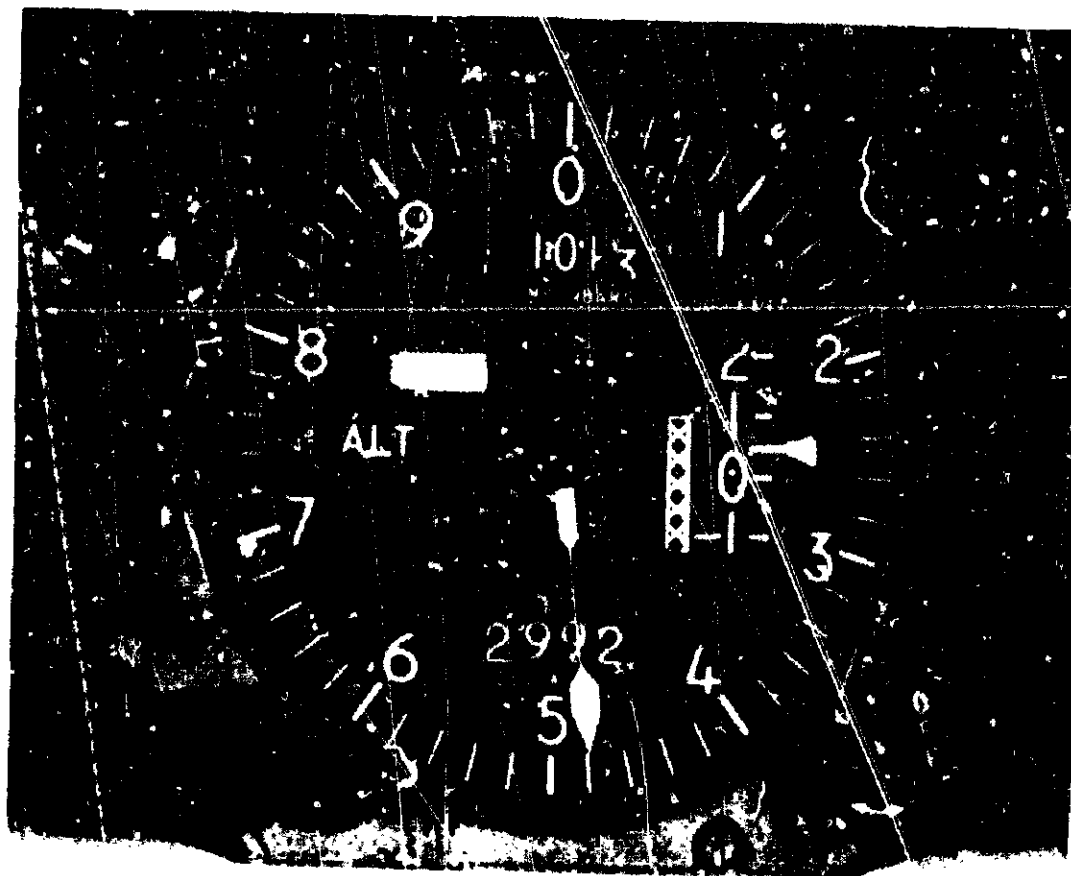
Figure 1. Kollsman Drum Pointer Altimeter

The captain's and first officer's instrument panels were equipped with Kollsman P/NA-41869-10.21 drum-pointer type barometric altimeters. (See figure 1.) This altimeter has a range from +50,000 ft to -1,500 ft. Hundreds of feet are indicated by a radial pointer, and thousands of feet are indicated on a rotating drum visible through a slot on the face of the instrument. A white crosshatch is painted on the left side of the drum adjacent to the numbers from +1,000 ft to -1,500 ft to increase the conspicuity of the lower altitude values.

The captain and first officer testified that they misread their barometric altimeters during the latter stages of the descent after they were cleared to descend from 1,700 ft.

The captain said that he misread his altimeter at 500 ft and believed he saw 1,500 ft. He stated that "When that figure got on my mind as I ran my scan after that, I was seeing 400 and 300 and they were 14 and 13 in my mind. I was looking at the needle instead of looking at the 1,000-foot marker in it. I didn't actually look at the thousand-foot pointer at that time. I just glanced down at the hundred-foot pointer."
