NATIONAL TRANSPORTATION SAFETY BOARD

AIRCRAFT ACCIDENT REPORT

**AIR NEW ENGLAND, INC.
DeHAVILLAND DHC-6-300, N383 EX
HYANNIS, MASSACHUSETTS
JUNE 17, 1979**

NTSB-AAR-80-1

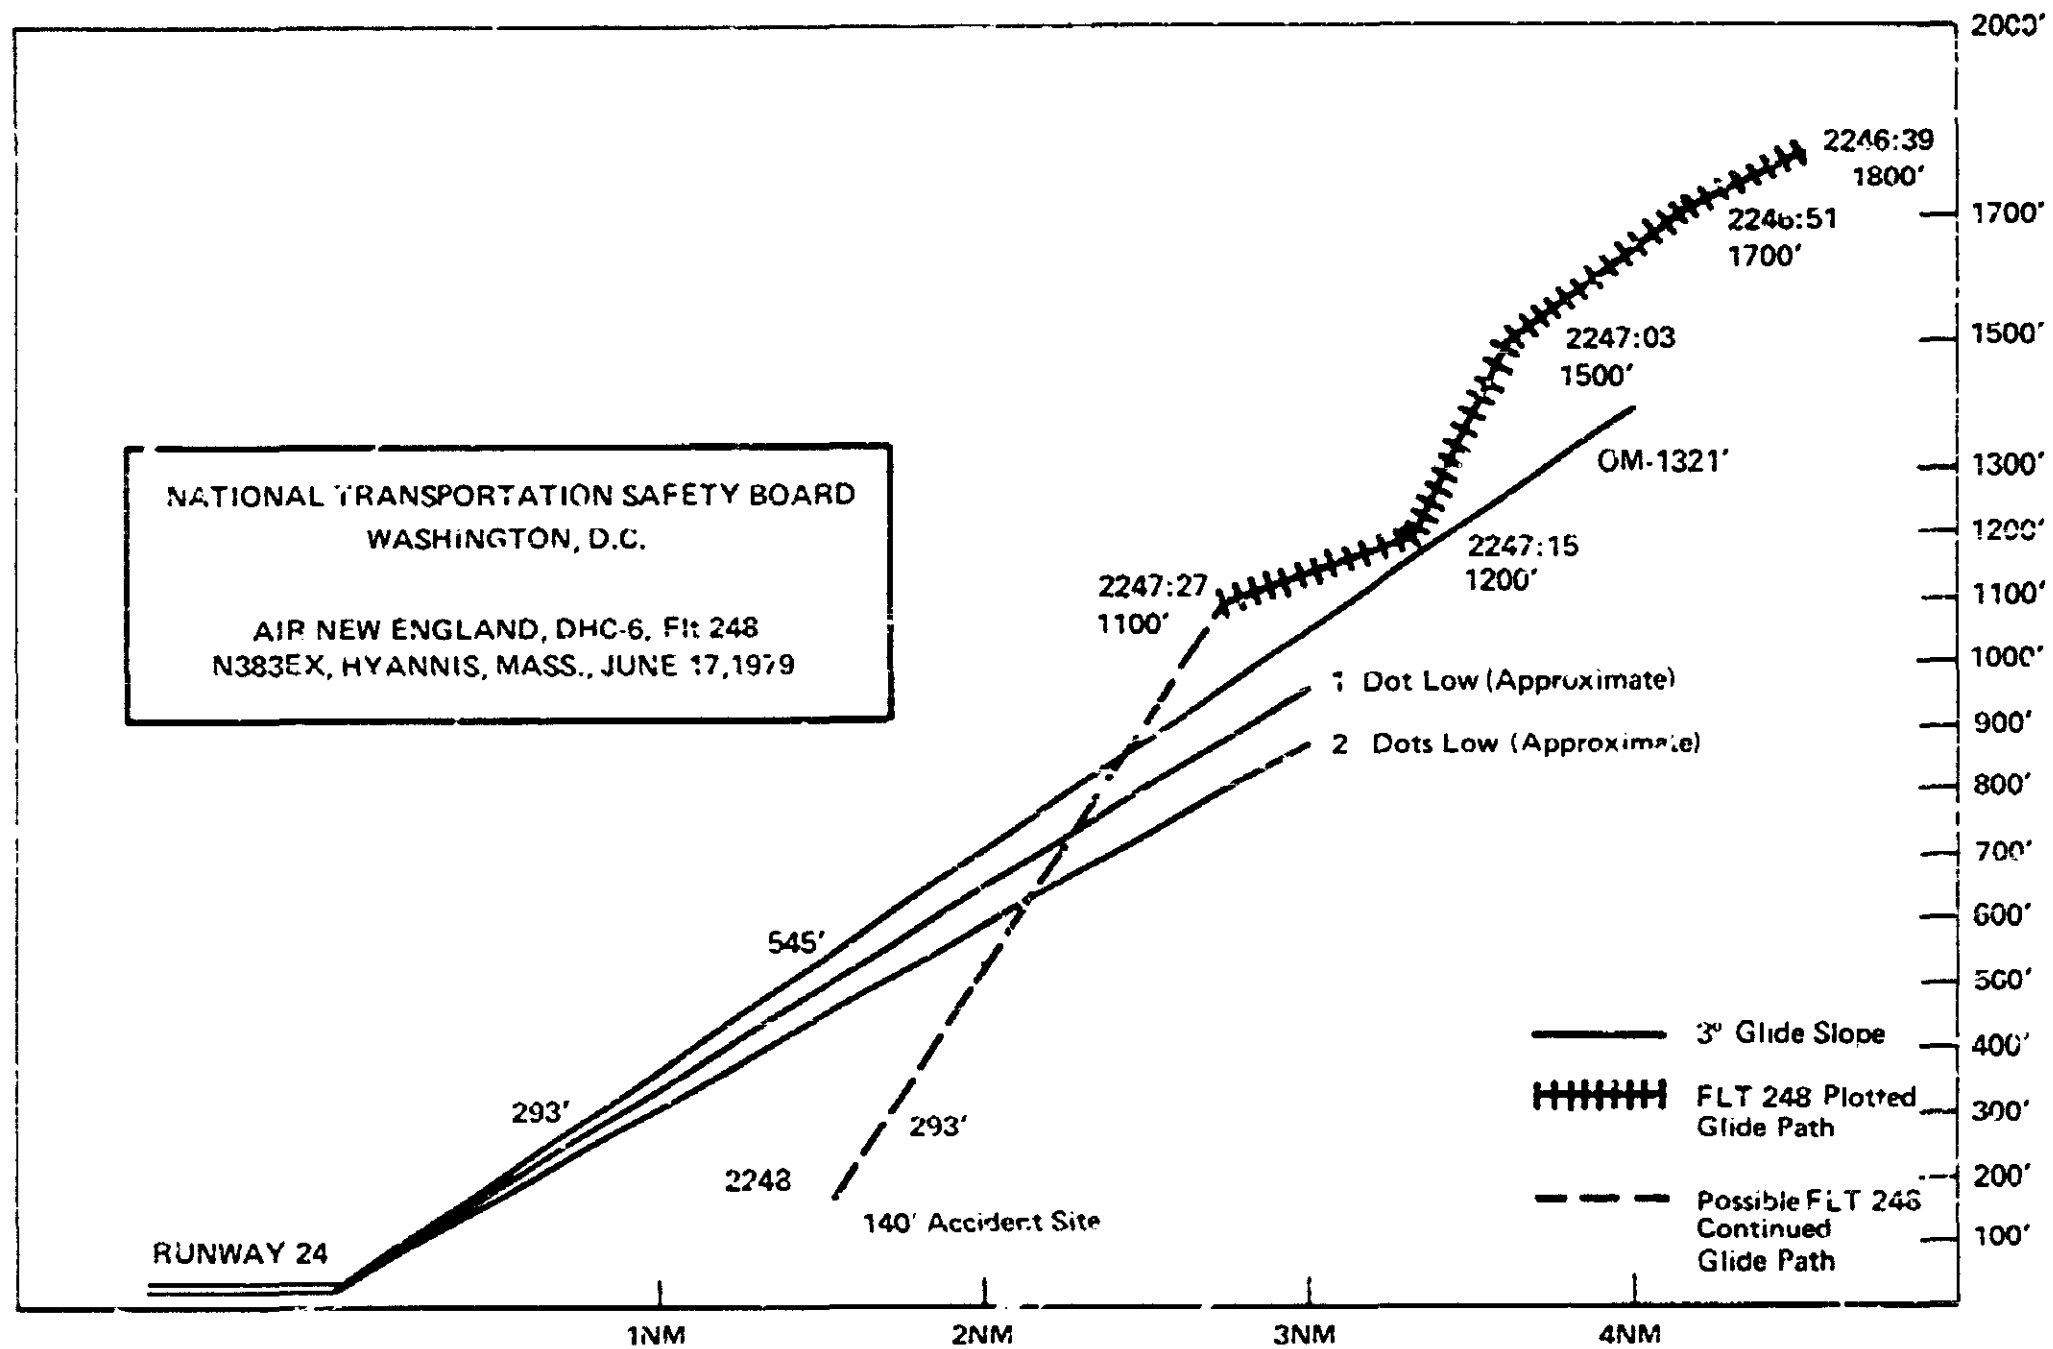
The Boston Air Route Traffic Control Center (Boston Center) was able to track Flight 248 to within 2.8 nmi of the intended touchdown point on runway 24. (See Figure 1.) Boston Center's computer printout showed the flight's position at 2246:51 about 0.35 nmi northeast of the ILS outer marker at 1,700 ft. It also showed the flight about 0.15 nmi southwest of the outer marker at 1,500 ft at 2247:03. The last radar position shown for the flight was about 1.1 nmi southwest of the outer marker at 2247:27 at 1,100 ft.

Figure 1.--Probable descent profile of N383EX determined from Boston Center data.
