NATIONAL TRANSPORTATION SAFETY BOARD

AIRCRAFT ACCIDENT REPORT

**VIEQUES AIR LINK, INC.,
BRITTEN-NORMAN BN-2A-6 ISLANDER, N589SA
VIEQUES, PUERTO RICO
AUGUST 2, 1984**

NTSB/AAR-85/08

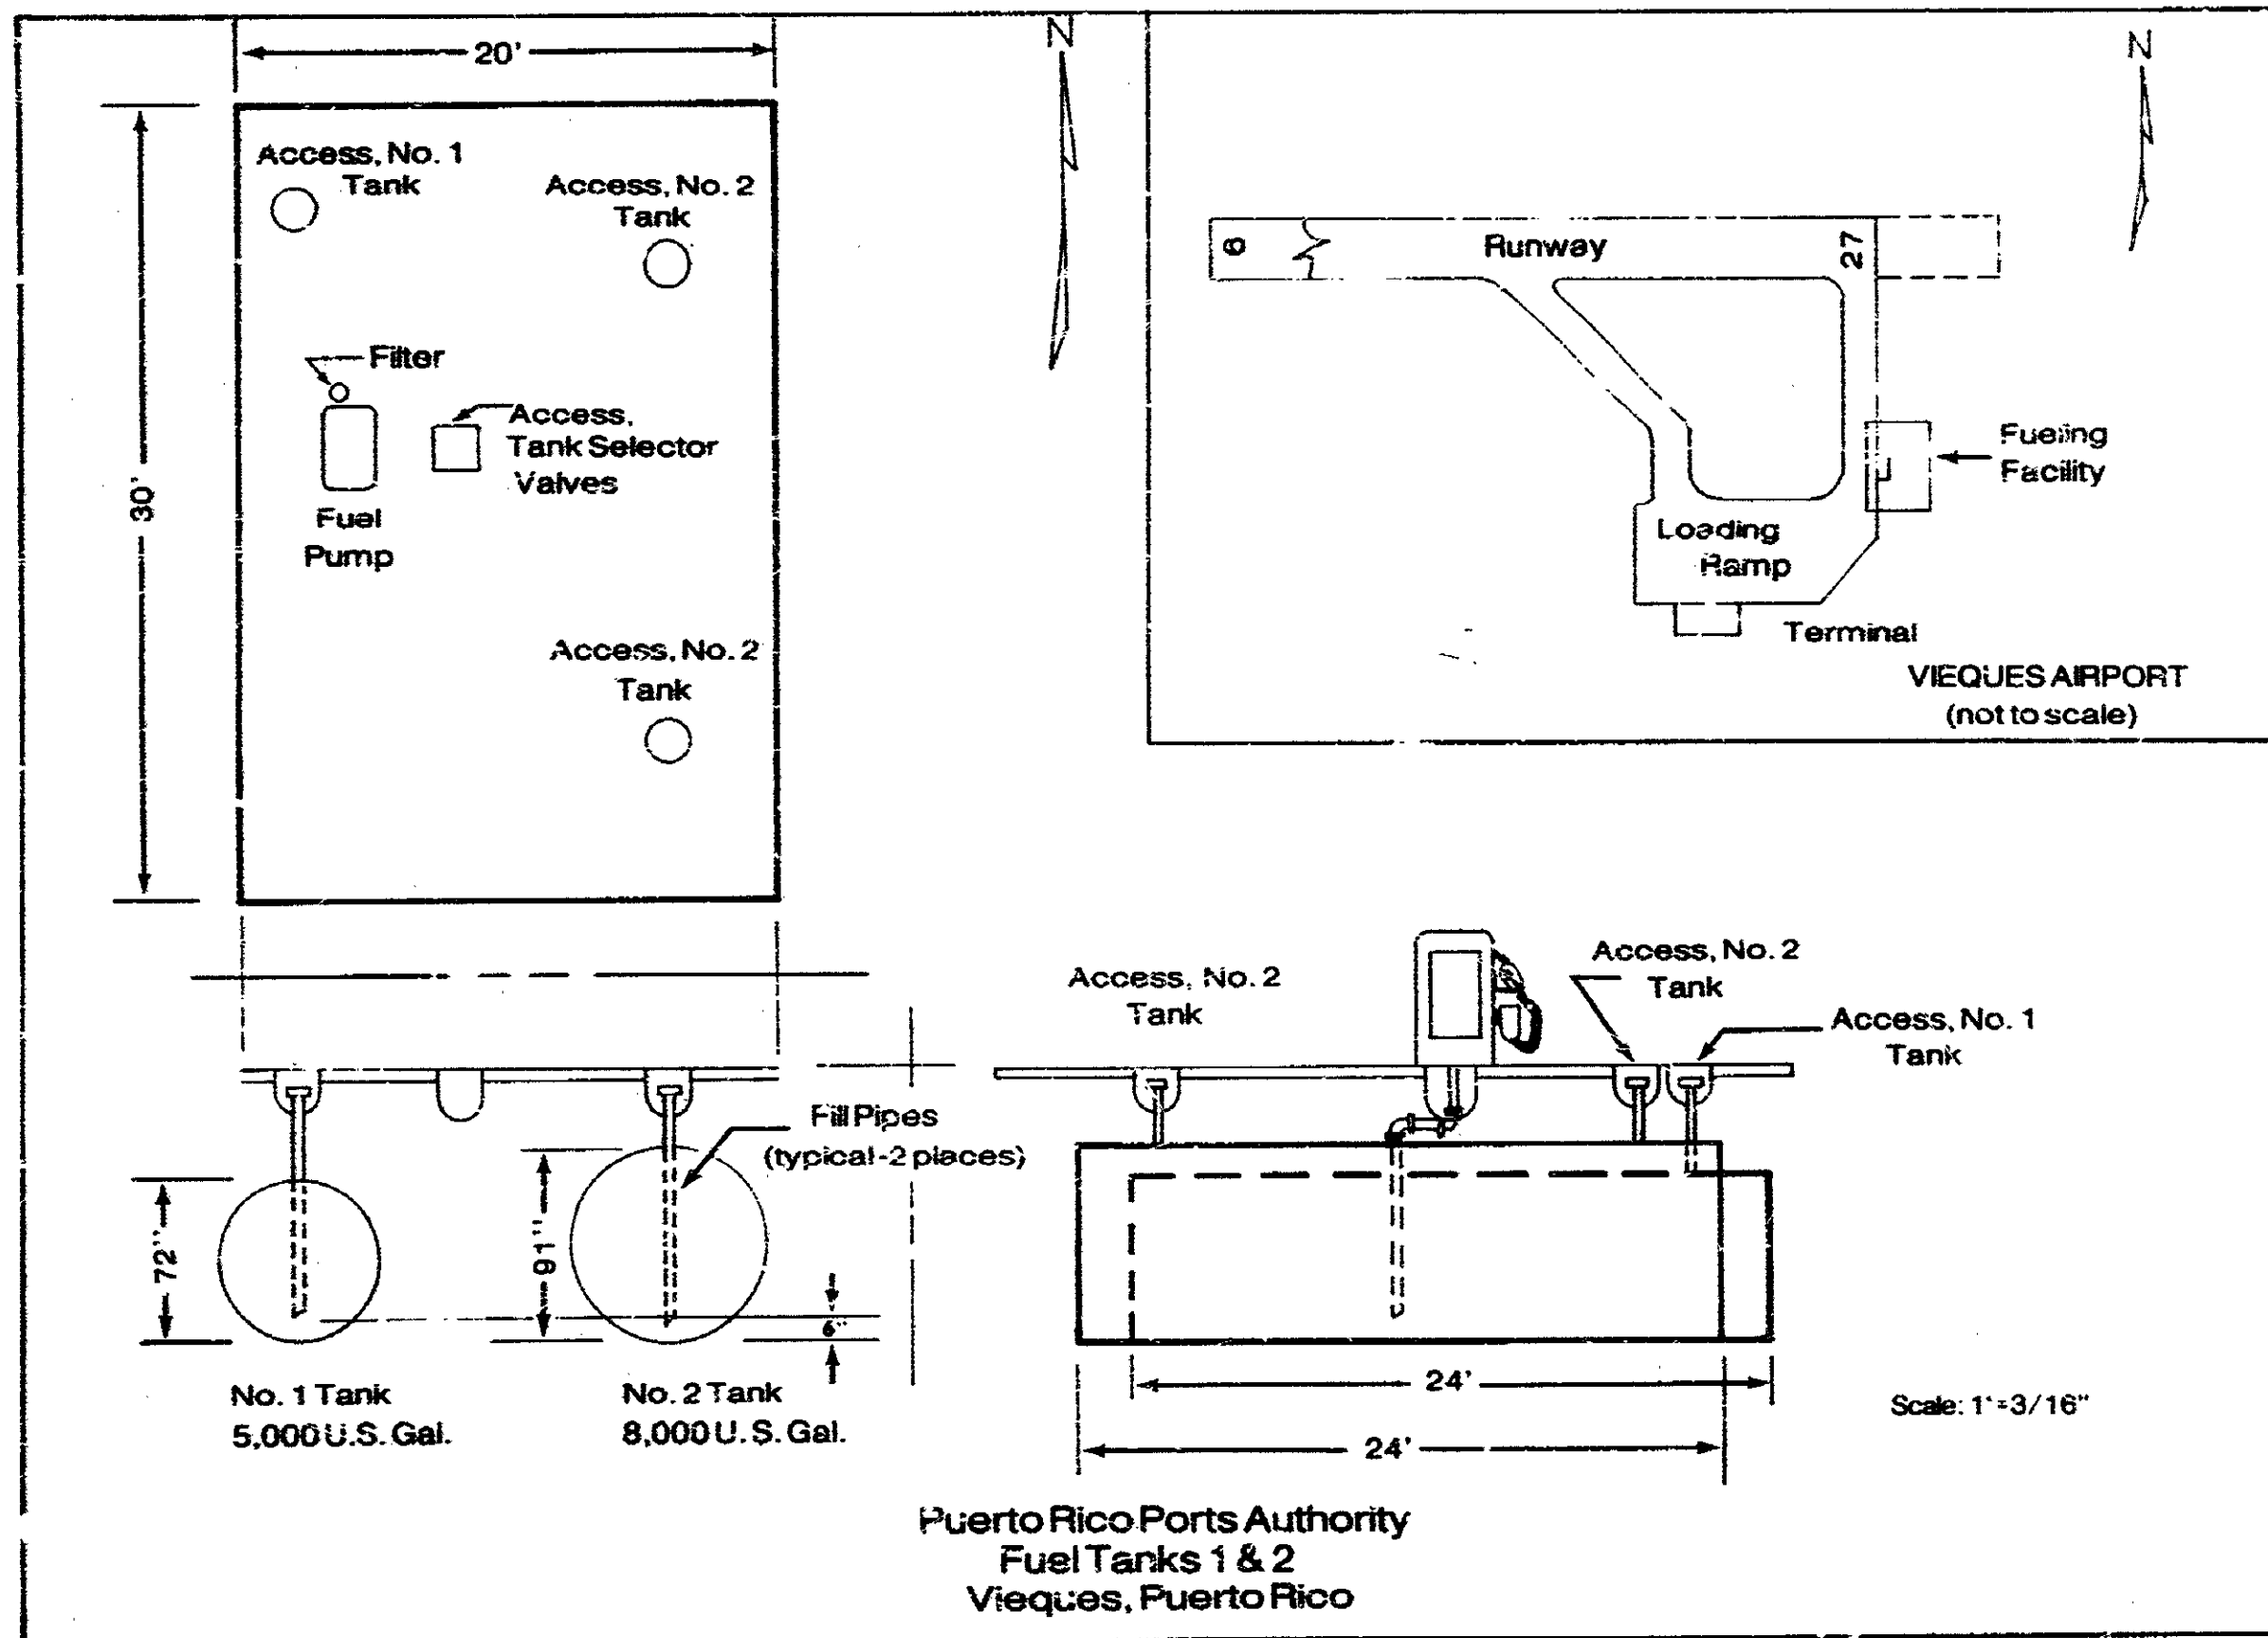
Figure 1.—Fuel facility.

The fueling facility operated by PRPA was located at the east end of the ramp area about 300 feet south of runway 9/27. (See figure 1.) The fueling station consisted of two in-ground steel tanks and one aboveground electric, automotive-type delivery pump.

The investigation revealed that 1 day after the accident the gravel base of the No. 2 fill pipe wells was wet and one of the fill pipe caps was loose on its fill pipe adapter, even though the cam locking levers were down (closed position). The cap could be moved vertically and did not provide an air-tight seal. A portion of the cap's gasket was missing; it measured about 1/4 inch wide in circumference. The outside and inside dimensions of the gasket were different from the gaskets on the other fill pipe caps. The loose gasket was red and the other two were black. The loose gasket was harder than the others and it appeared to have been manufactured locally.

After a very hard rain 2 days after the accident, Safety Board personnel found both fill pipe wells of the No. 2 in-ground tank to be full or partially full of water.
