NATIONAL TRANSPORTATION SAFETY BOARD

AIRCRAFT ACCIDENT REPORT

PROVINCETOWN-BOSTON AIRLINES
FLIGHT 1039

EMBRAER BANDEIRANTE, EMB-110P1, N96PB
JACKSONVILLE, FLORIDA
DECEMBER 6, 1984

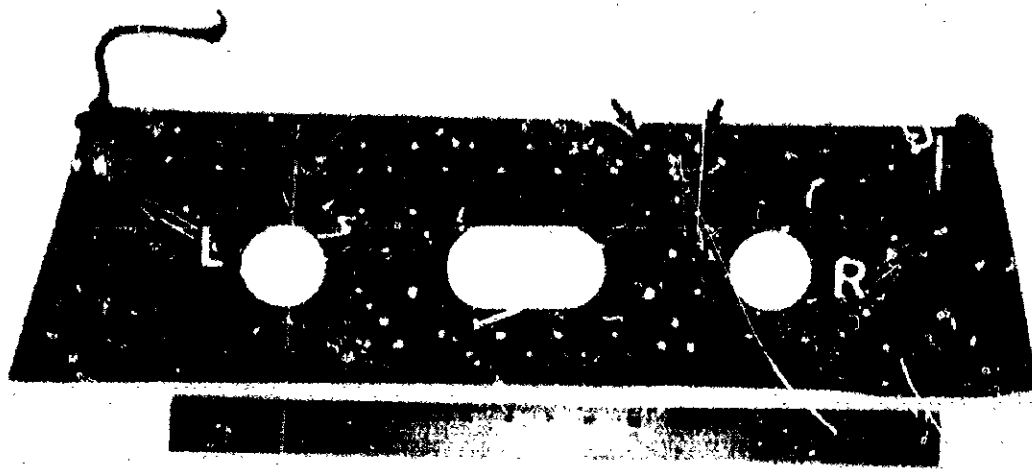
The forward attachment fitting of the horizontal stabilizer on N96PB failed at bulkhead No. 33 when the male lugs of the attachment fitting fractured first in shear and then in tensile overstress. (See figures 2A, 2B, 3A, 3B, and 4.) The separated male lugs remained bolted to the clevises on the stabilizer. The tail cone, including bulkhead No. 36, and the ventral fin also separated with the stabilizer. The stabilizer rear attachment structure was deformed, but it continued to connect the stabilizer rear spar and the fuselage bulkhead No. 36 fittings.

The examination of the bulkhead No. 33 structure disclosed fretting around some rivet holes in channels which transmit the loads from the upper right corner of the forward attachment fitting into the fuselage structure forward of the bulkhead. The bulkhead web break contained a small preexisting fatigue crack, 5/16 inch long.

Figure 2B.--Forward attachment fitting removed from bulkhead No. 33.

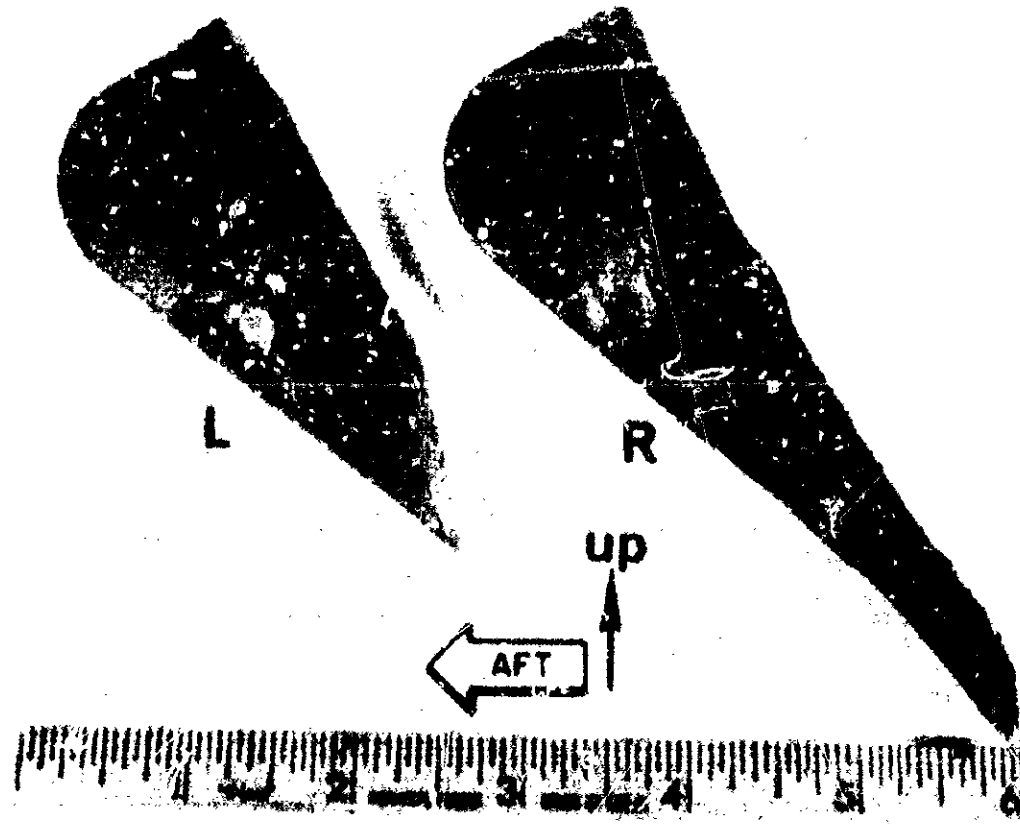
Figure 3A.—Left and right ears of forward attachment fitting which remained attached to horizontal stabilizer.

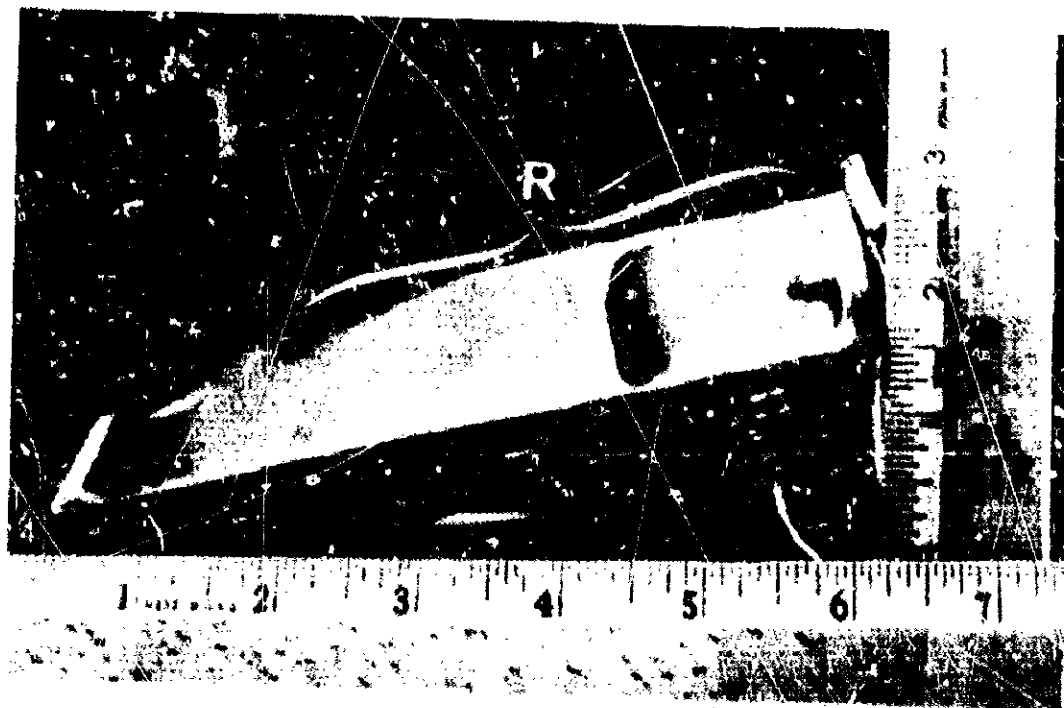
The stabilizer forward attachment fitting on the aft side of bulkhead No. 33 was deformed with the upper right corner pulled aft and down, tearing the bulkhead web and separating the structural attachments on the forward side of the bulkhead. The left side of the forward attachment fitting remained flushed and attached to the structure forward of the bulkhead, with many fasteners still intact. The deformation indicated that the male lugs on the attachment fitting fractured from overstress forces as the horizontal stabilizer moved aft and twisted clockwise (looking forward) relative to the fuselage.

Figure 3E.—View from right side showing twist in forward attachment fitting.

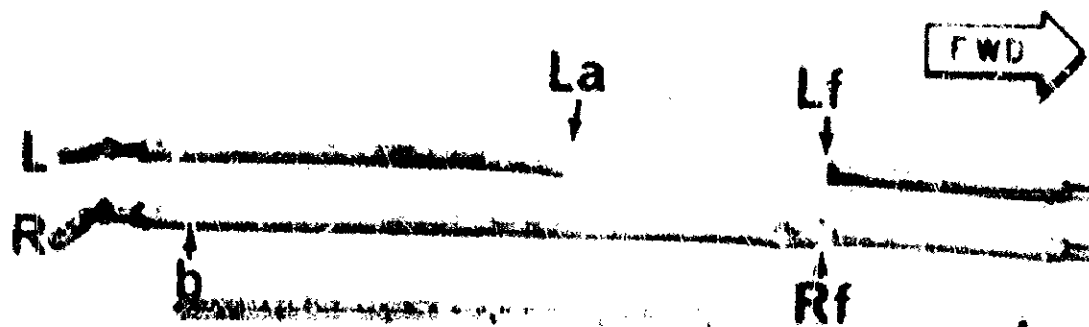
When the horizontal stabilizer on N96PB separated from the fuselage, both the left and right elevator control rods were deformed and had separated in line with bulkhead No. 34 (11 inches aft of the aft bellcranks.) (See figures 6A and 6B.) The forward portion of each rod remained attached to its respective fuselage mounted bellcrank. The remaining 32 1/2 inches of the aft portion of the right elevator control rod remained attached to the right elevator actuating arm after the separation. However, only 21 1/2 inches of the left elevator control rod was still attached to the left elevator actuating arm. The left elevator control rod was fractured in two places; the aft fracture which occurred near the midpoint of the rod, was a compression buckling failure. The 8-inch section of the left control rod between the two fractures was not recovered. There was an impact mark on the aft side of an upper channel at fuselage bulkhead No. 35 which matched the shape of the fracture surface on the aft portion of the left control rod. (See figures 6A and 6B.)

Figure 6A.—Left and right elevator control rods showing symmetrical fractures 11 inches aft of aft bellcranks. Note missing sections of left elevator control rod.
