NATIONAL TRANSPORTATION SAFETY BOARD

AIRCRAFT ACCIDENT REPORT

BAR HARBOR AIRLINES FLIGHT 1808
BEECH BE-99, N300WP
AUBURN-LEWISTON MUNICIPAL AIRPORT
AUBURN, MAINE
AUGUST 25, 1985

NTSB/AAR-86/06

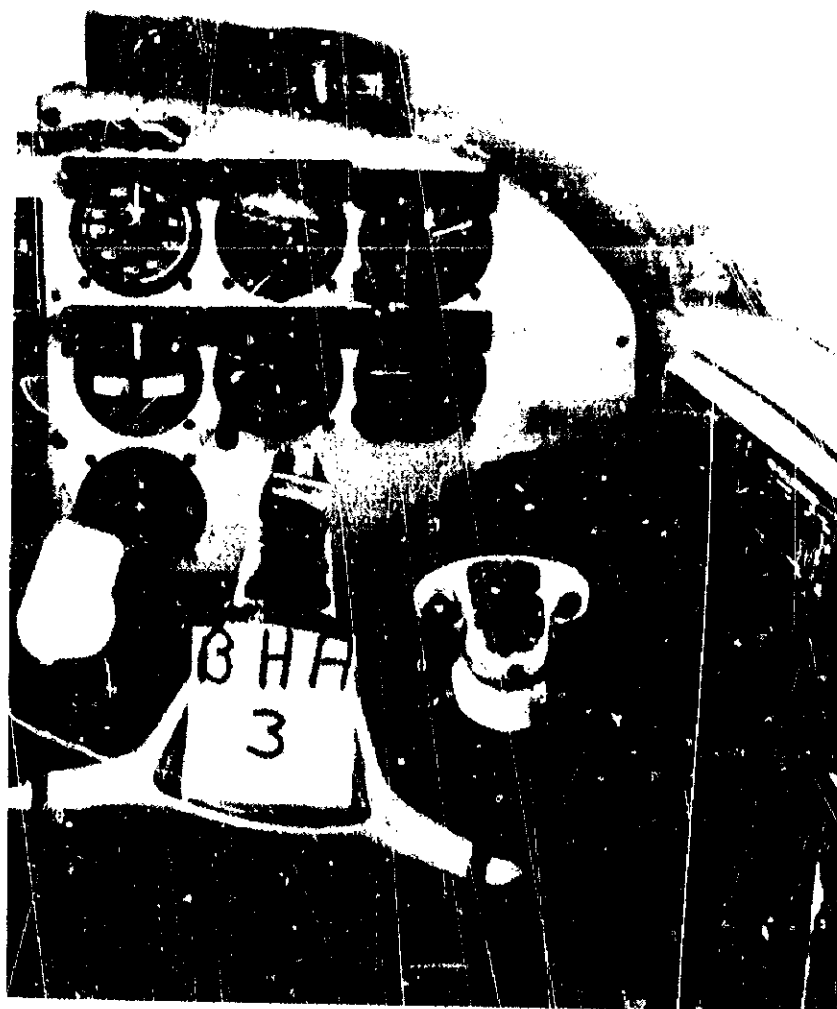
Figure 5.—First officer's instrument panel.

A King KI-214, VOR/LOC Converter Indicator with glideslope, installed in the lower left-hand corner of the first officer's instrument panel, sustained damage to both the front and rear sides of the unit. (See figure 5.) The heading selector was set at 040. Although the VOR/LOC needle was stopped at 1 1/2 dots left of center and the glideslope (GS) needle was stopped at 1 1/2 dots below center, the manufacturer believed that both needles may have been displaced from their original positions and captured by broken glass and a distorted bezel. No meaningful information could be obtained from a similar unit installed in the lower left-hand corner of the captain's instrument panel. The "repeater" indicator installed to the right side of the captain's ILS indicator, and remoted to the No. 2 NAV, was not located. (See figure 6.)

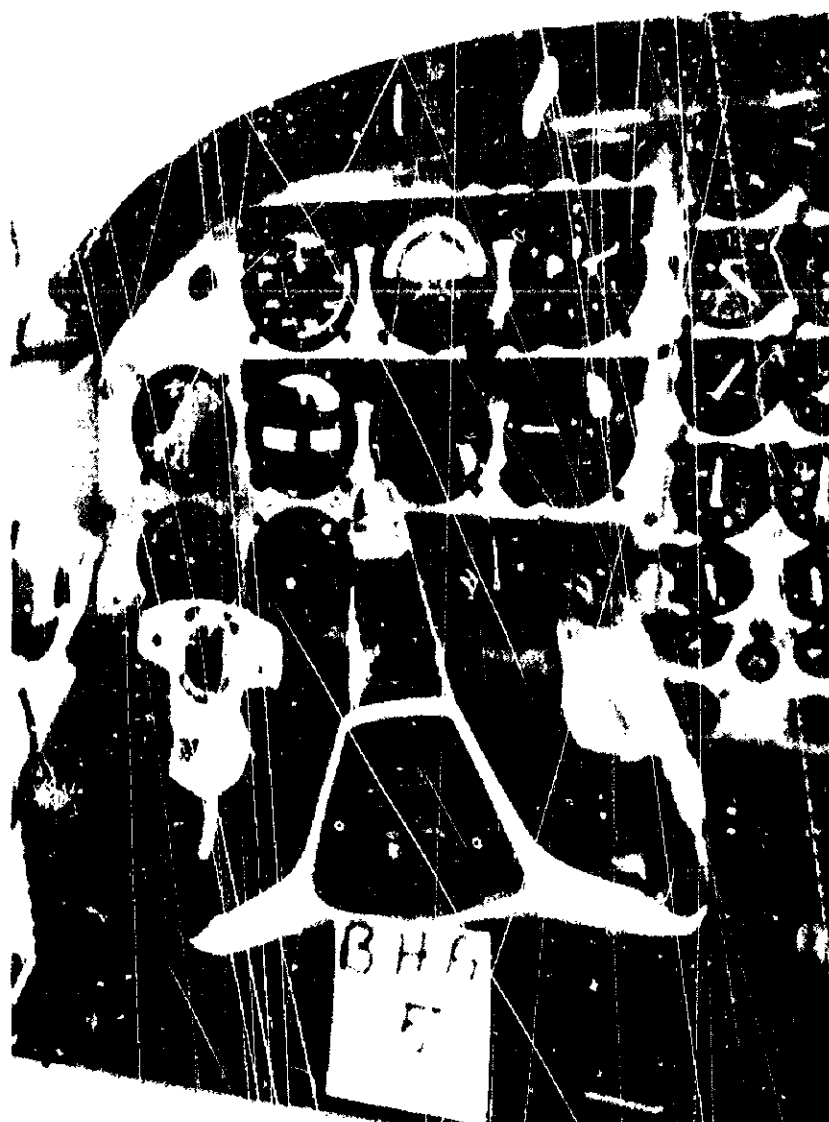
Figure 8.--Captain's instrument panel.

Flight Instruments--Examination of some of the captain's flight instruments showed no evidence of a failure or malfunction of the electrically driven attitude gyro. His airspeed indicator indicated a speed of 115 knots. The Kollsman Alti-Coder II altimeter showed a barometric setting of 30.42 inHg. The barometric setting knob could not be moved by hand. All three components were damaged by impact and fire.

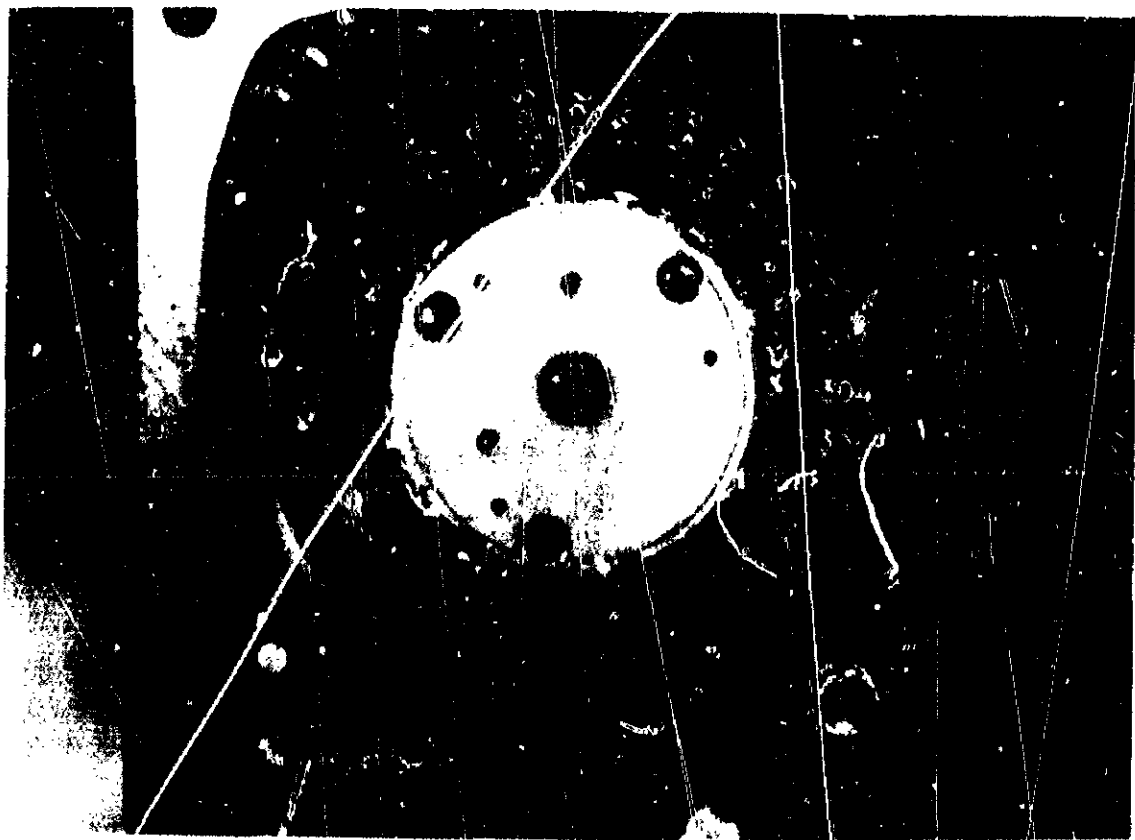
Figure 7.—Top view: Captain's Kollsman Alti-Coder II altimeter.
Bottom view: Position of the barometric dial showing the front end gear train and adjustment knob shaft at lower left-hand corner.

Extensive fire damage to the captain's altimeter. There was no evidence of barometric setting, gear system derangement and the gear train was in good condition despite the fire damage and moisture contamination found upon disassembly. There was no damage to the front end pressure gear train pivots and gears. The barometric setting adjustment knob shaft (steel) was bent and the case was melted against the shaft input gear which prevented the shaft from rotating. (See figure 7.) There were no broken pivots or jewels within the altimeter pressure mechanism. The primary damage to the altimeter was due to heat and moisture. There was no apparent indication of altimeter malfunction prior to impact and fire damage.

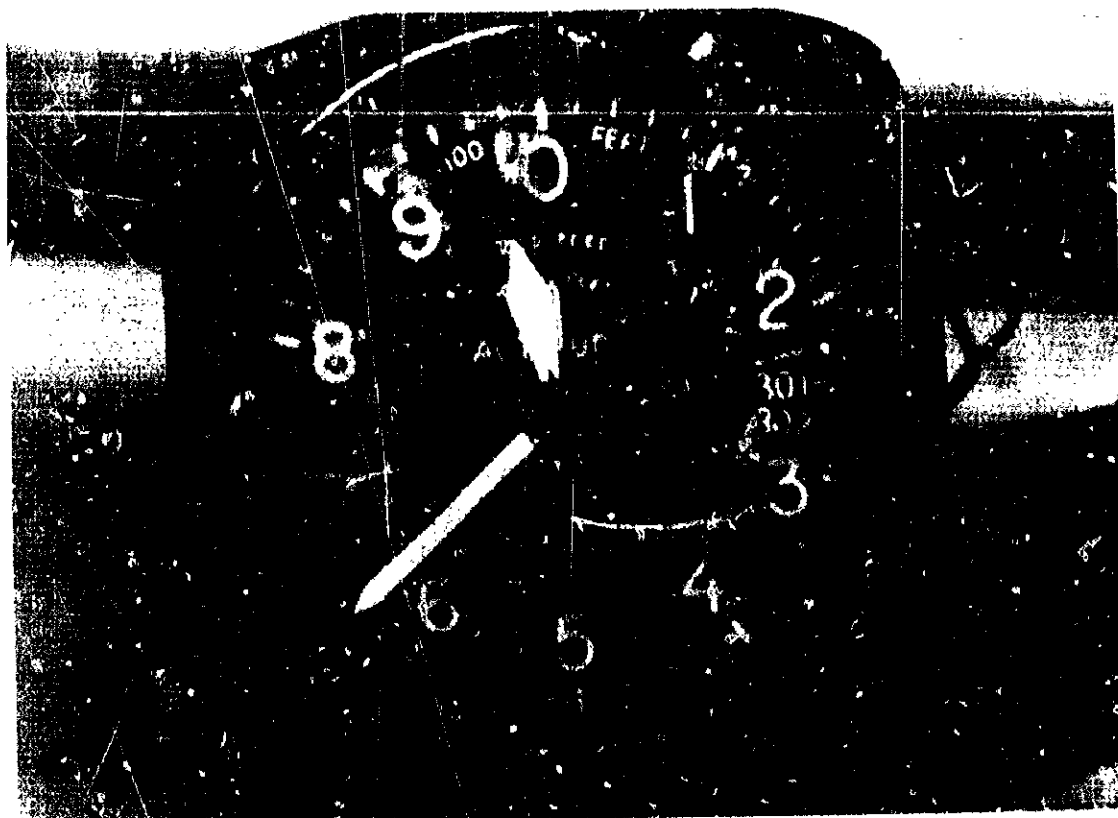
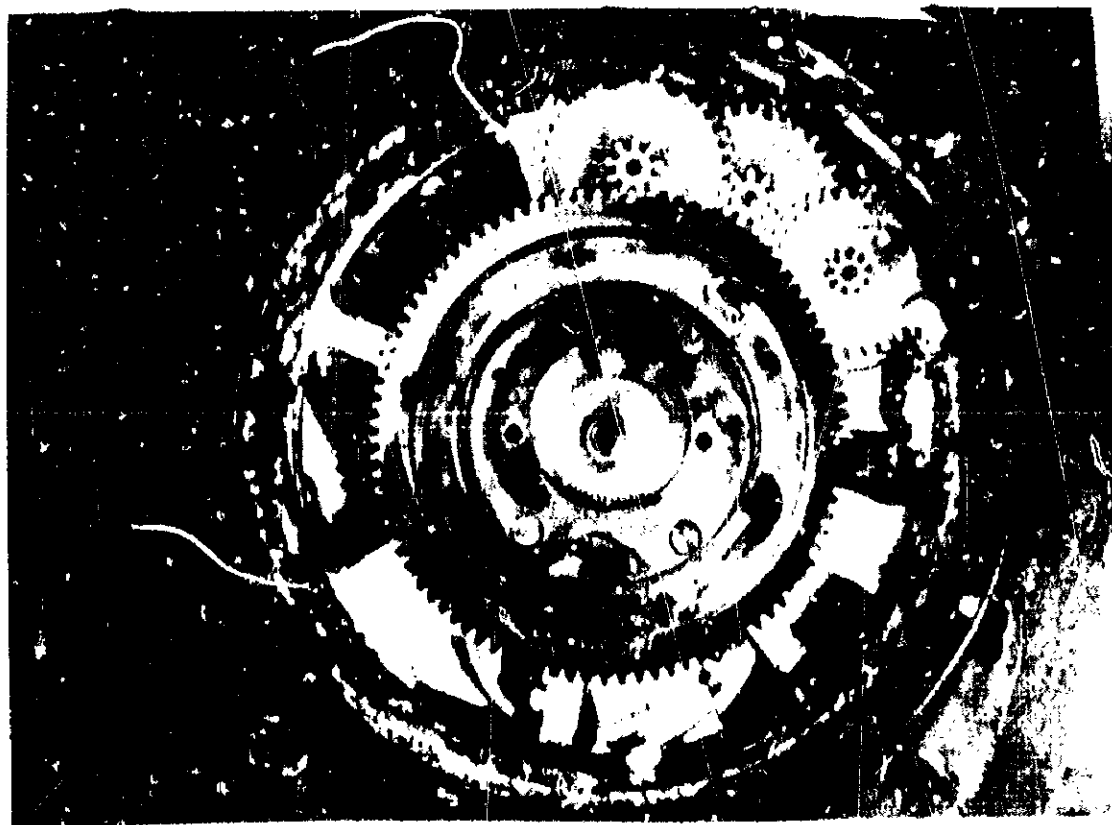
Figure 8.—First officer's altimeter.

The first officer's altimeter showed little external fire damage, but extensive moisture and foam (white powdery substance) damage. The barometric adjustment knob was broken off at the flange and missing. (See figure 8.) Rotation of the case showed that the 1000-foot per turn needle was free to rotate, indicating that the shaft was broken. Disassembly revealed that the shaft was broken, but there was no apparent indication of derangement of the barometric setting gears as a result of the accident. There were several broken parts in the pressure mechanism and the intermediate gear shaft pivots as a result of impact forces.
