NATIONAL TRANSPORTATION SAFETY BOARD

AIRCRAFT ACCIDENT REPORT

MIDAIR COLLISION OF SKYWEST AIRLINES
SWEARINGEN METRO II, N163SW,
AND MOONEY M20, N6485U,
KEARNS, UTAH
JANUARY 15, 1987

NTSB/AAR-88/03

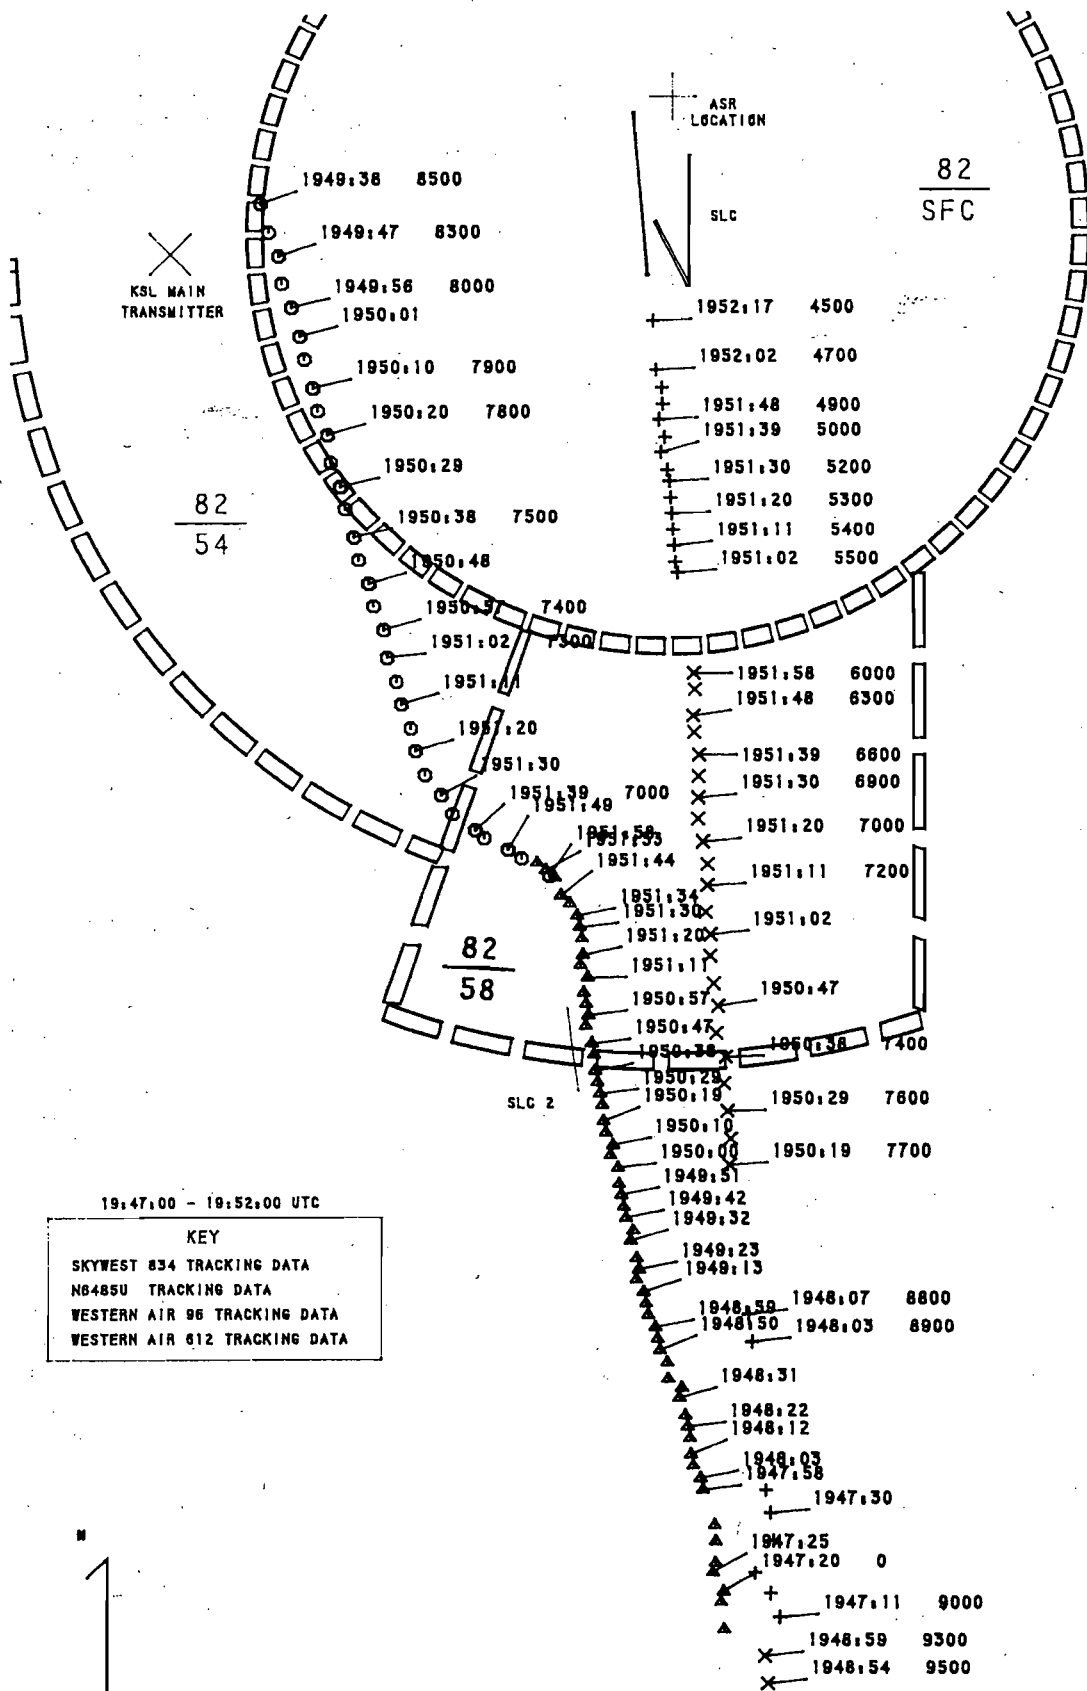
Figure 2--Plotted radar data.

The retrack program was run from 1240 until 1255. Beginning at the start of the run, a triangle target, which depicted a VFR non-mode-C aircraft, was observed approximately 25 miles south southeast of SLC. This was the only nontagged VFR target that was displayed during the retrack program and the only target that merged with the target of SkyWest 1834. The VFR target

maneuvered in this general area and subsequently made a turn to the northwest. The target continued to track to the northwest until, at 1250:47, it flew nearly directly over SLC 2. The target moved parallel to runway 34 at SLC 2, and at 1251:30, about 1 mile north of the airport, a gradual left turn was noted until the target merged with the target of SkyWest 1834 at 1251:58.

According to the aircraft performance calculations based on the radar data, the image of the Mooney did not subtend a 0.2° arc to the pilots of the METRO II until about 14 seconds before impact. The METRO II subtended the 0.2° arc to the Mooney pilots about 27 seconds before impact.
