NATIONAL TRANSPORTATION SAFETY BOARD

AIRCRAFT ACCIDENT REPORT

**EXECUTIVE AIR CHARTER, INC.,
dba AMERICAN EAGLE, FLIGHT 5452
CASA C-212, N432CA
MAYAGUEZ, PUERTO RICO
MAY 8, 1987**

NTSB/AAR-88/07

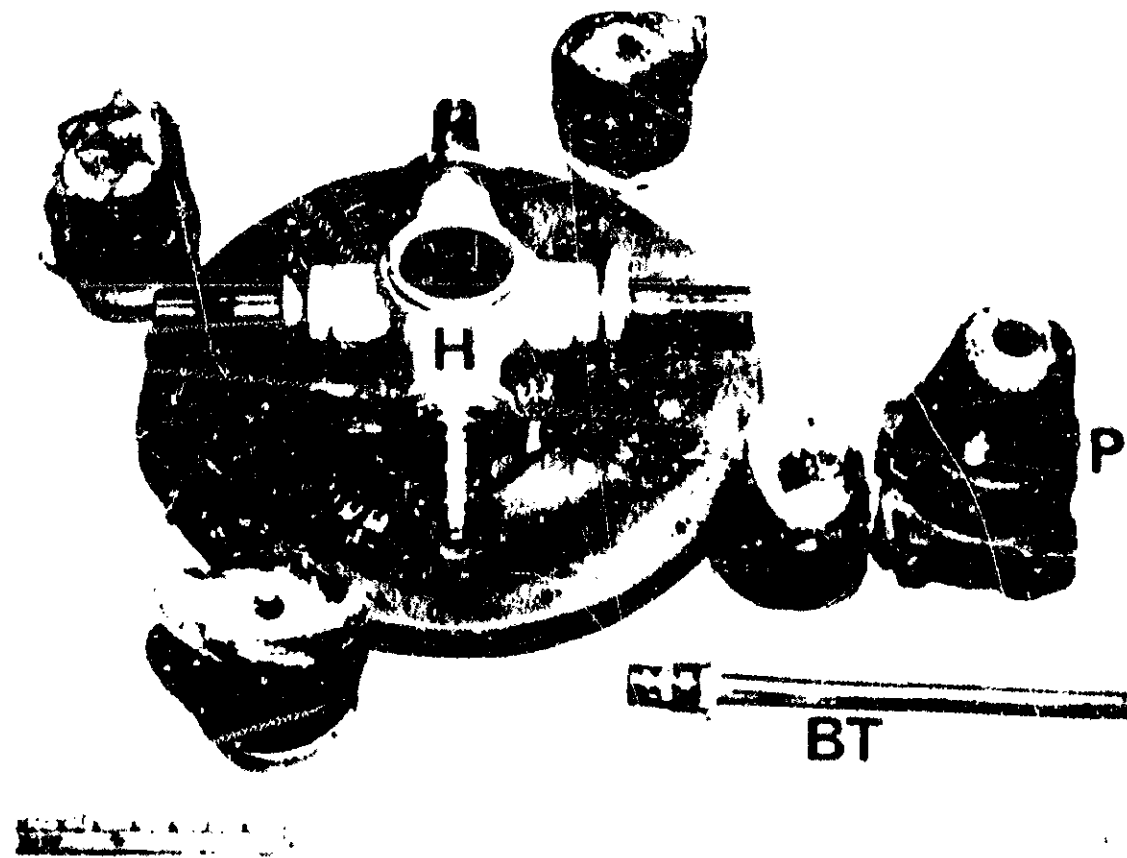
The right propeller sustained severe impact damage. The beta tube was bent, the dome assembly (piston, cylinder, and spring assembly) was canted about 13°, and the cylinder was stripped from the hub. The nose of the piston was crushed and gouged in a diagonal pattern; the deepest gouge was located between two of the blades. There was a 390°-spiral gouge on the inside of the

Figure 4.--Overall view of the right propeller components submitted for examination. "H" indicates hub which is surrounded by the four propeller butt ends. "BT" locates portion of beta tube and "P" denotes the piston.

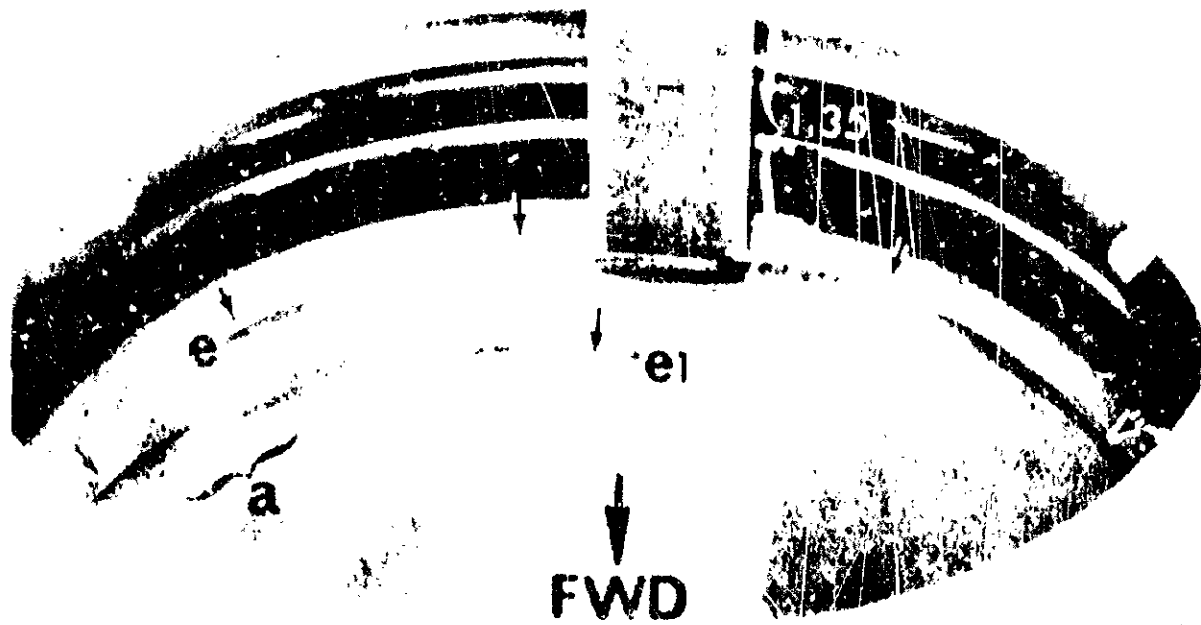
Metallurgical examination indicated that the spiral gouge mark on the inside of the piston of the right propeller was probably made when the propeller struck the ground, forcing the piston to contact the forward corner of the cylinder under impact forces.

Mechanical deformation of the gouge indicated that the piston had moved aft relative to the cylinder and had rotated slightly from the normal fixed position of the cylinder. (See figure 5.) There was no buildup of piston material at the forward edge of the gouge, but the aft edge contained numerous areas of buildup and a ridge as shown by the lower two arrows in figure 6. This buildup indicated that the piston had rotated and moved aft relative to cylinder and toward the feather position. Examination of a section cut through this gouge confirmed the aft movement, which produced extreme grain deformation transverse to the gouge as shown in figure 7. The position of the forward edge of the cylinder at the time it made the initial gouge in the wall of the piston corresponded to a 0°-blade angle.

Figure 5 -- Oblique view looking into the inner cavity of the piston showing the spiral indent mark on the hole wall of the piston
