PB90-910402
NTSB/AAR-90/02

AIRCRAFT ACCIDENT REPORT

**EVERGREEN INTERNATIONAL AIRLINES
McDONNELL DOUGLAS DC-9-33F, N931F
SAGINAW, TEXAS
MARCH 18, 1989**

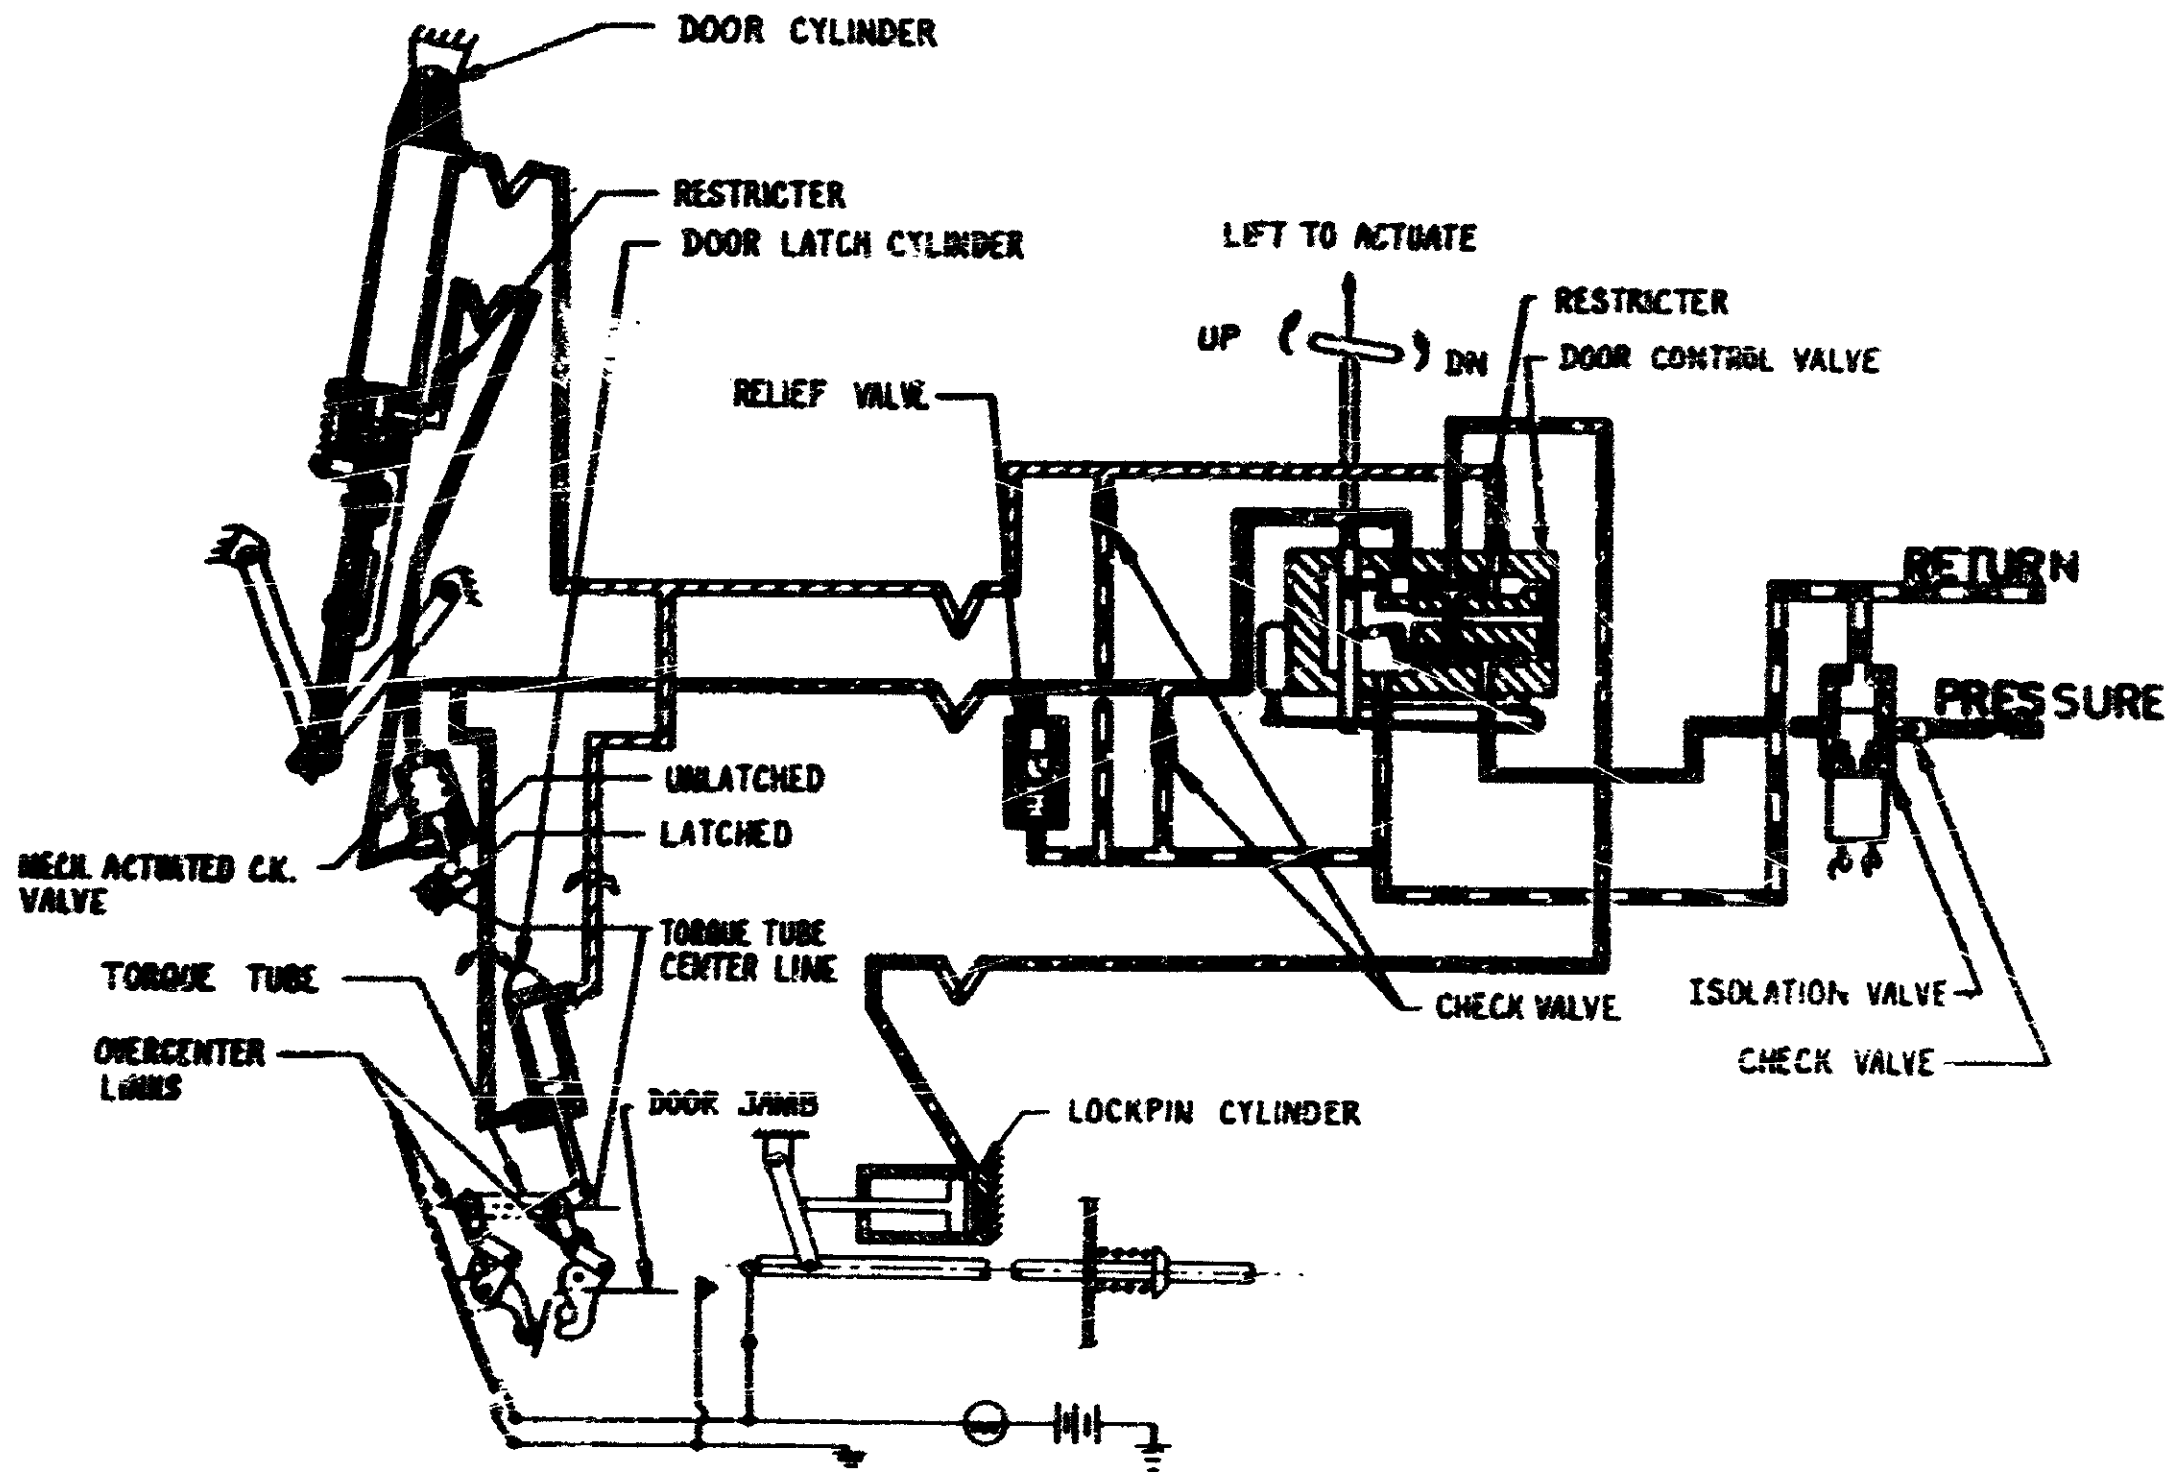
Figure 1.--Hydraulic routing within the cargo door hydraulic system.

1. The cargo door control valve - This valve was found in the "valve neutral" position (as opposed to the "door open" or the "door closed" position) within the wreckage. Damage to the valve did not allow testing in the "door open" or "door closed" positions. The valve was disassembled at its manufacturer's facility and no anomalies were found. See Figure 1 for a cut-away diagram of this valve in its three operating positions.

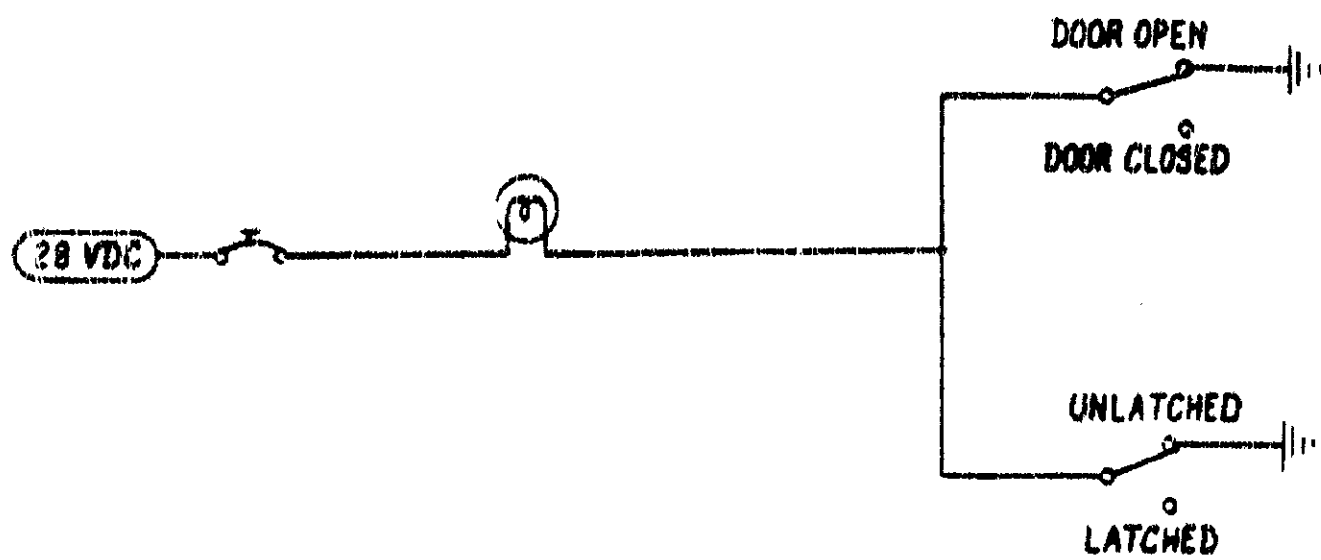
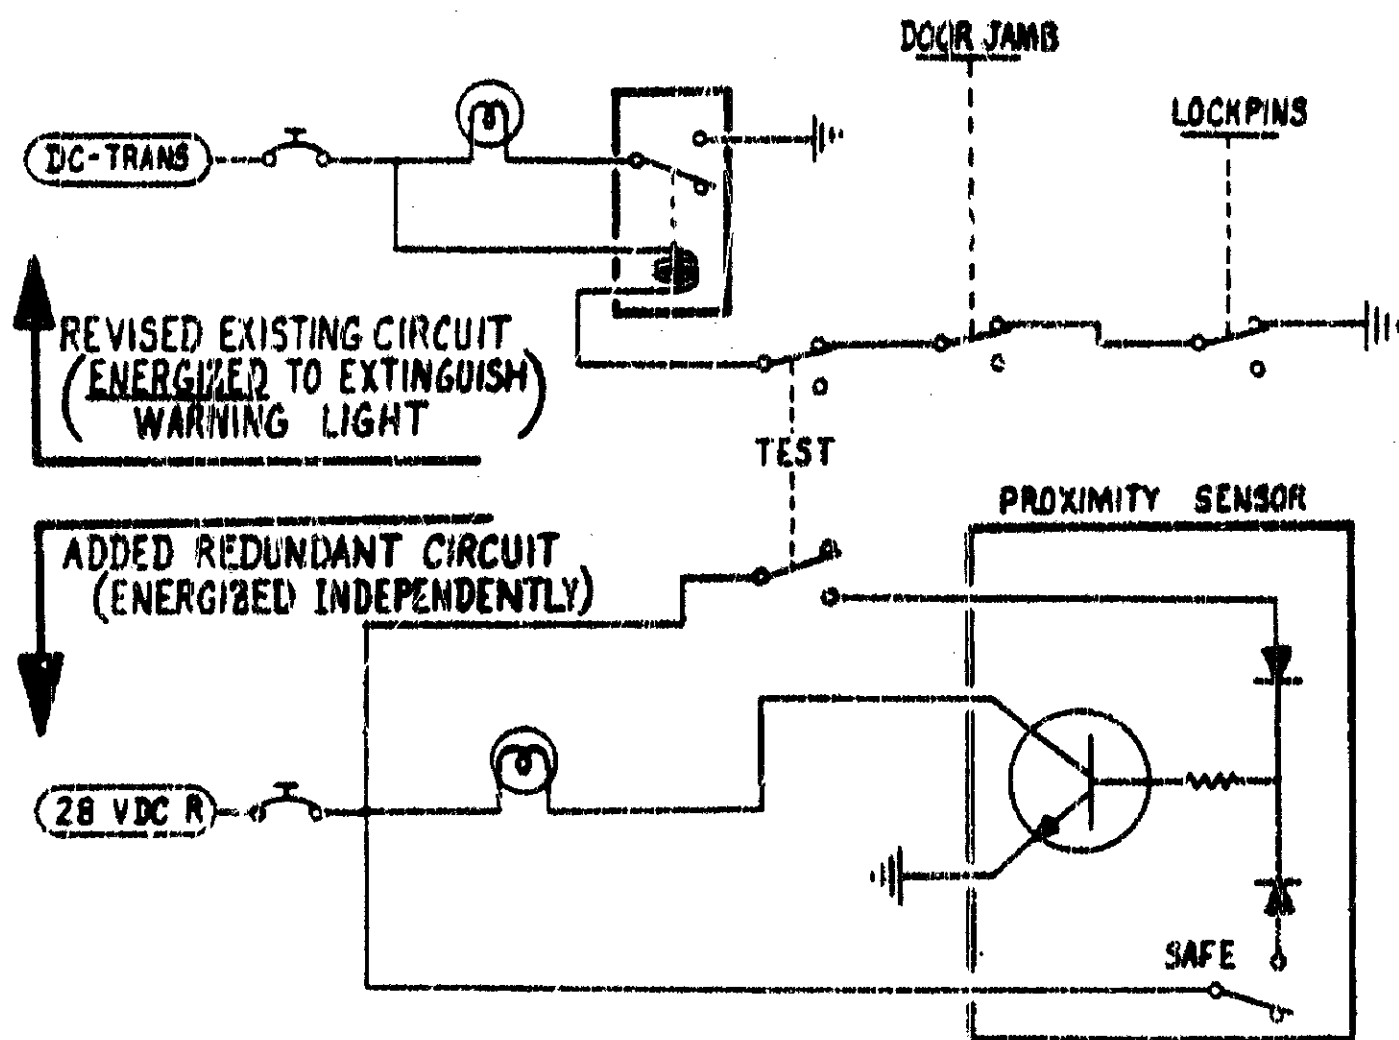
Figure 3.--Cargo door warning switch electrical diagrams.

The SB modification eliminates an undesirable failure mode of the original cargo door cockpit warning light system wherein a failure of either the door jamb switch or the lockpin switch to close will remain undetected and the cockpit warning light will appear to function

normally; that is, the light would illuminate when the other functional switch closes and extinguish when it opens. Thus, if the lockpin switch is the one failed, the door will appear safe when closed even though it is not fully latched and locked. The modification to the existing circuit consists of adding a relay which must be energized with 28 volts dc to extinguish the cockpit warning light. The door jamb and lockpin switches are rewired in a series circuit so that electrical continuity through both switches will energize the relay. With the logic of the switches inverted and placed in series instead of parallel, a failure of either switch to close will result in an illuminated warning light.

- g. SB 52-92 - Issued on April 7, 1976, with revision 2 on November 21, 1985 - This SB recommended a modification of the original cargo door cockpit warning light system electrical circuit and the addition of a redundant independently energized warning light and circuit.
