PB91-910404
NTSB/AAR-91/04

AIRCRAFT ACCIDENT REPORT

AVIANCA, THE AIRLINE OF COLUMBIA
BOEING 707-321B, HK 2016
FUEL EXHAUSTION
COVE NECK, NEW YORK
JANUARY 25, 1990

**ADOPTED: APRIL 30, 1991
NOTATION: 5255B**

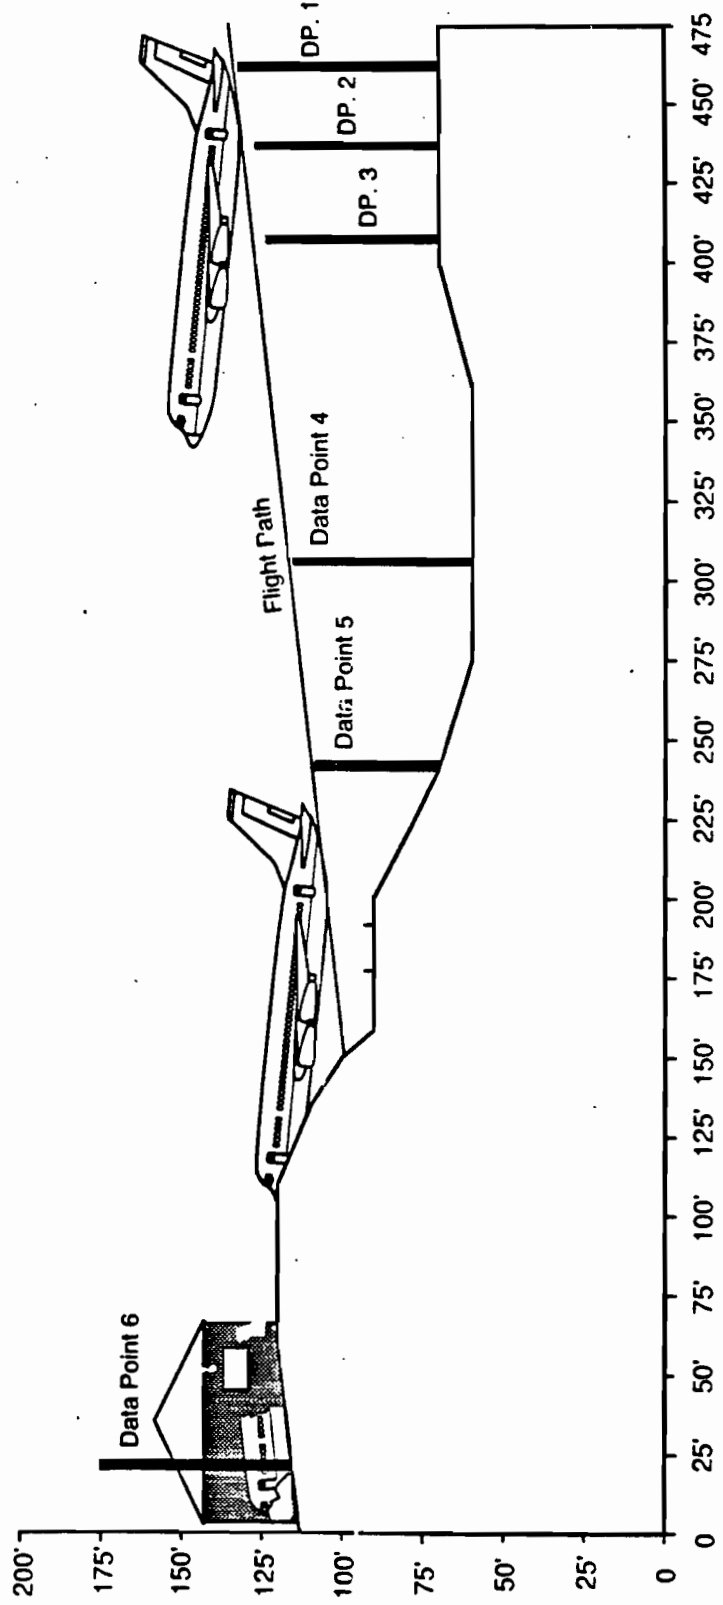
Figure 5.--Terrain impact, AVA052.

Several trees were sheared off just prior to and at the time that the airplane impacted with the ground. The starboard side of the forward fuselage fractured the wooden deck of a residence. Property damage is estimated at approximately \$250,000.
