PB91-910410
NTSB/AAR-91/09

AIRCRAFT ACCIDENT REPORT

**RYAN INTERNATIONAL AIRLINES
DC-9-15, N565PC
LOSS OF CONTROL ON TAKEOFF
CLEVELAND-HOPKINS INTERNATIONAL AIRPORT
CLEVELAND, OHIO
FEBRUARY 17, 1991**

**Adopted: November 16, 1991
Notation 5499A**

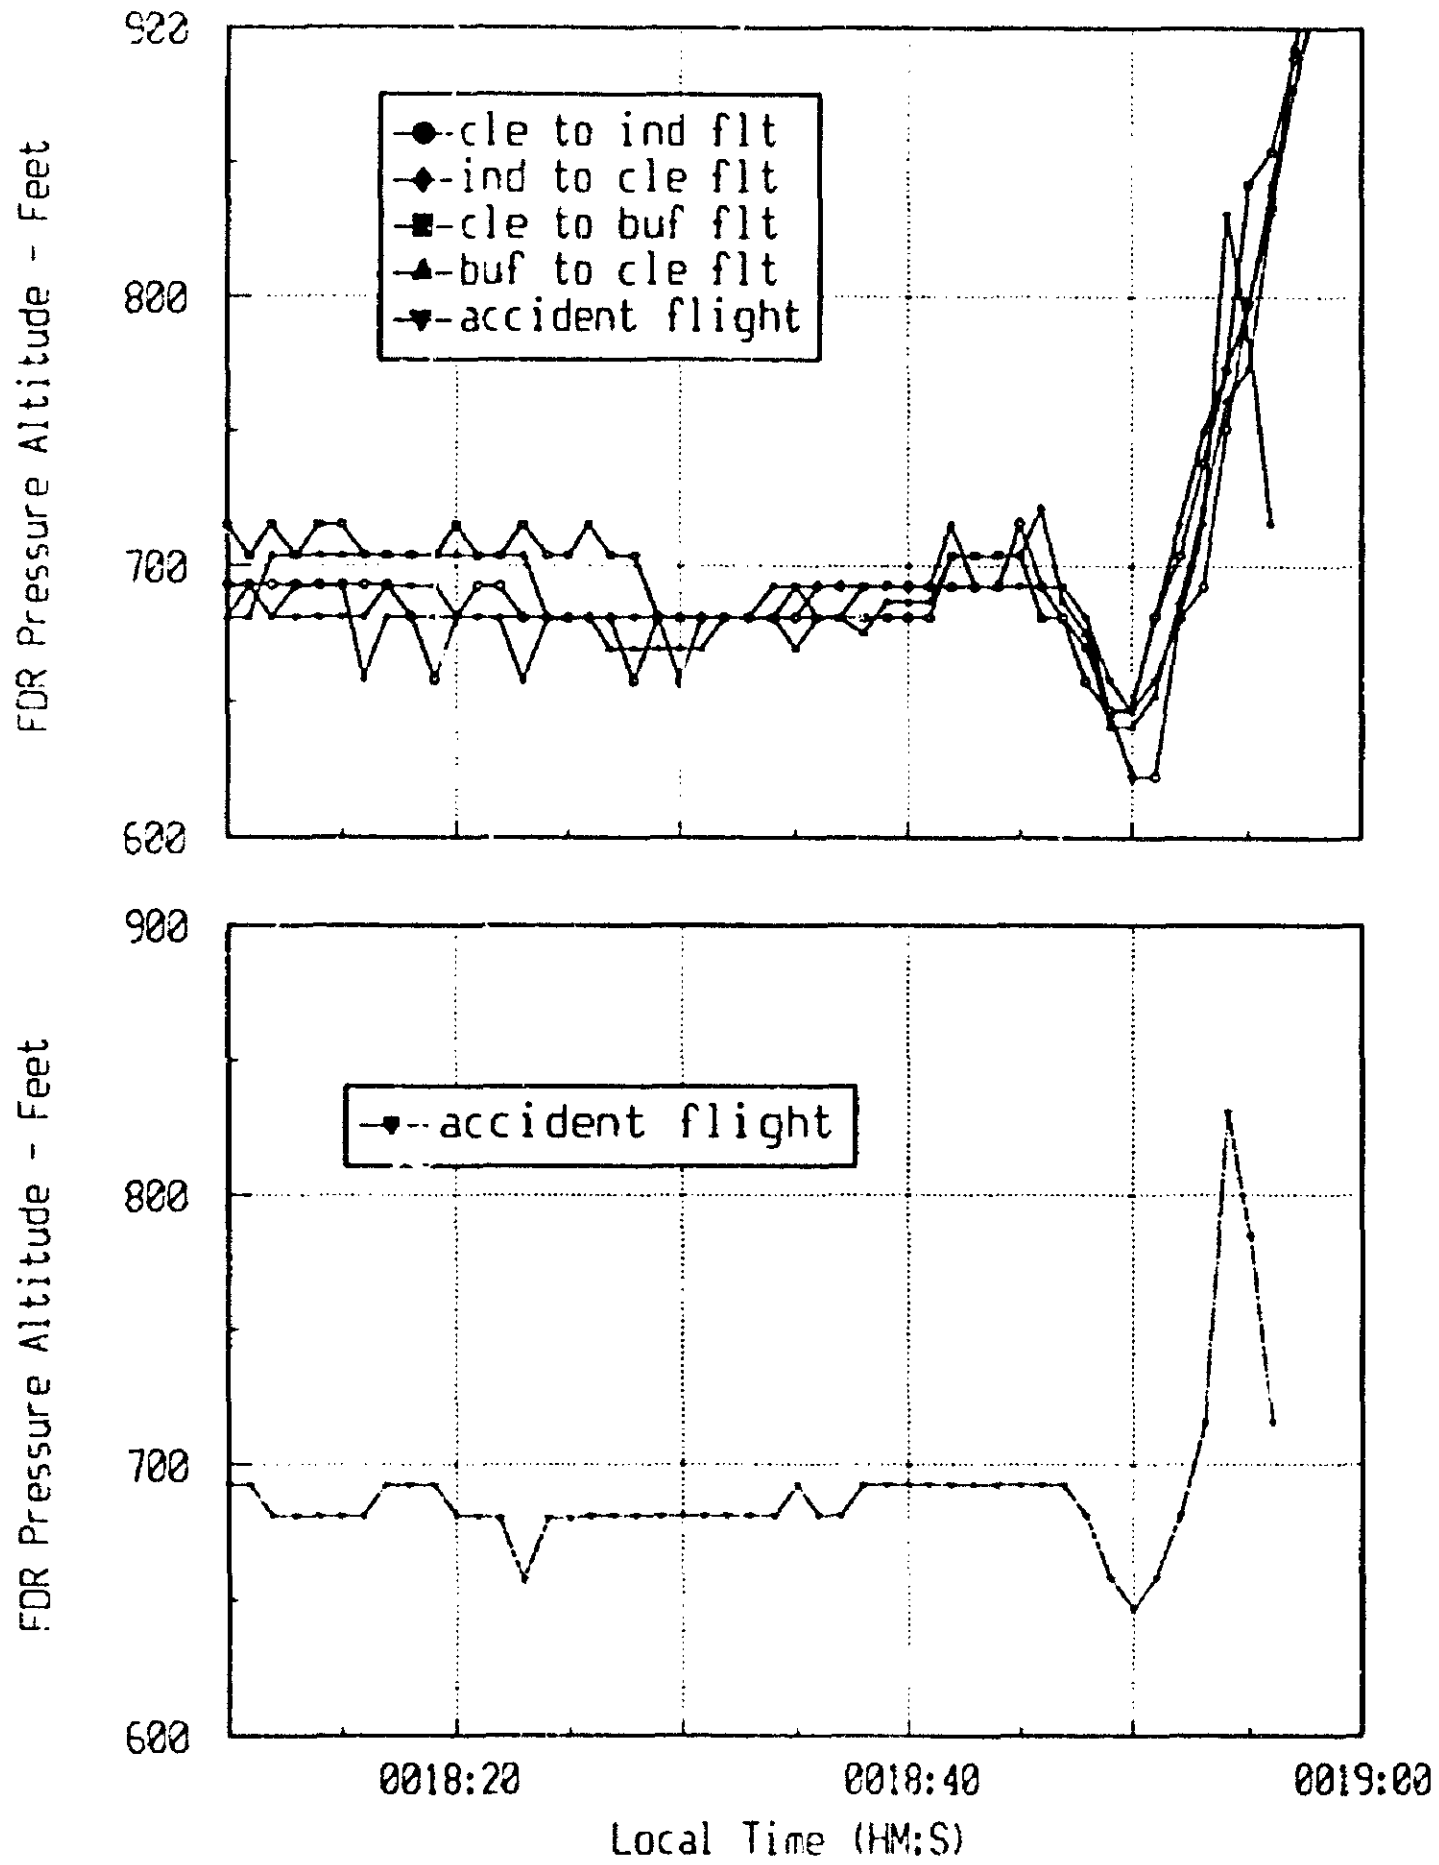
Figure 3.--Altitude versus time.

The resulting correlation of airspeed, pressure altitude, normal acceleration, and airplane heading as a function of the common time reference is shown in figures 2 through 5 respectively. It is noted in figure 4 that the scatter of the normal acceleration values recorded on the FDR made the data difficult to interpret and of limited reliability. Consequently, a moving average technique was used to smooth this data. The resulting normal acceleration plot was considered as the best one obtainable for evaluation of the airplane's flight performance.

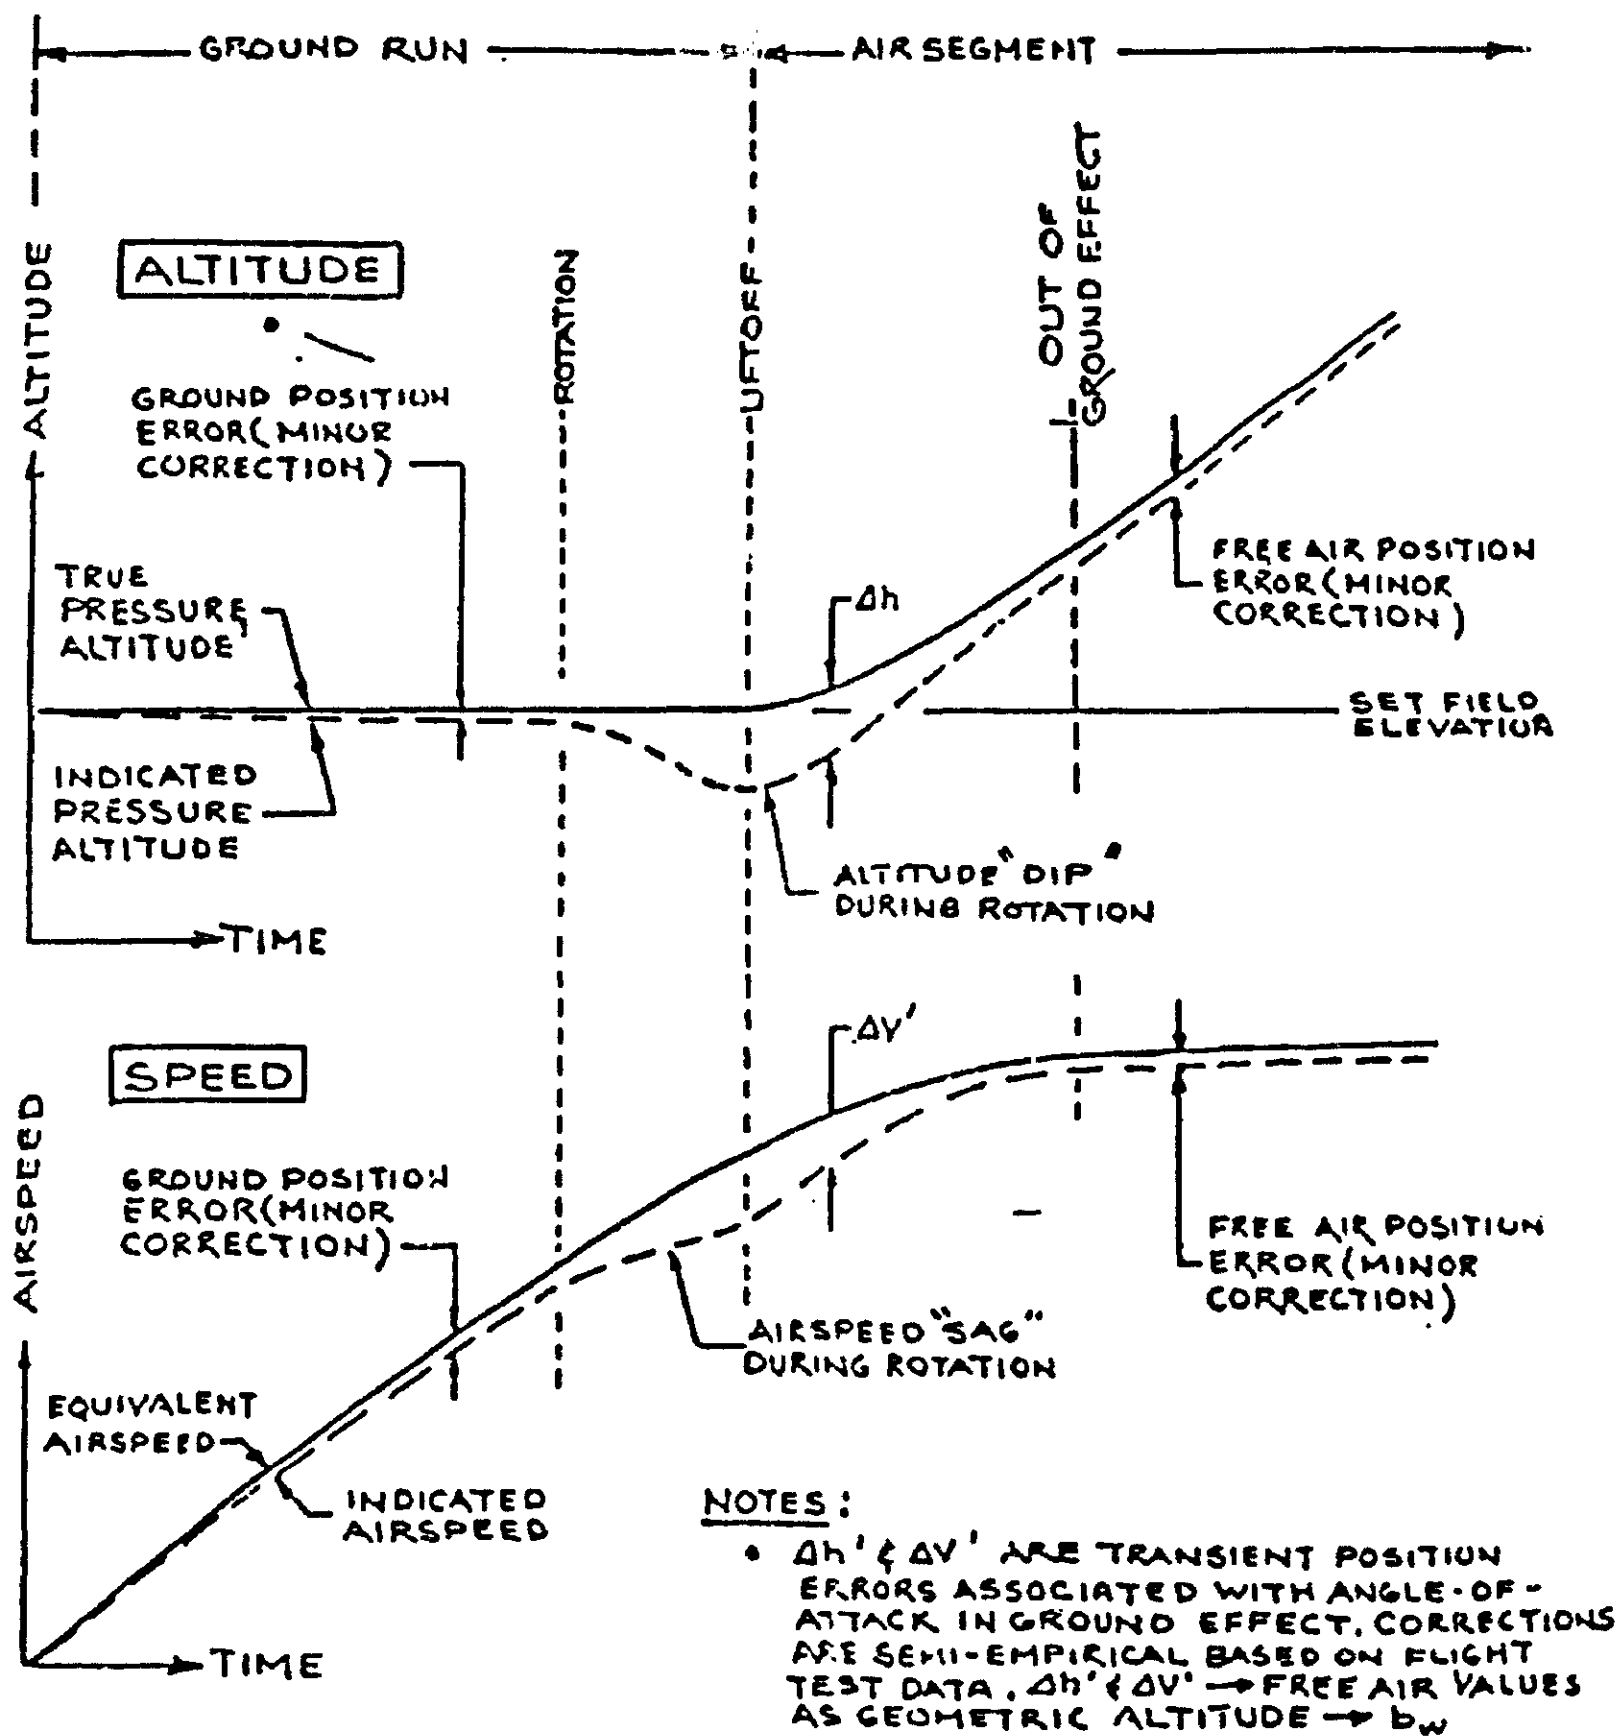
Figure 7.--Air data parameters during takeoff.

Figure 7 shows the typical altitude and airspeed variations from the start of the takeoff roll until the airplane leaves ground effect. Rotation of an airplane during takeoff changes the airflow patterns across the static ports, resulting in a static pressure measurement that is higher than the actual static pressure. The difference between the measured and the actual pressure is called the static position error and is apparent by corresponding errors in the recorded altitude and airspeed. On Figure 7, "delta H" and "delta V" represent the transient position errors associated with angle-of-attack (AOA) in ground effect. The measured values of altitude and airspeed as recorded on an FDR decrease below actual values during this time, with liftoff occurring near the bottom of the altitude dip. According to the manufacturer, the normal indicated altitude dip that occurs during the takeoff rotation of a DC 9-10 airplane is about 50 feet (below field elevation).

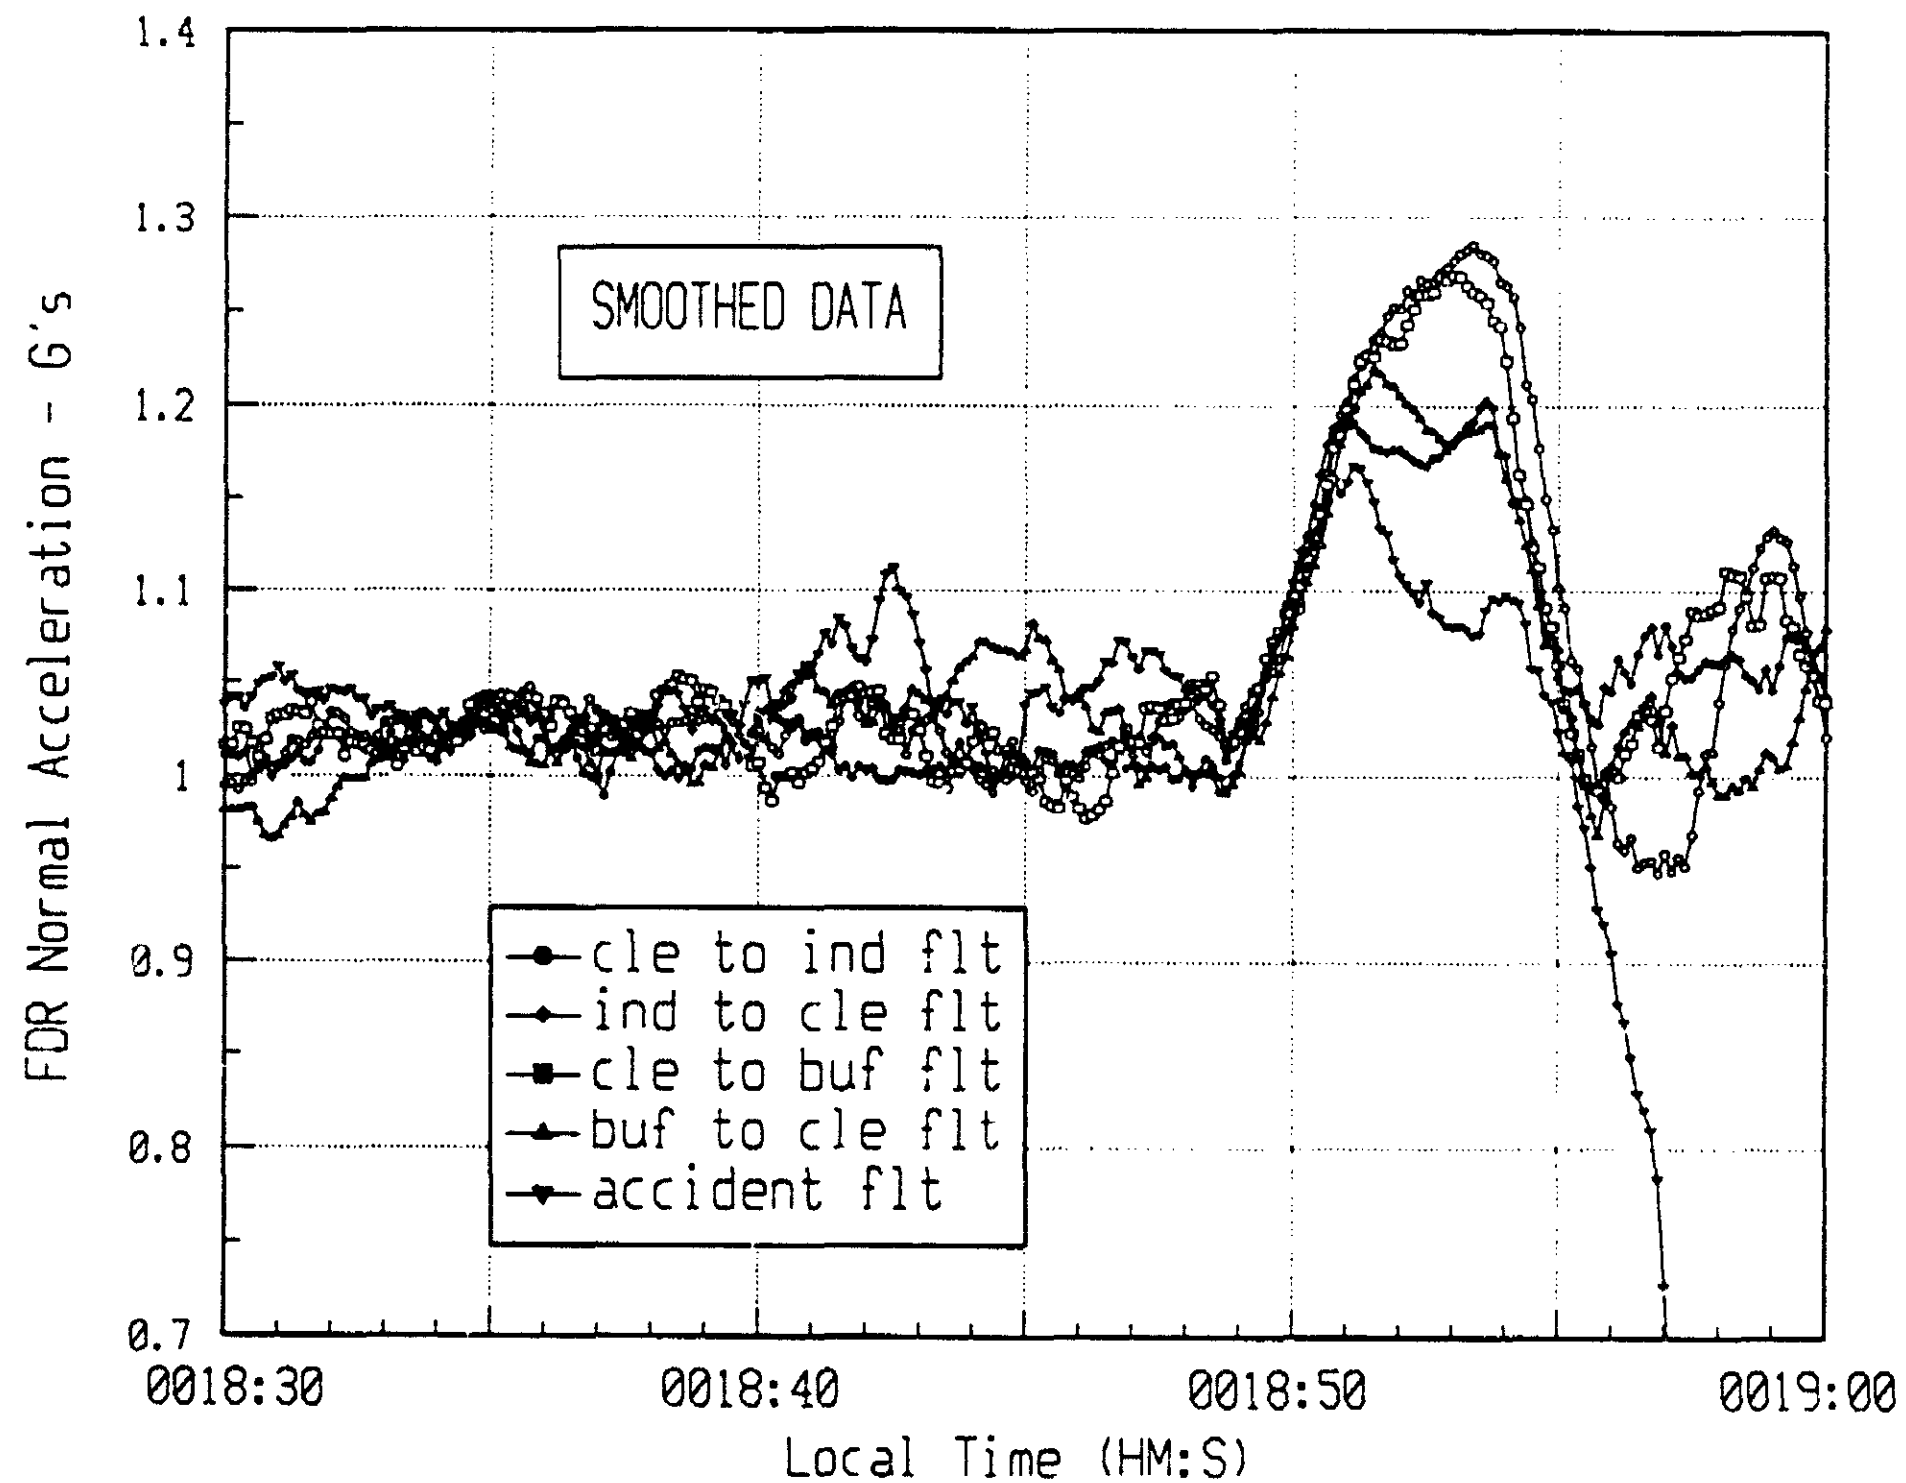
Figure 8.--Normal acceleration data for previous takeoffs.

As the airplane transitioned to climbing flight on previous takeoffs, there was a buildup in normal acceleration, followed by a return to near 1 g values. A comparison of the accident takeoff to the previous four takeoffs is plotted in figure 8. Smoothed acceleration curves for the previous takeoffs were offset so that the beginning of each buildup coincides with that of the accident flight. All five takeoffs display an increase in normal acceleration early in the transition phase, except that the buildup in g values during the accident takeoff abruptly ended after reaching about 1.17 g, and then decreased prematurely. On the previous flights, the positive normal accelerations were sustained for 3 to 5 seconds reaching peak values between 1.2 g and 1.3 g.

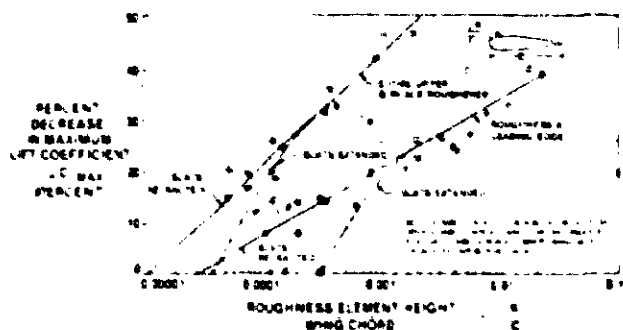
Figure 6. Correlation of the Effect of Wing Surface Roughness on Maximum Lift Coefficient

Figure 6 shows an empirical correlation of lift loss due to wing surface roughness, including ice contamination. It is interesting to note that this simple correlation encompasses data representing a Reynolds Number range from 6×10^7 up to 29×10^7 and airfoil shapes ranging from simple symmetrical sections to those representative of second generation turbojet aircraft (see Table 3).

The lower line in Figure 6 shows the lift loss due to a localized strip or narrow band of contamination on the leading edge. Much of the data for the lesser amounts of contamination have been obtained from maintenance or flight training experience where some form of contamination such as insect debris, chipped paint, or buried rivets caused premature stall when the slats were retracted, but caused little or no noticeable effect when the slats were extended. Wind tunnel data indicate that as the contamination on the leading edge becomes larger, such as for in-flight ice

Although Figure 6 shows a significant difference in lift loss between a narrow band of roughness at the leading edge and roughness over the entire upper surface, it is worthy to note that recent unpublished data for slight roughness extending aftward from the leading edge to about 7 percent chord on both the upper and lower surfaces (as might occur during a mild icing encounter) can cause lift losses similar to those caused by a fully roughened upper surface.

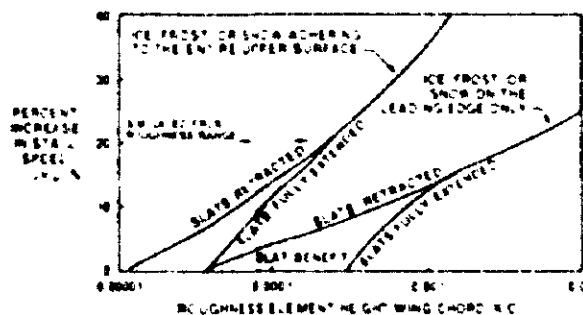
Figure 7. Approximate Effect of Wing Ice Contamination on Airplane Stall Speed

Figure 7 expands the data from Figure 6 into an operationally meaningful percent increase in stall speed. From this figure, the importance of maintaining the "clean wing" philosophy begins to show, because it becomes readily apparent that it takes only a relatively small amount of roughness on the wing upper surface to cause large increases in stall speeds even with slats extended. Further expanding the data to compare the measure of roughness (K/C) with various grades of abrasive paper, an estimate can be made (Figure 8) of the stall speed increase that would occur on an aircraft about the size of a DC-9, 737, or BAC-111 if the wing upper surface was contaminated by ice having the roughness of various grades of abrasive paper. Those familiar with the icing roughness that can occur during a freezing drizzle or when snow has partially melted and then refrozen to a surface will probably agree that this range of roughness is not at all unusual under such conditions. With the stall speed increases shown in Figure 8, stall warning margins and margins to stall decrease markedly or disappear altogether.

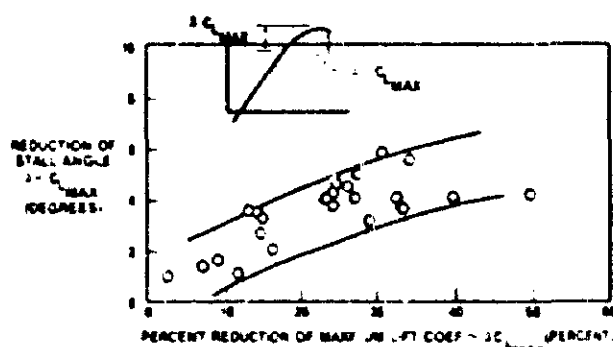
Figure 9. Reduction of the Angle of Attack at Stall Due to Wing Surface Roughness

As noted earlier, the increases in stall speed also occur at much lower than normal angles of attack (Figure 9). This can have at least two adverse effects. First, many contemporary stall warning systems are actuated at prescheduled angles of attack. If wing ice contamination causes a stall before this prescheduled angle is reached, the flight crew will receive no warning of impending stall. Second, the reduced stall angle of attack compounds the problem of the tendency of an ice-contaminated airplane to pitch up during rotation, increasing the risk of overshooting the stall angle shortly after liftoff.

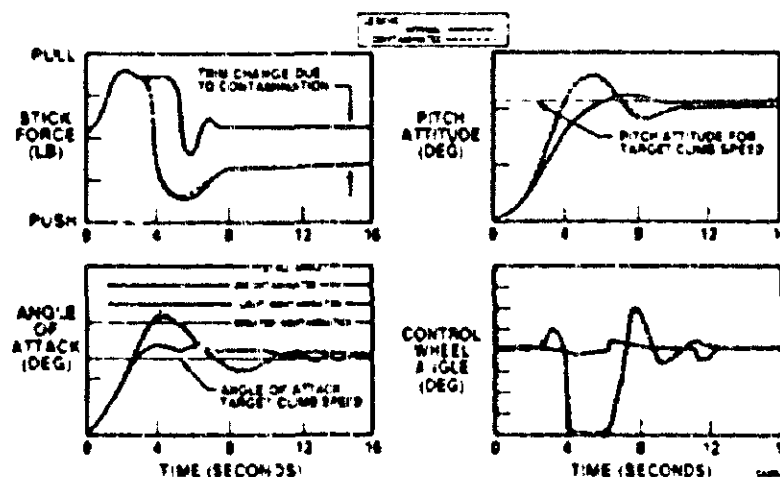
Figure 10. Effect of Wing Ice Contamination on Longitudinal Control Characteristics

The overall effects of wing ice contamination on various flight characteristics of an aircraft during takeoff are summarized in Figure 10. In this figure, stick force is the amount of push or pull on the control column required to manage the pitch attitude of the aircraft. Pitch attitude is the angle of the airplane with respect to a horizontal reference plane, angle of attack is the angle of the airplane with respect to its flight path, and wheel angle is the rotation of the control wheel required to manage the bank, or roll attitude, of the airplane.
