**PB92-910405
NTSB/AAR-92/04**

AIRCRAFT ACCIDENT REPORT

**BRITT AIRWAYS, INC., d/b/a
CONTINENTAL EXPRESS FLIGHT 2574
IN-FLIGHT STRUCTURAL BREAKUP
EMB-120RT, N33701
EAGLE LAKE, TEXAS
SEPTEMBER 11, 1991**

**Adopted: July 21, 1992
Notation 5612B**

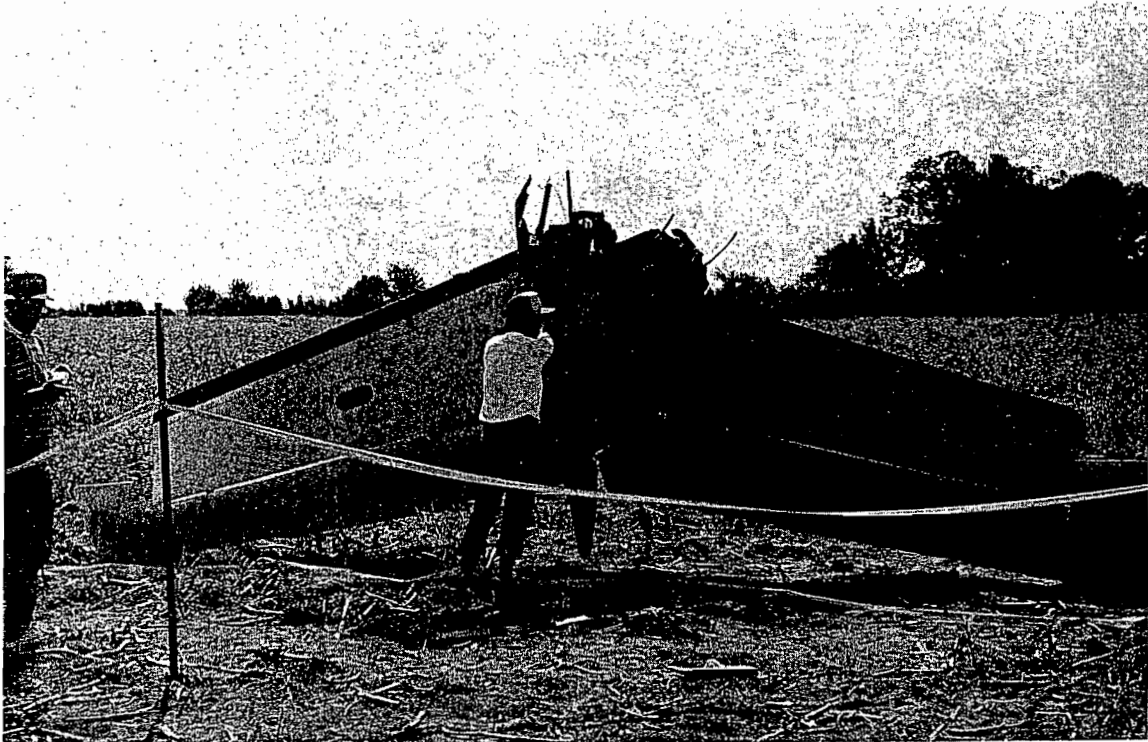
During the Safety Board's examination of the wreckage, none of the 47 screws that would have attached the upper surface of the leading edge assembly for the left side of the horizontal stabilizer was found. There was no evidence of distress in the upper attachment holes for the left side leading edge assembly or indication that the attaching screws were installed when the left side leading edge assembly separated from the horizontal stabilizer. In addition, a "lip" was formed on the forwardmost frame on the left lower side of the horizontal stabilizer spar cap. That frame (spar cap), with receptor holes for the lower attaching screws, was the area into which the screws mounted the underside of the left side leading edge assembly to the stabilizer. This lower frame area showed signs of distress. Figures 1a through 1d show the condition of the left horizontal stabilizer leading edge.

The lower attachment screws remained installed, but the leading edge assembly had separated from the stabilizer, with the exception of a small portion of composite structure remaining below the two farthest inboard screw heads. The spar cap on the lower left side of the horizontal stabilizer showed evidence of being pulled down so that it would project into the wind stream along with the leading edge. This pulling damage is consistent with the left side leading edge assembly having been ripped down and away from the lower attaching screws as it separated from the horizontal stabilizer. This evidence was consistent with screws missing on the top side of the left leading edge assembly, and the lower attaching screws holding fast, pulling down the frame (spar cap) on the lower side of the stabilizer, and thereby forming the lip.

Figure 1a.--View of horizontal stabilizer from underside.

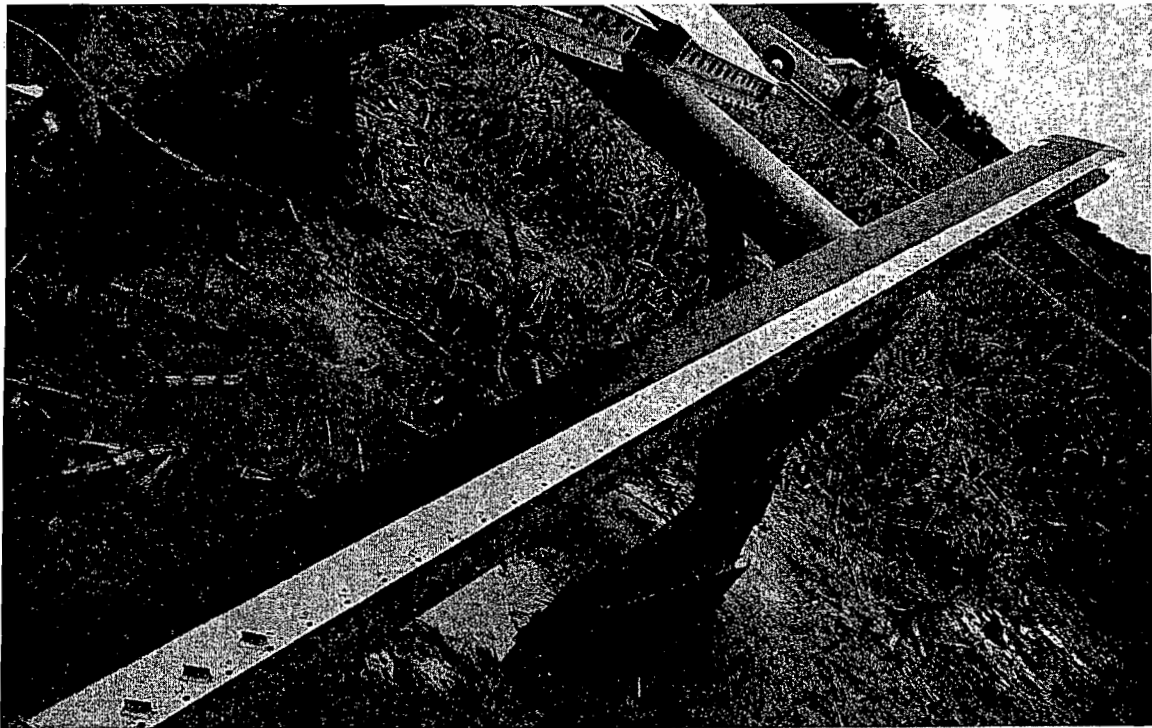
Figure 1b.--Leading edge assembly and outboard portion of left side of horizontal stabilizer.

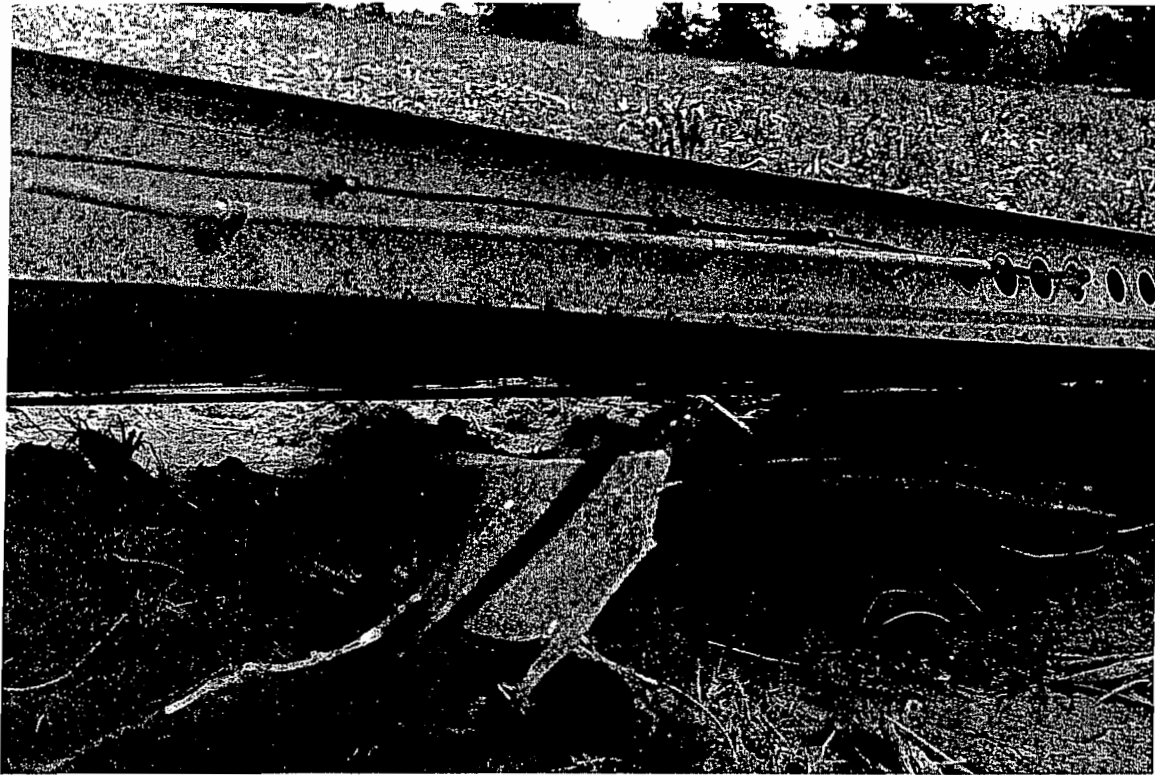
Figure 1c.--Front frame of left side of horizontal stabilizer with lower screw attaching area angled downward.

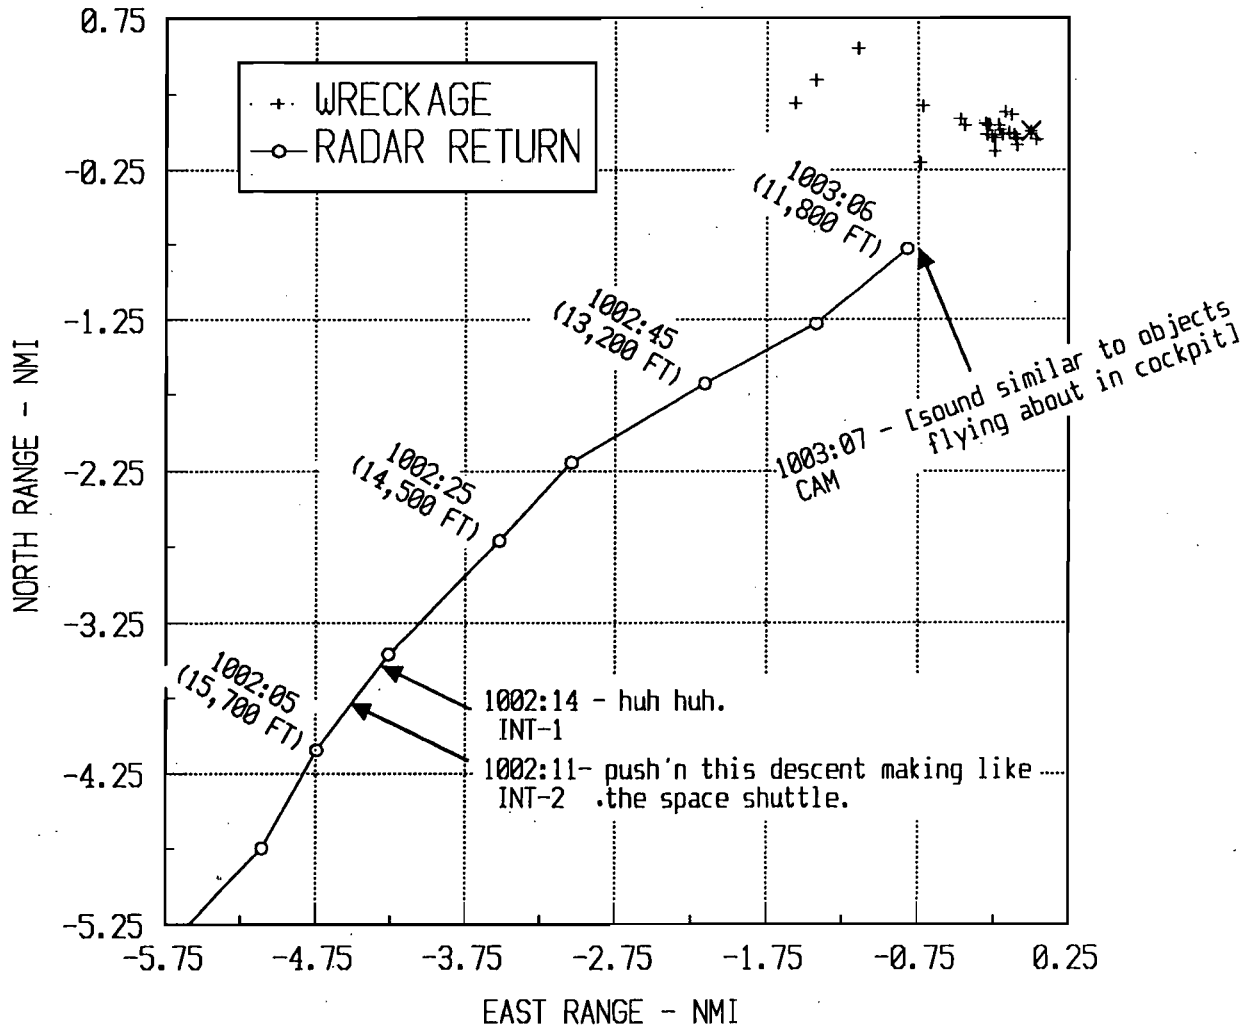
Figure 2.--Radar-derived ground track, CVR sounds, and wreckage distribution.

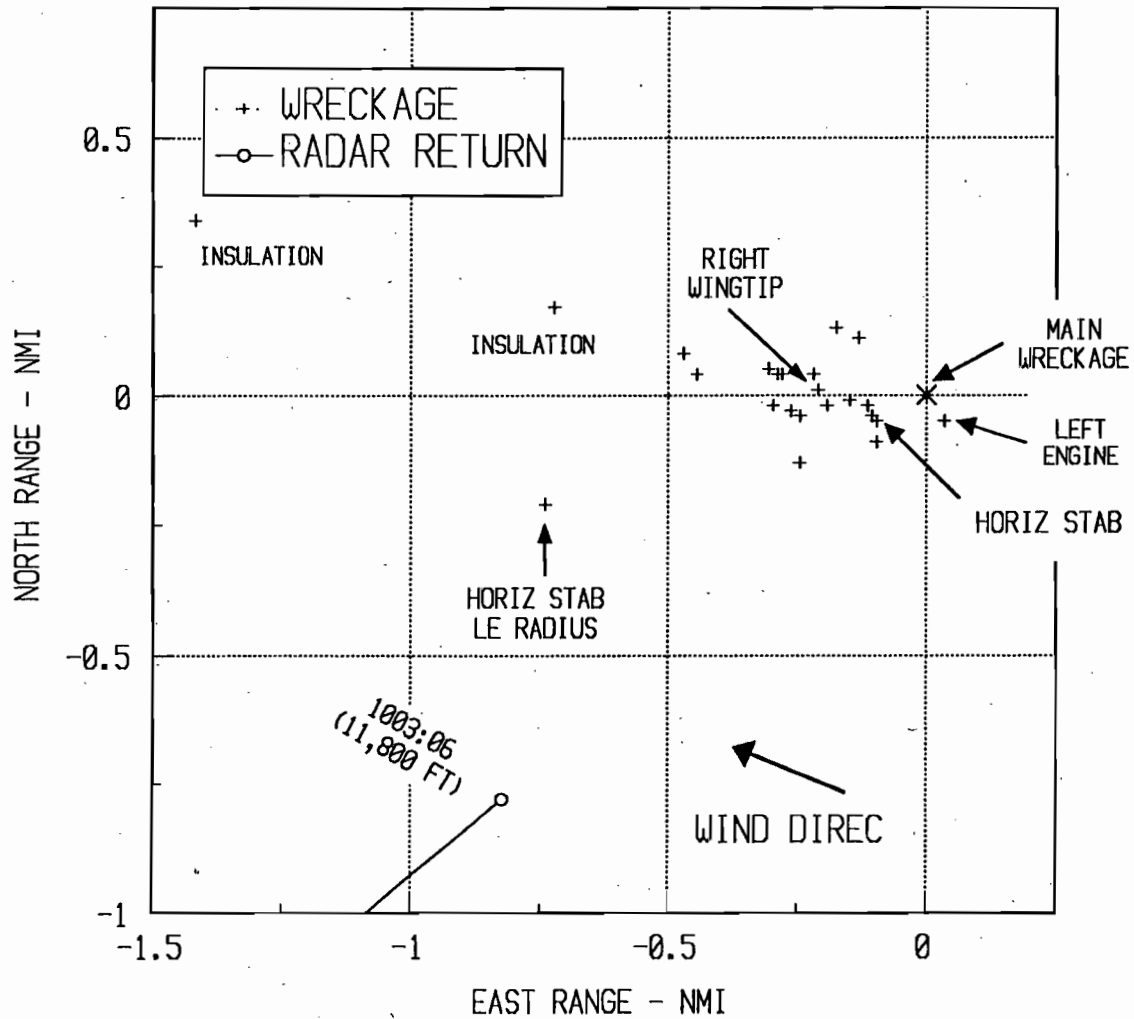
Figure 3 provides a closeup view of part of the ground track and wreckage distribution. The piece of airplane structure farthest from the main wreckage was the left side leading edge (LE) of the horizontal stabilizer. The LE

Figure 3.--Closeup view of part of ground track and wreckage distribution.

was the first piece of structure along the flight's northeasterly ground track, preceding the next piece by roughly 1/2 of a nautical mile.

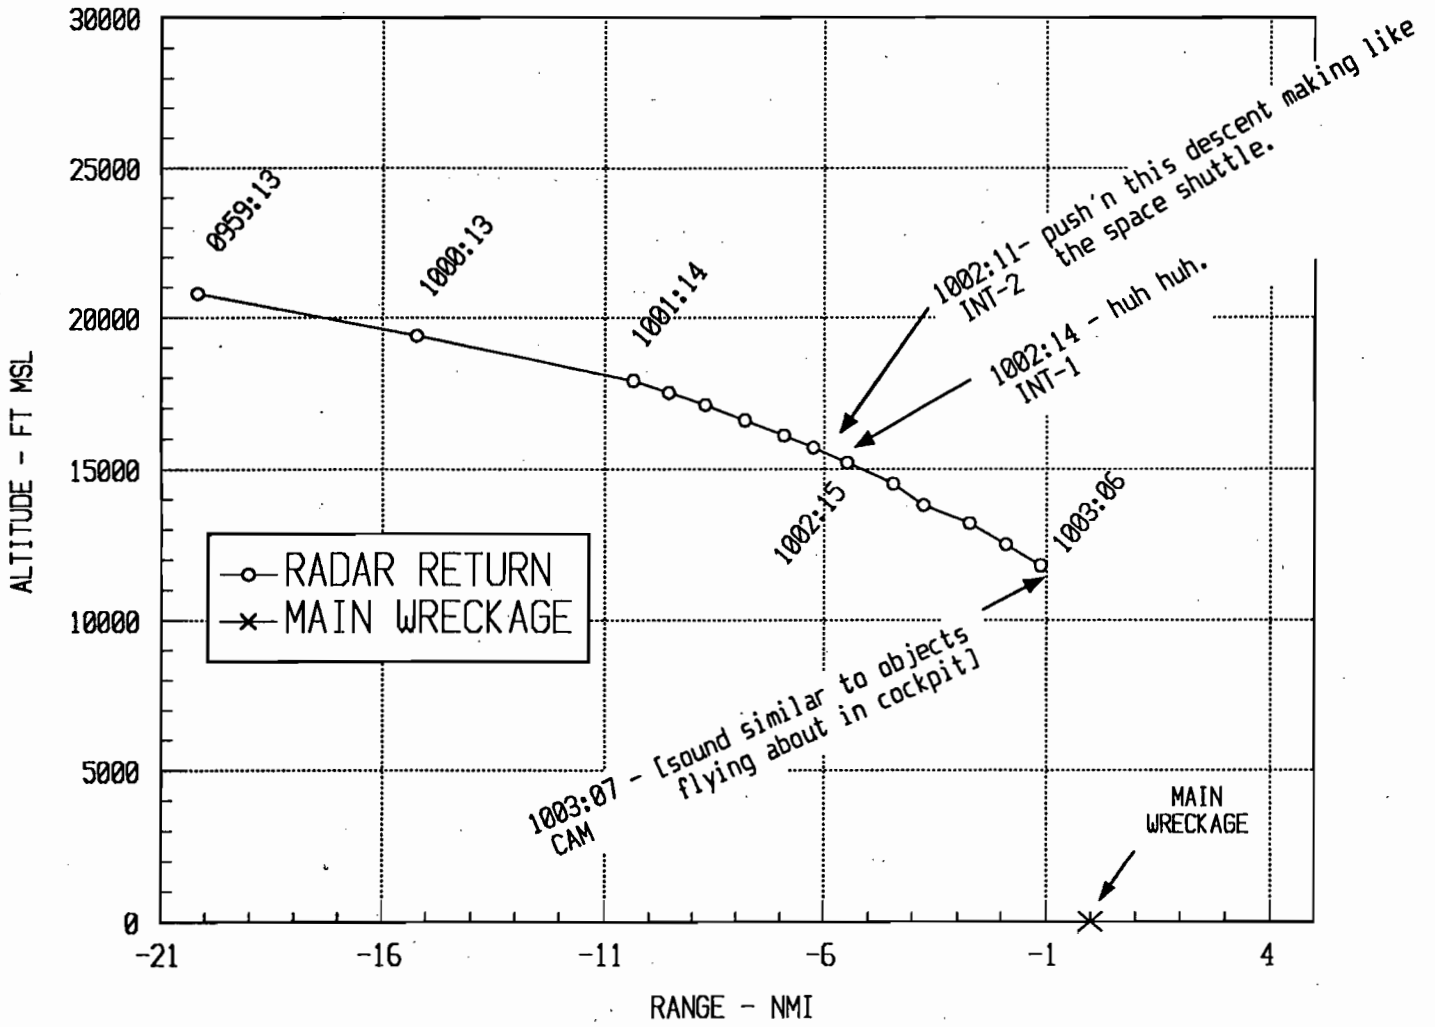
Figure 4.--Radar-derived descent profile.
