AIRCRAFT ACCIDENT REPORT

RUNWAY DEPARTURE FOLLOWING LANDING
AMERICAN AIRLINES FLIGHT 102
McDONNELL DOUGLAS DC-10-30, N139AA
DALLAS/FORT WORTH INTERNATIONAL AIRPORT, TEXAS
APRIL 14, 1993

Notation 6109B

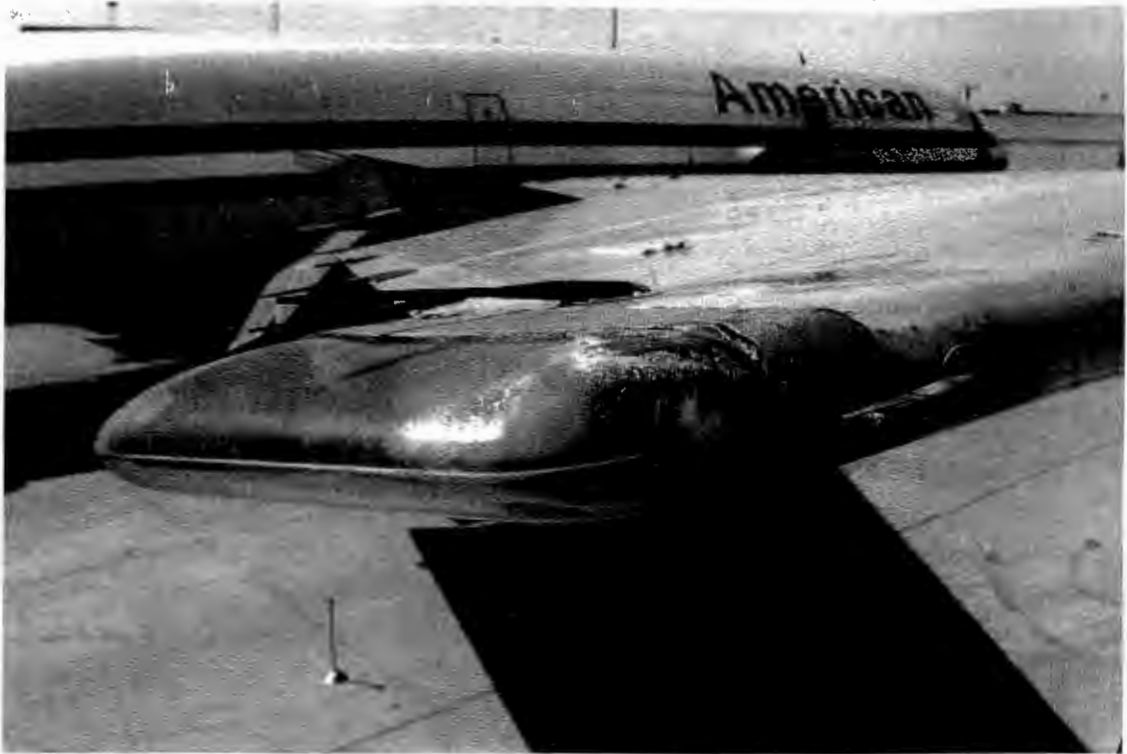
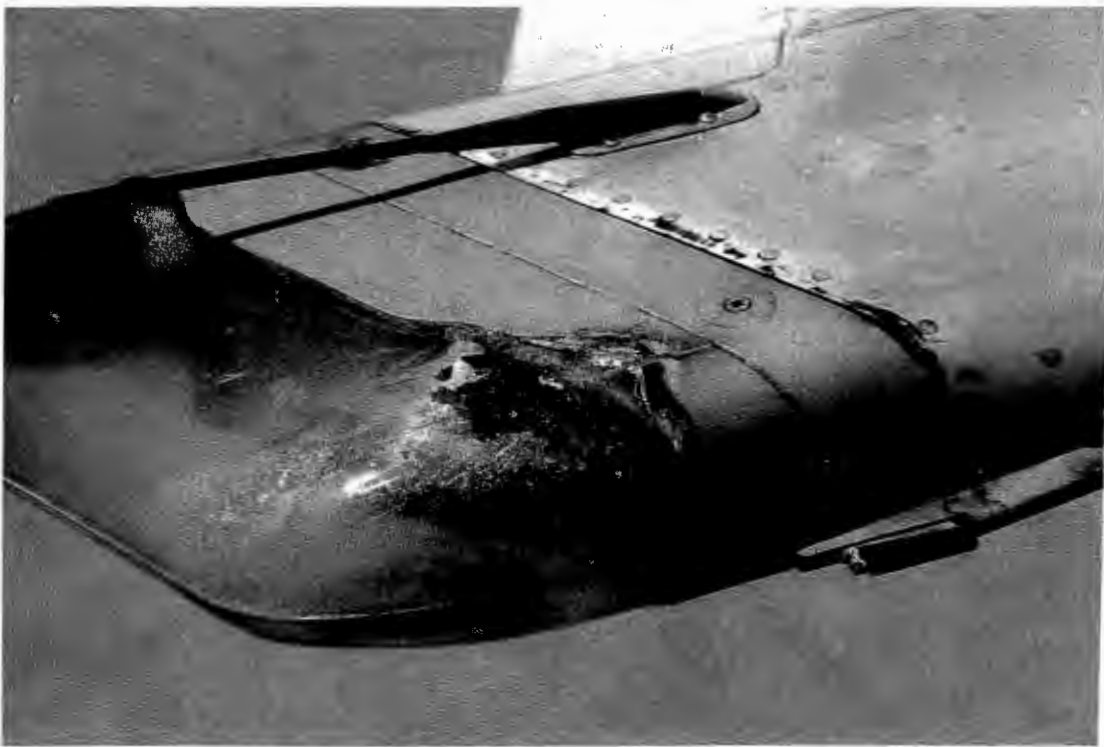
Figures 1a and 1b.--Lightning damage to right wing tip.

The top of the light lens on the right wing tip trailing edge exhibited melting and discoloration characteristic of a lightning strike. Melting and discoloration were also observed along the boundary of the lens and on the static discharger located outboard and adjacent to the lens. Only the retainer portion of the static discharger was found. No similar damage was observed on the remaining static dischargers on the airplane. However, three other dischargers were found broken--one each on the right wing trailing edge, left wing trailing edge, and left wing tip.

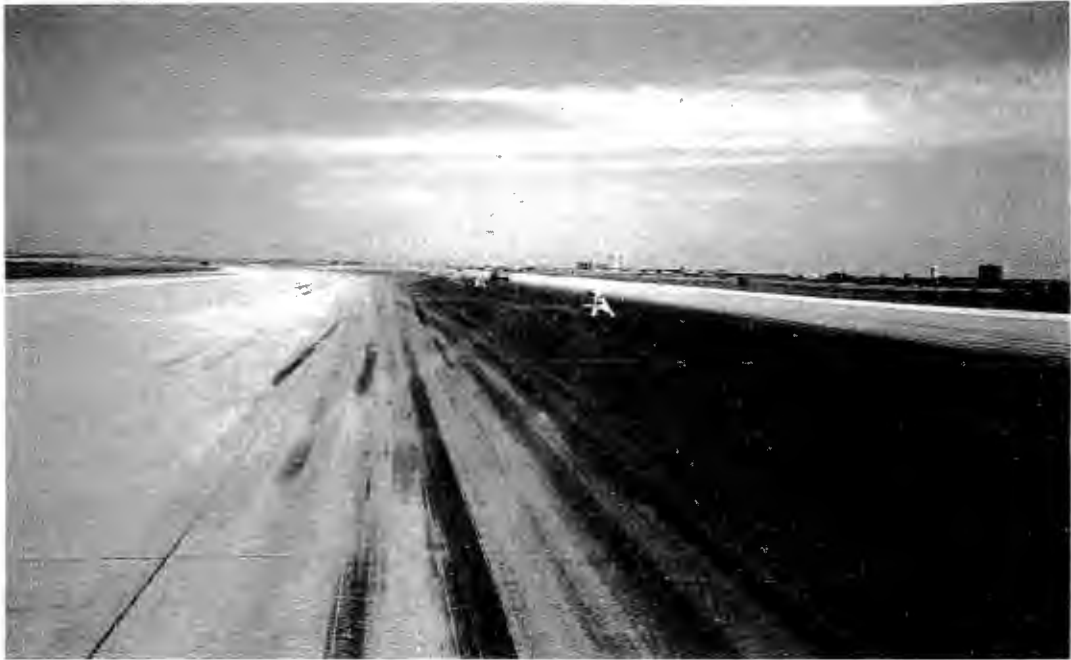
The first tire marks found on the runway were traced to the left and right main landing gear, and started at 4,303 feet from the beginning of the runway. The tracks approximately paralleled the runway centerline for about 1,700 feet, then turned gradually to the right until they departed the runway.

Figure 3a.--Tire marks on landing runway 17L (looking north).

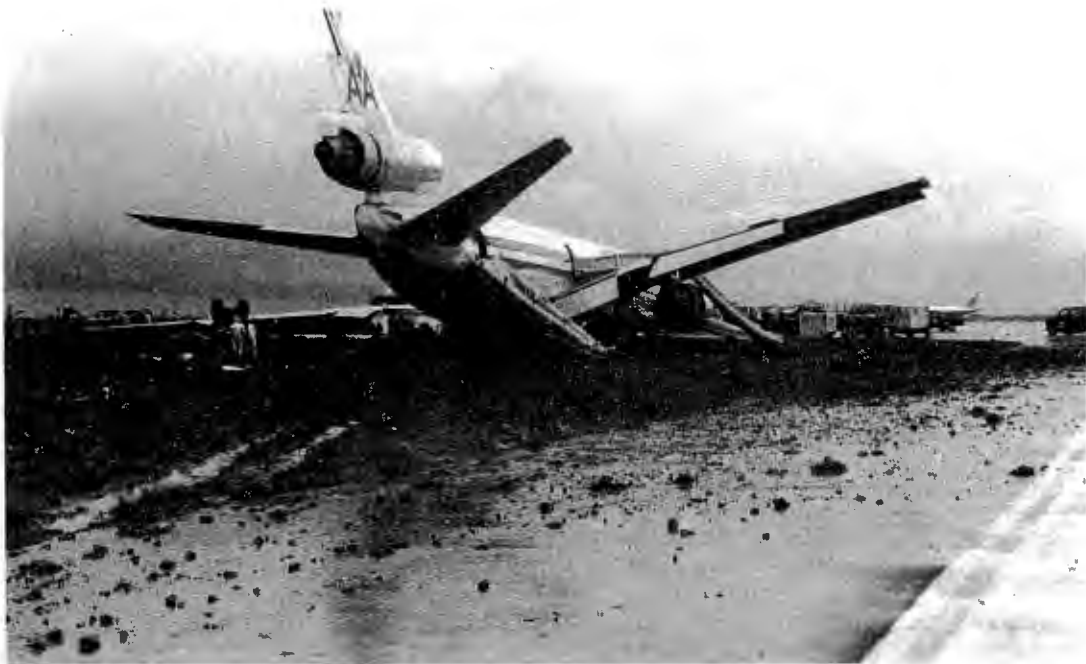
Investigators examined the landing runway after the accident and found three long sets of lightly shaded tire traces that paralleled the centerline but then angled to the right and departed the runway. The tracks from the right main landing gear continued as furrows in the soil.

Figure 3b.--Tire marks on high speed taxiway 3S, and trenches in the soil leading to the final resting position of the airplane.

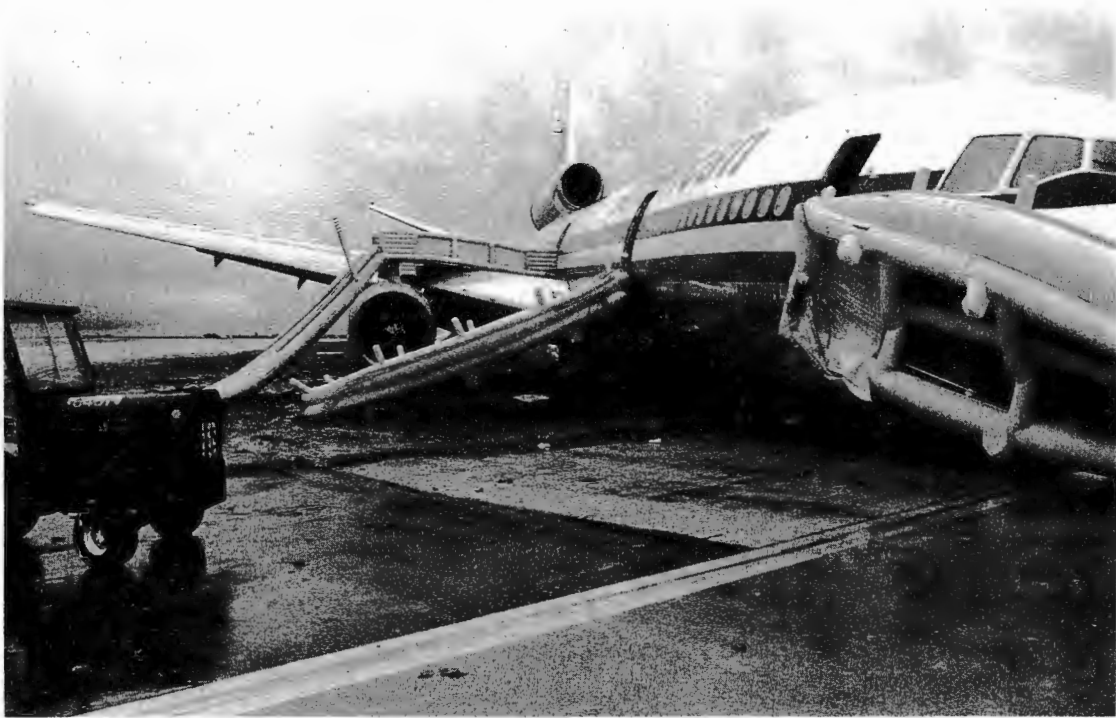
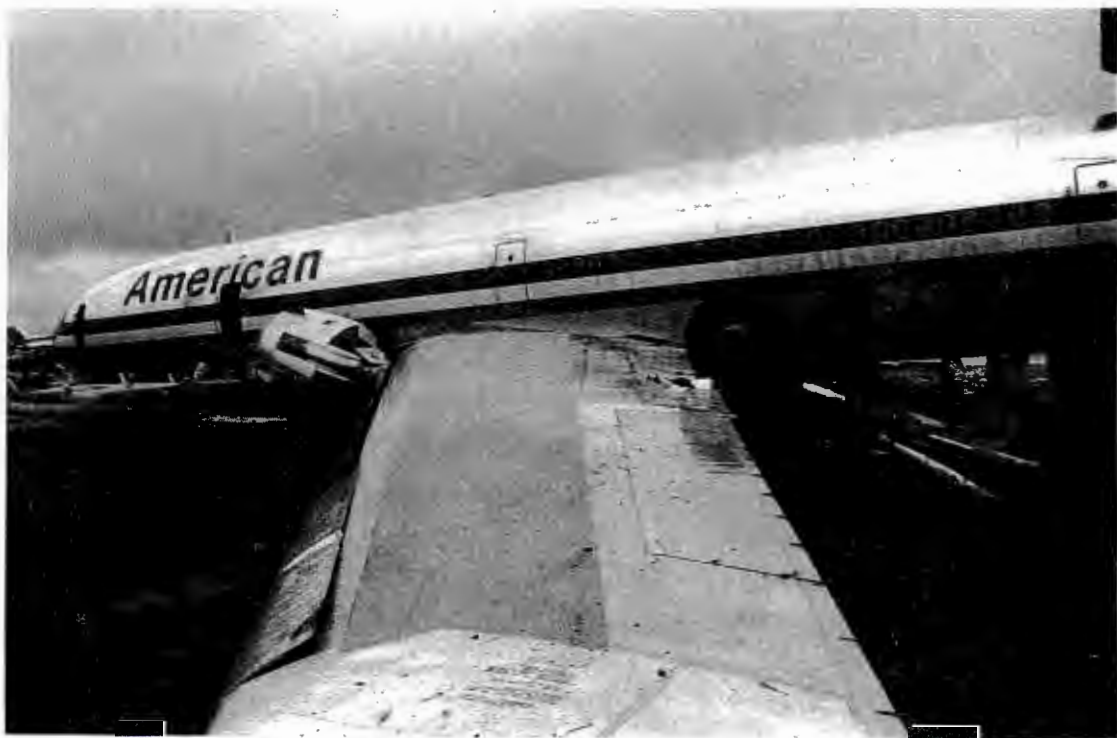
Figures 4a and 4b.--Airplane resting attitude and location.

The airplane came to rest supported by the forward fuselage, the center and right main landing gear, and the left wing and No. 1 engine. The left main gear strut was fractured and the nose gear strut was folded aft. The airplane came to rest slightly nose low and about 10 degrees left wing low. In its final resting position, the left wing and forward fuselage, as well as the right main and center gear, provided support and areas of ground contact.

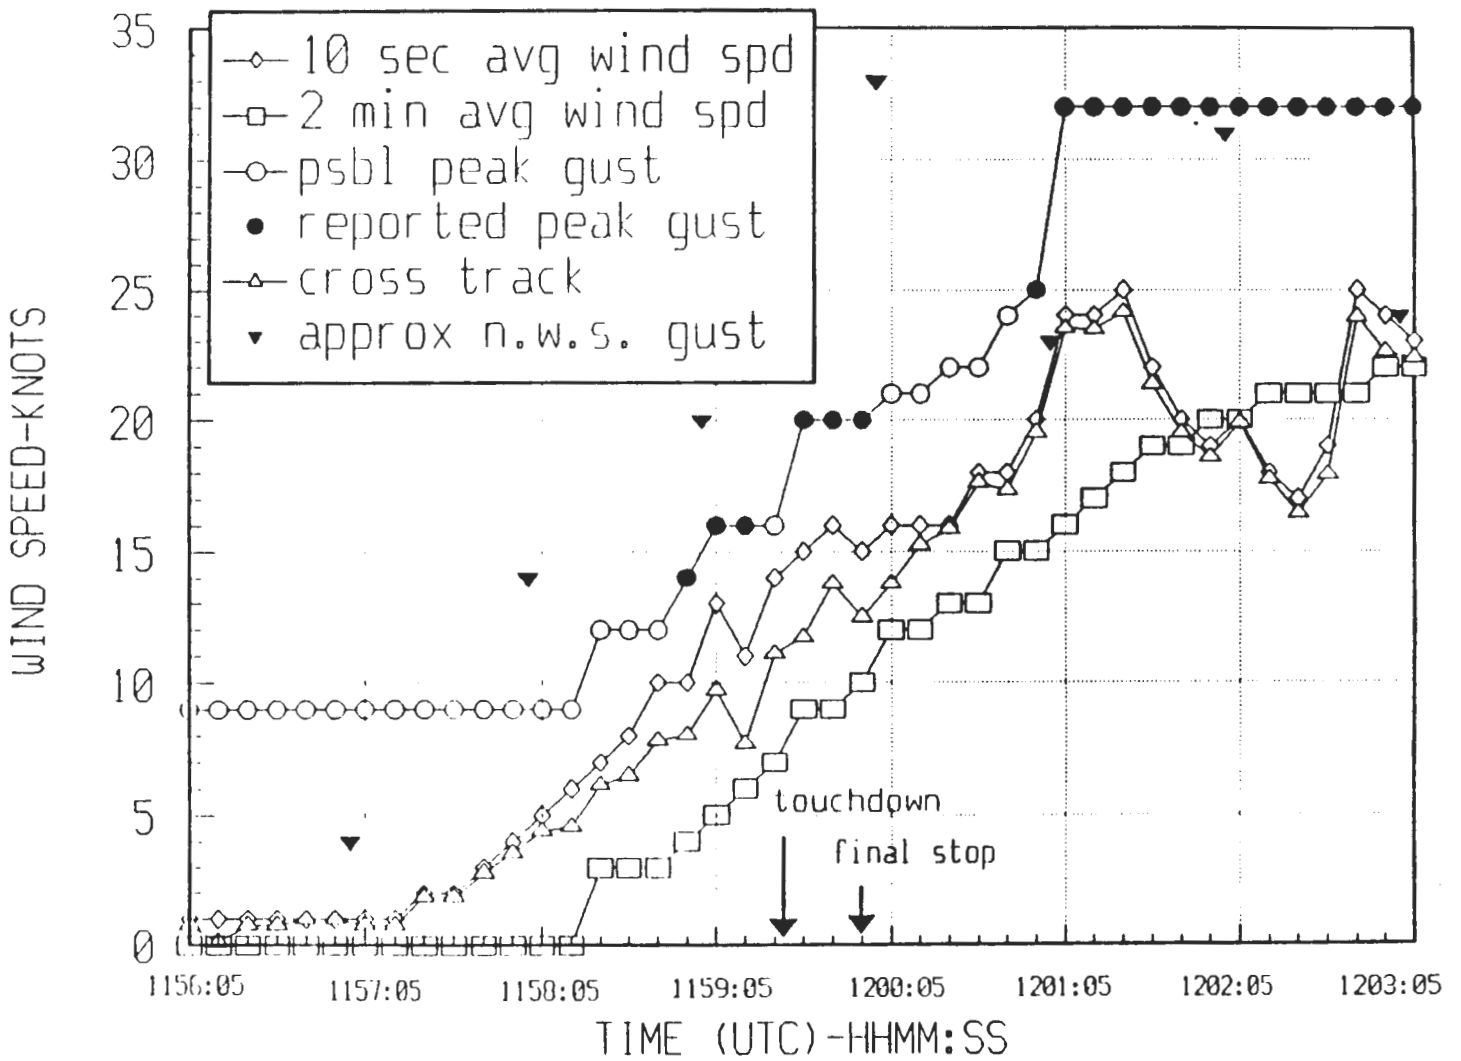
Figure 5.--LLWAS data.

all six sensors. The northwest, west, and center field sensors were found to be out of tolerance. The three anemometers were shipped to the manufacturer and under direction of the Safety Board's Investigation Weather Group Chairman, the "out of tolerance" anemometers were further evaluated. The sensor from the center field was found to be within manufacturer's tolerances. The generator output from the sensor from the northwest DFW field position was found stable, and tested root mean square errors were found only slightly out of tolerance. The sensor from the west field station at DFW failed potentiometer tests in nearly every direction, with high root mean square errors.

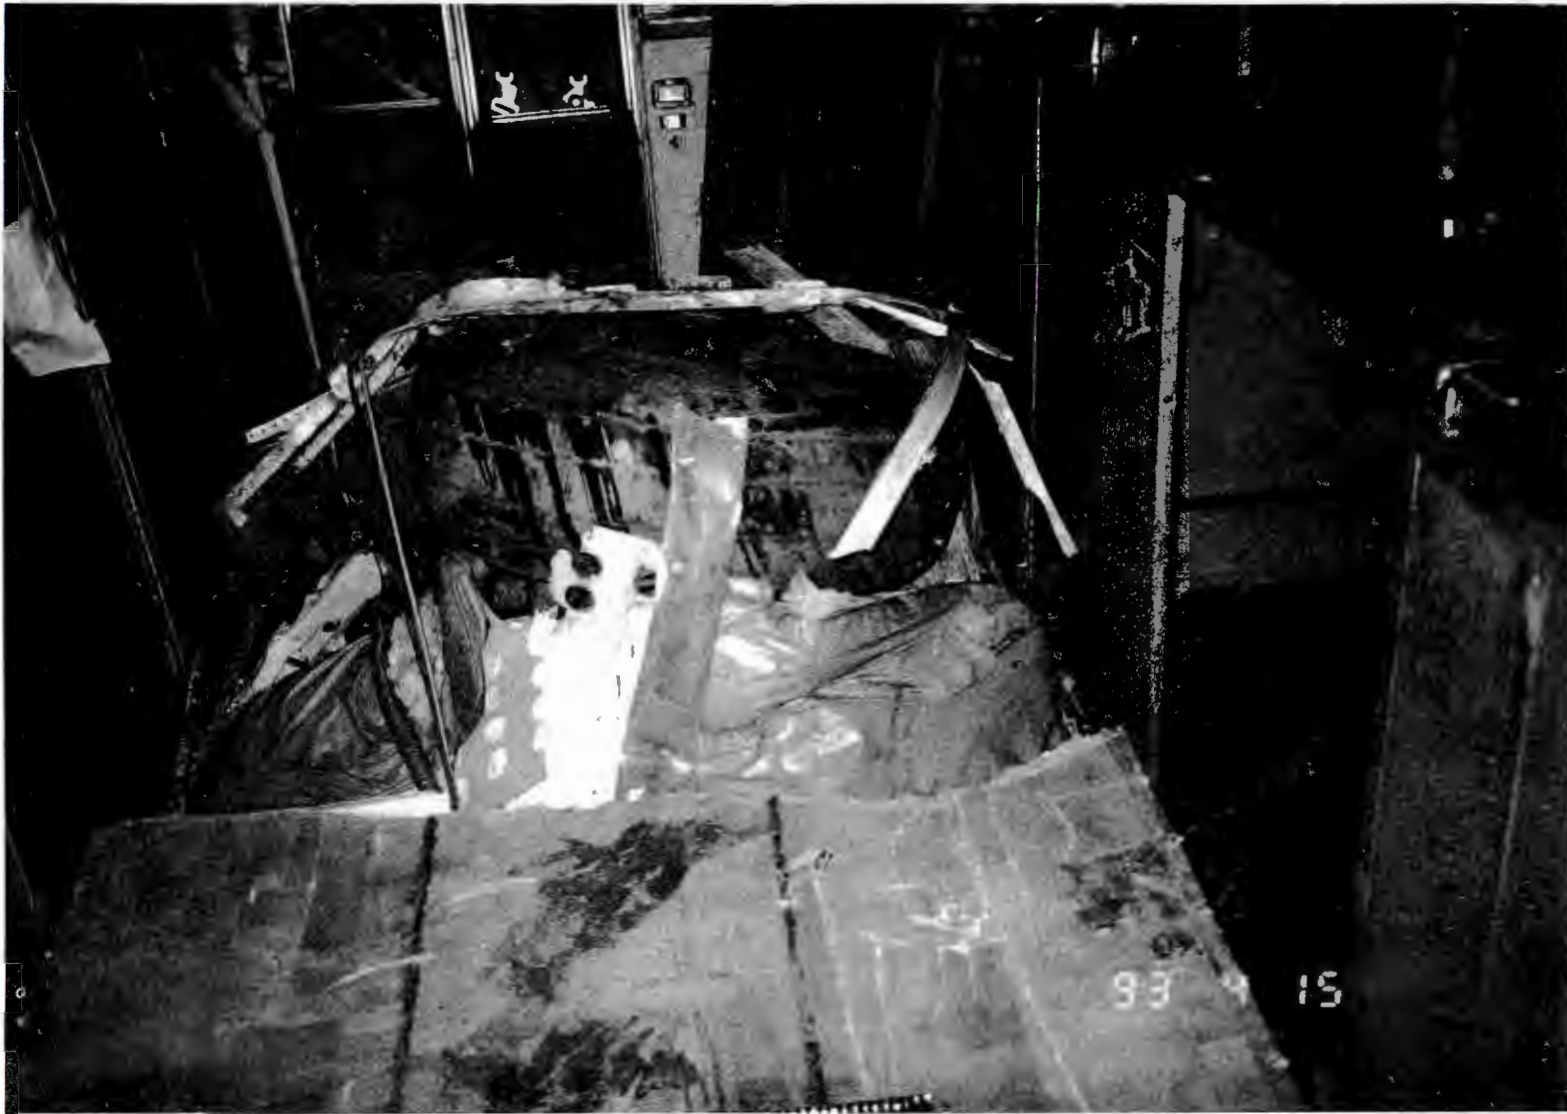
The nose gear was found folded aft. The wheel and tire assembly penetrated the floor of the lower lobe galley, and the wheels were turned about 90 degrees to the right. (See figure 7, which is a photograph of the lower lobe galley, showing the final position of the nose gear tires).

Figure 7.--Lower lobe galley.

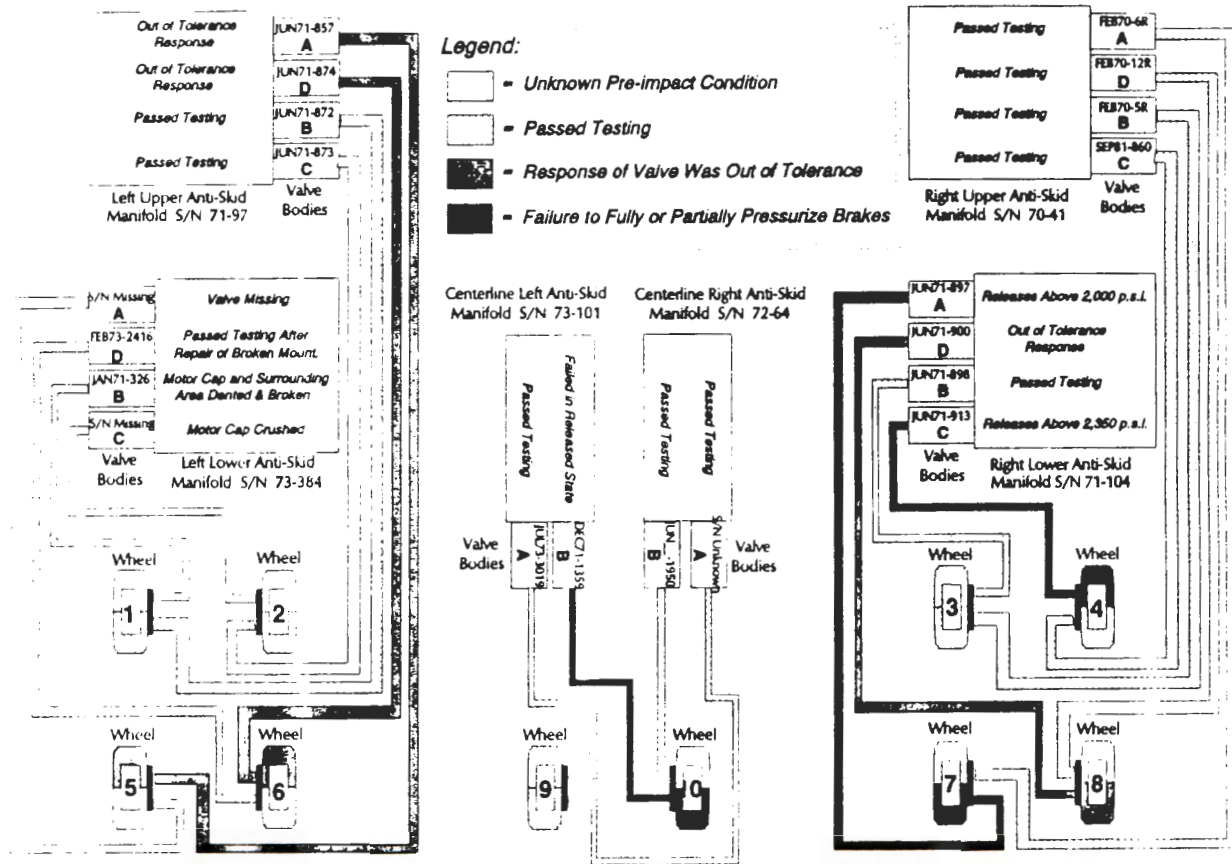
Figure 8.--Brake manifold system.
