# Safer Seas 2013

LESSONS LEARNED FROM MARINE  
ACCIDENT INVESTIGATIONS

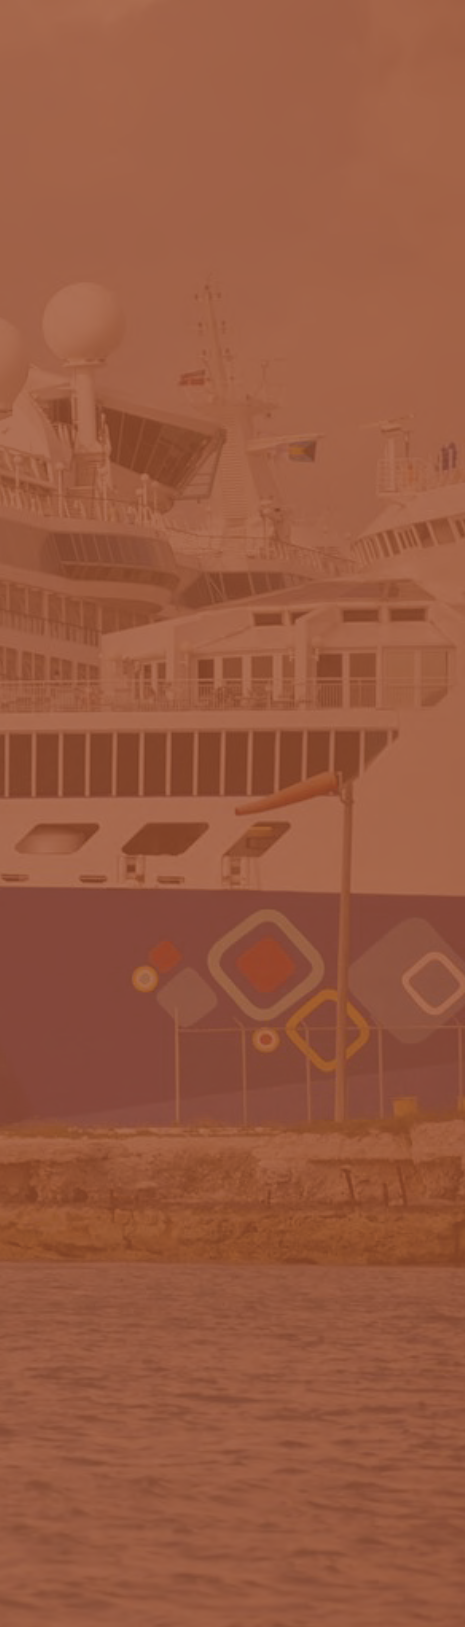
The National Transportation Safety Board is an independent Federal agency charged by Congress with investigating every civil aviation accident in the United States and significant accidents in other modes of transportation – marine, railroad, highway and pipeline. The NTSB determines the probable cause of the accidents and issues safety recommendations aimed at preventing future accidents. In addition, the NTSB carries out special studies concerning transportation safety and coordinates the resources of the federal government and other organizations to provide assistance to victims and their family members impacted by major transportation disasters.

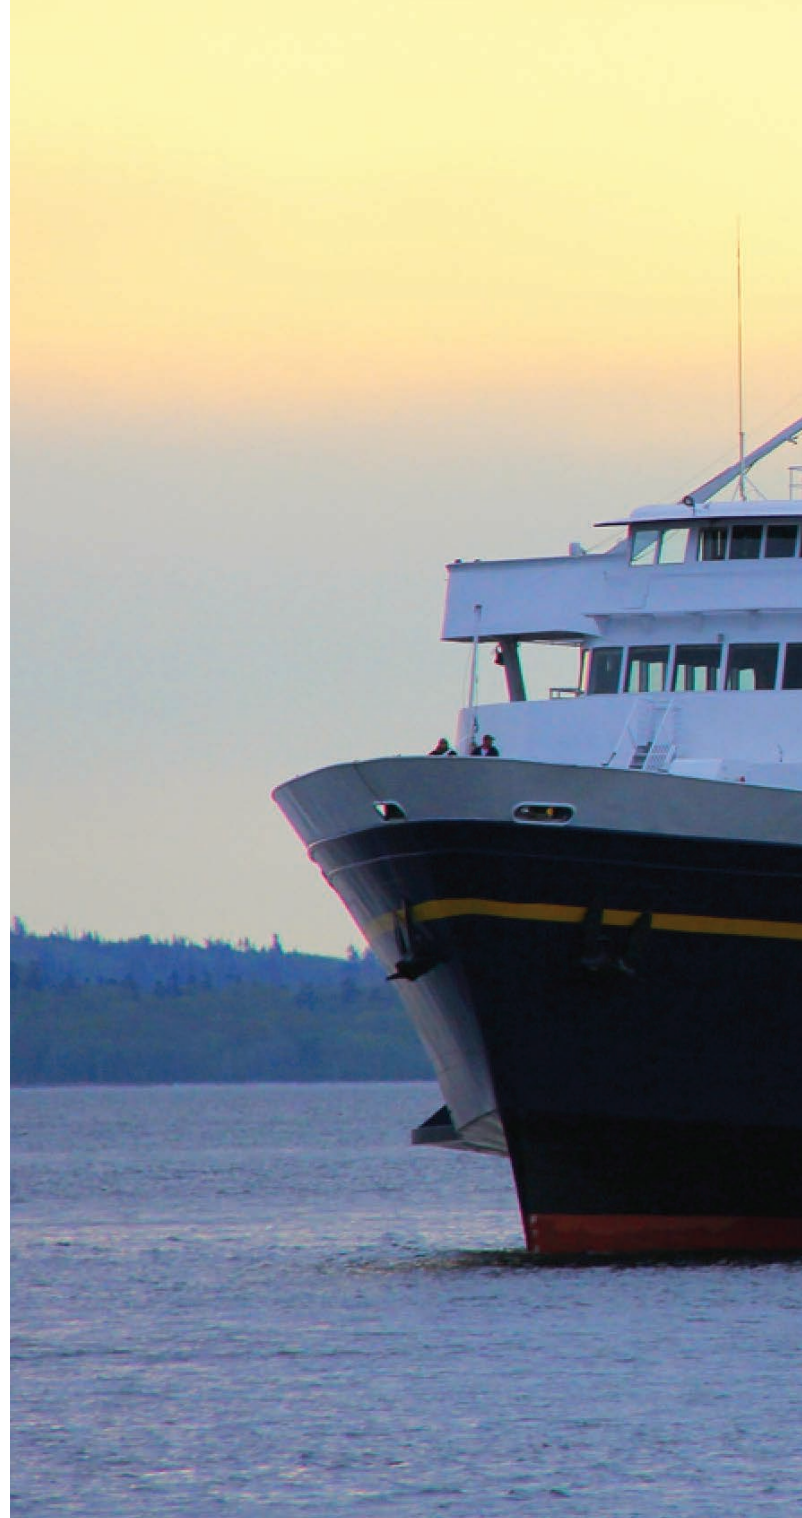
But if mariners are not constantly vigilant and if their organization’s culture does not reinforce their respect for marine safety, humans themselves can cause incidents, accidents, and even tragedies.

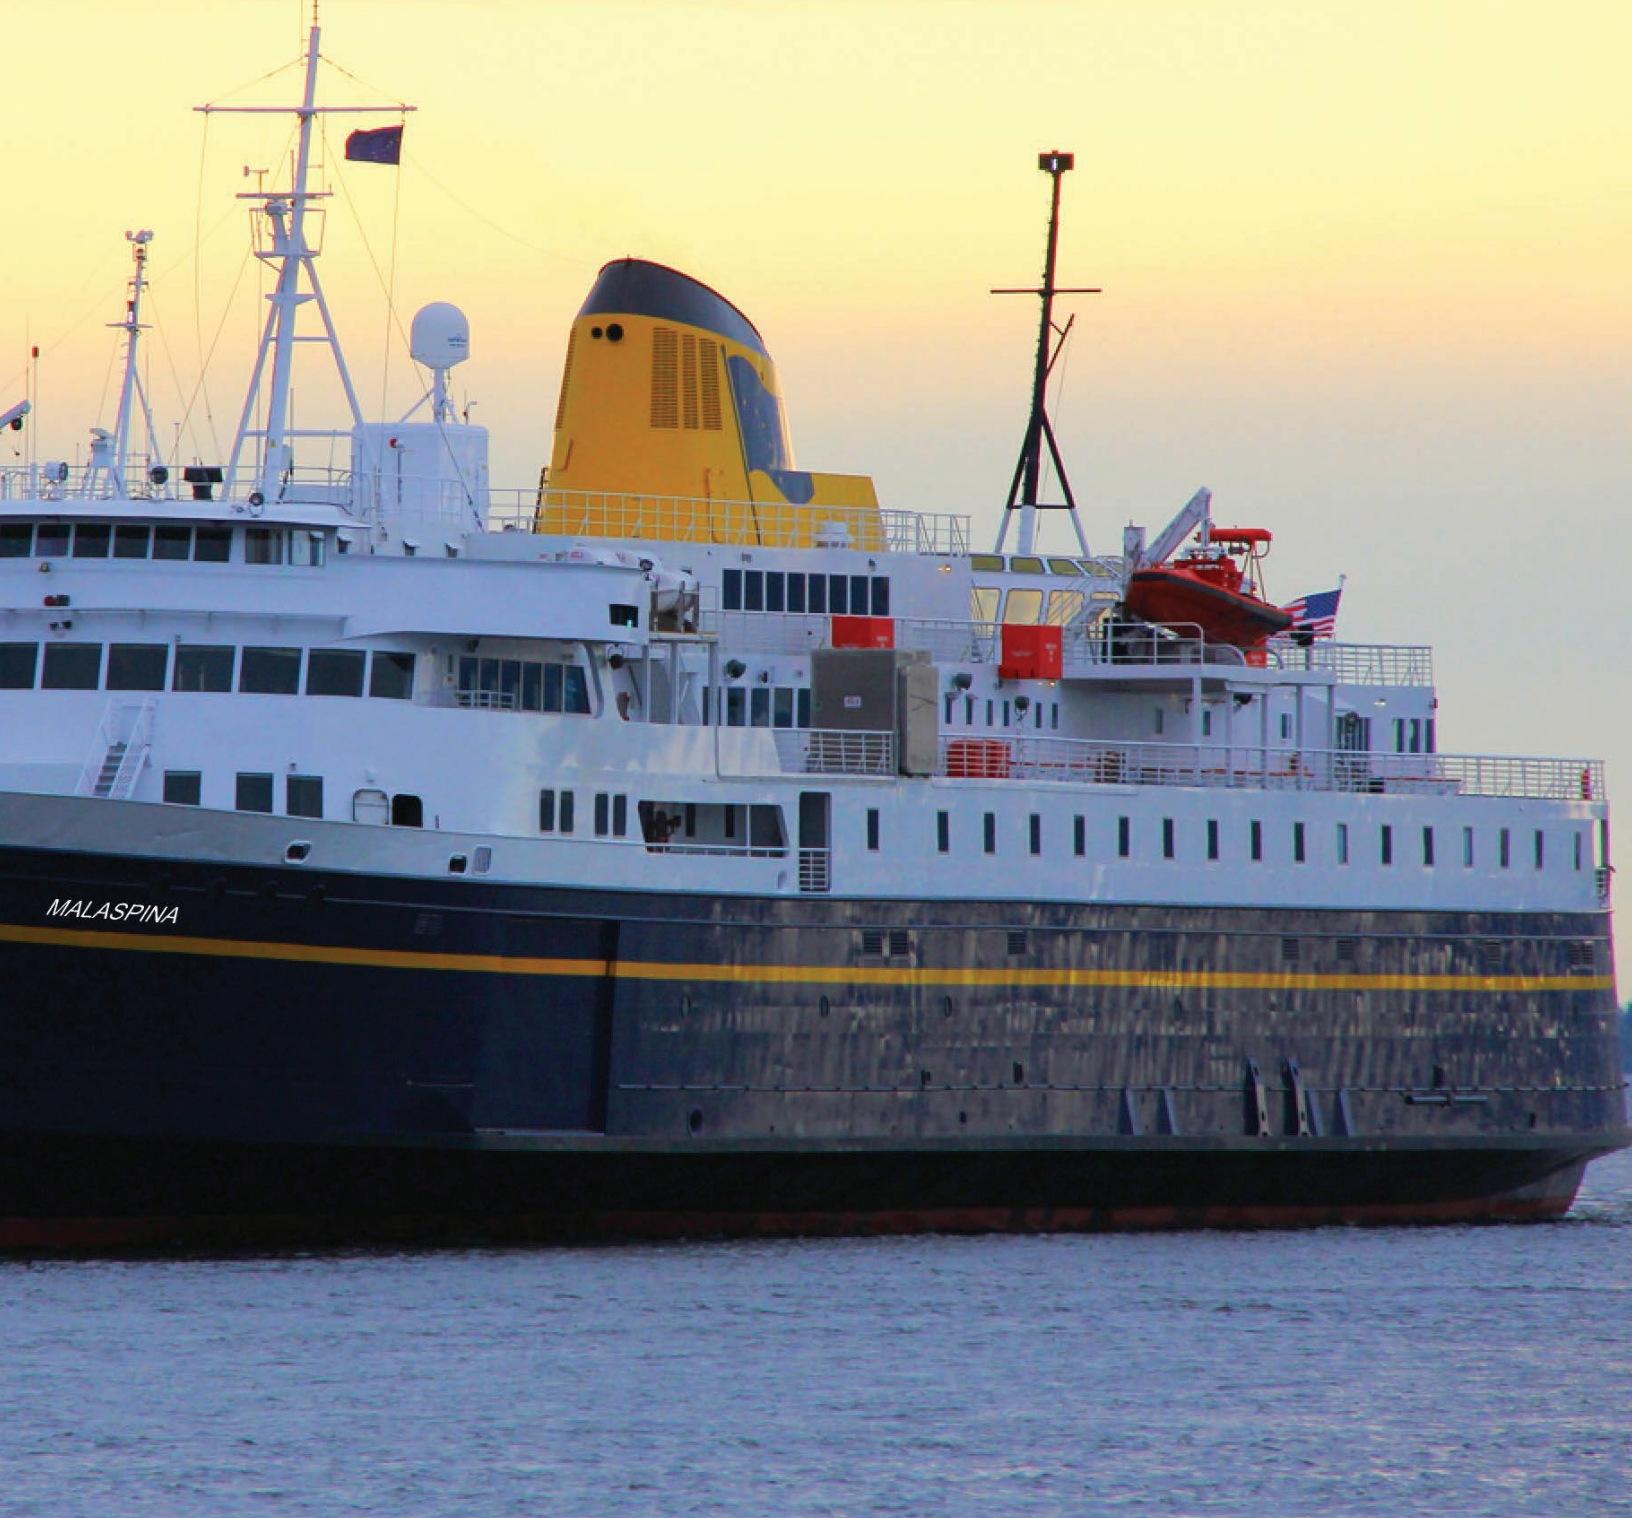
that by reading and using these reports in the field, operators will improve their awareness and learn from others' misfortunes.

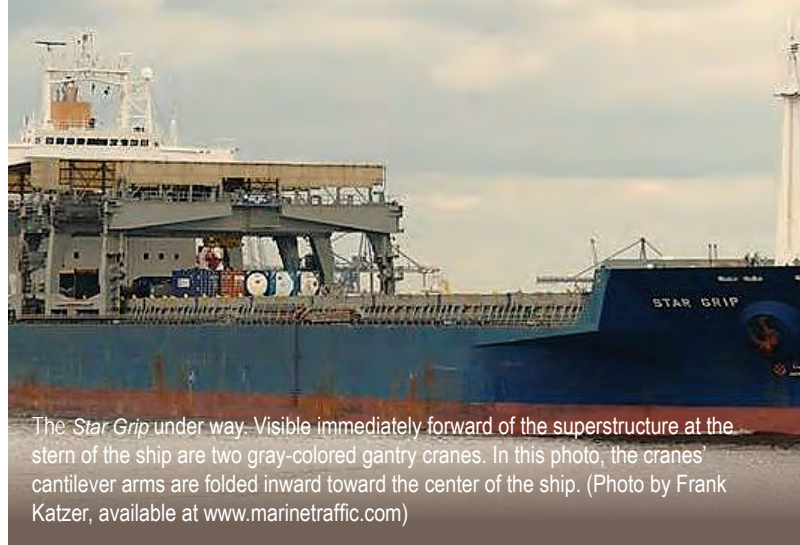
The *Star Grip* under way. Visible immediately forward of the superstructure at the stern of the ship are two gray-colored gantry cranes. In this photo, the cranes' cantilever arms are folded inward toward the center of the ship. (Photo by Frank Katzer, available at [www.marinetraffic.com](http://www.marinetraffic.com))

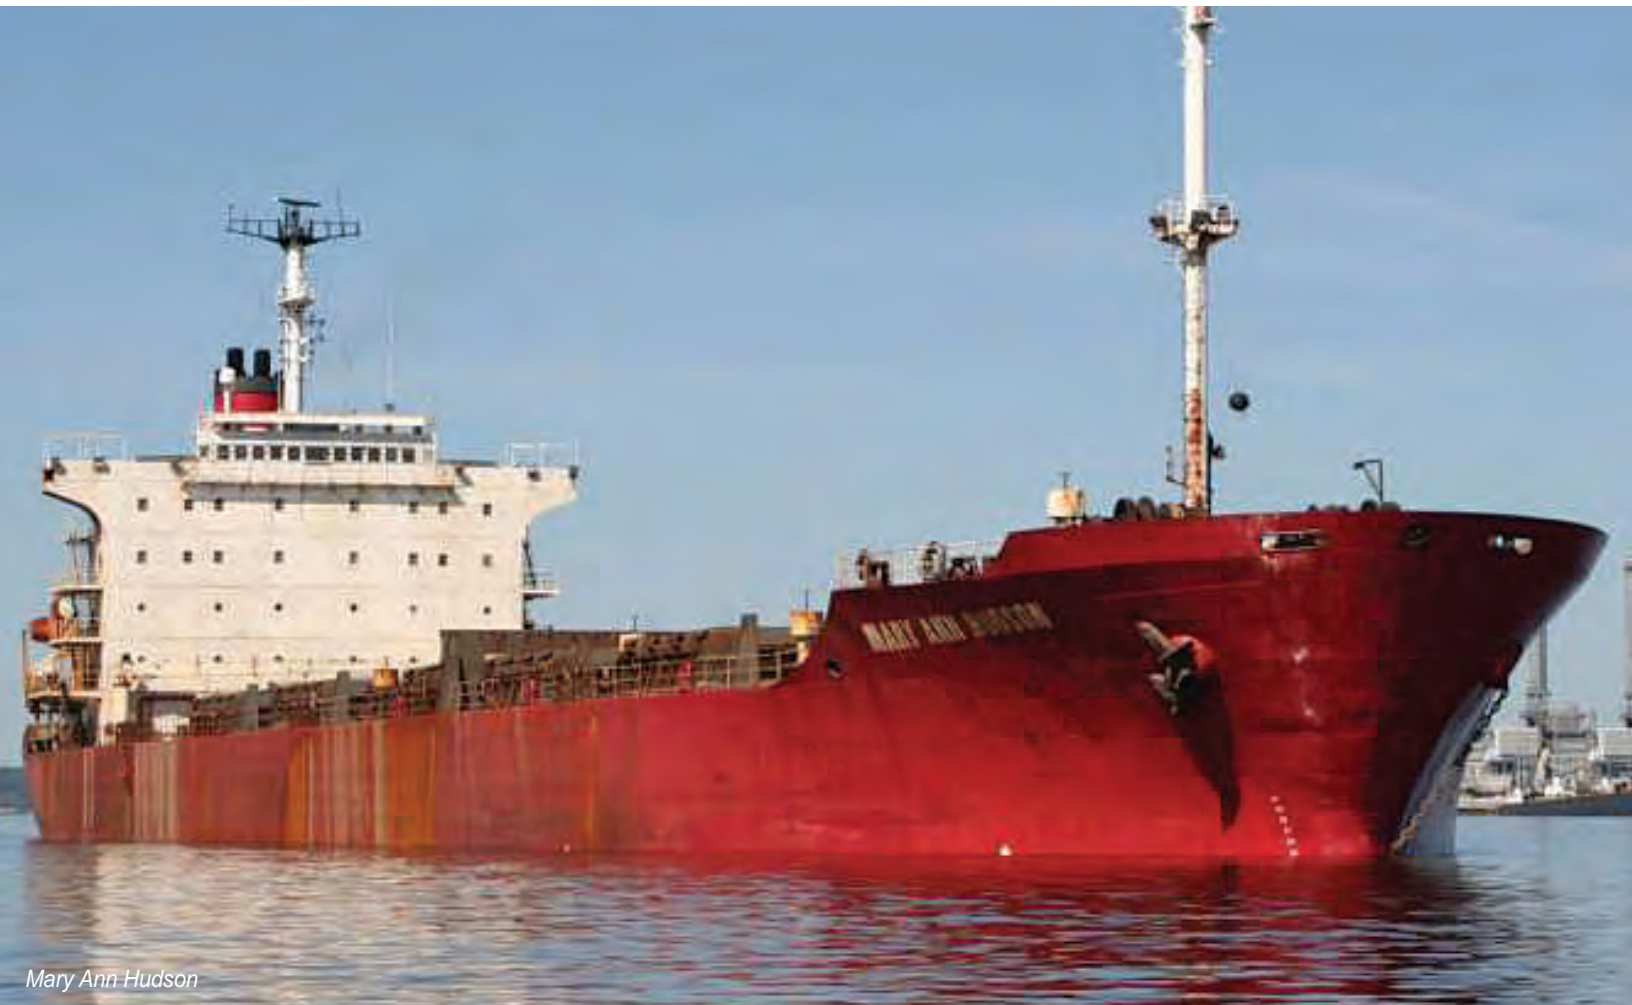
The National Transportation Safety Board determines that the probable cause of the collision between bulk carriers *Mary Ann Hudson* and *Star Grip* was the pilot's ineffective handling of the *Mary Ann Hudson* and his ineffective use of the two tugboats to maneuver the vessel around the *Star Grip*'s crane arms, which were extending into the navigable waterway.

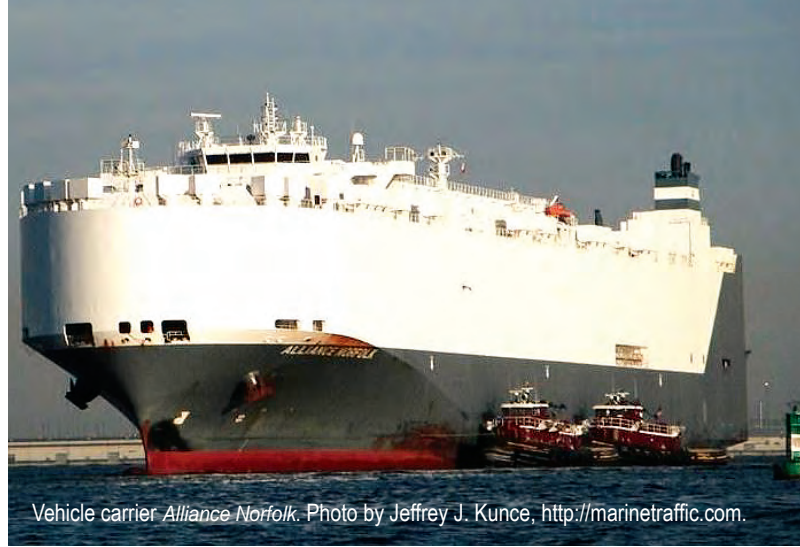
Vehicle carrier *Alliance Norfolk*. Photo by Jeffrey J. Kunce. <http://marinetraffic.com>.

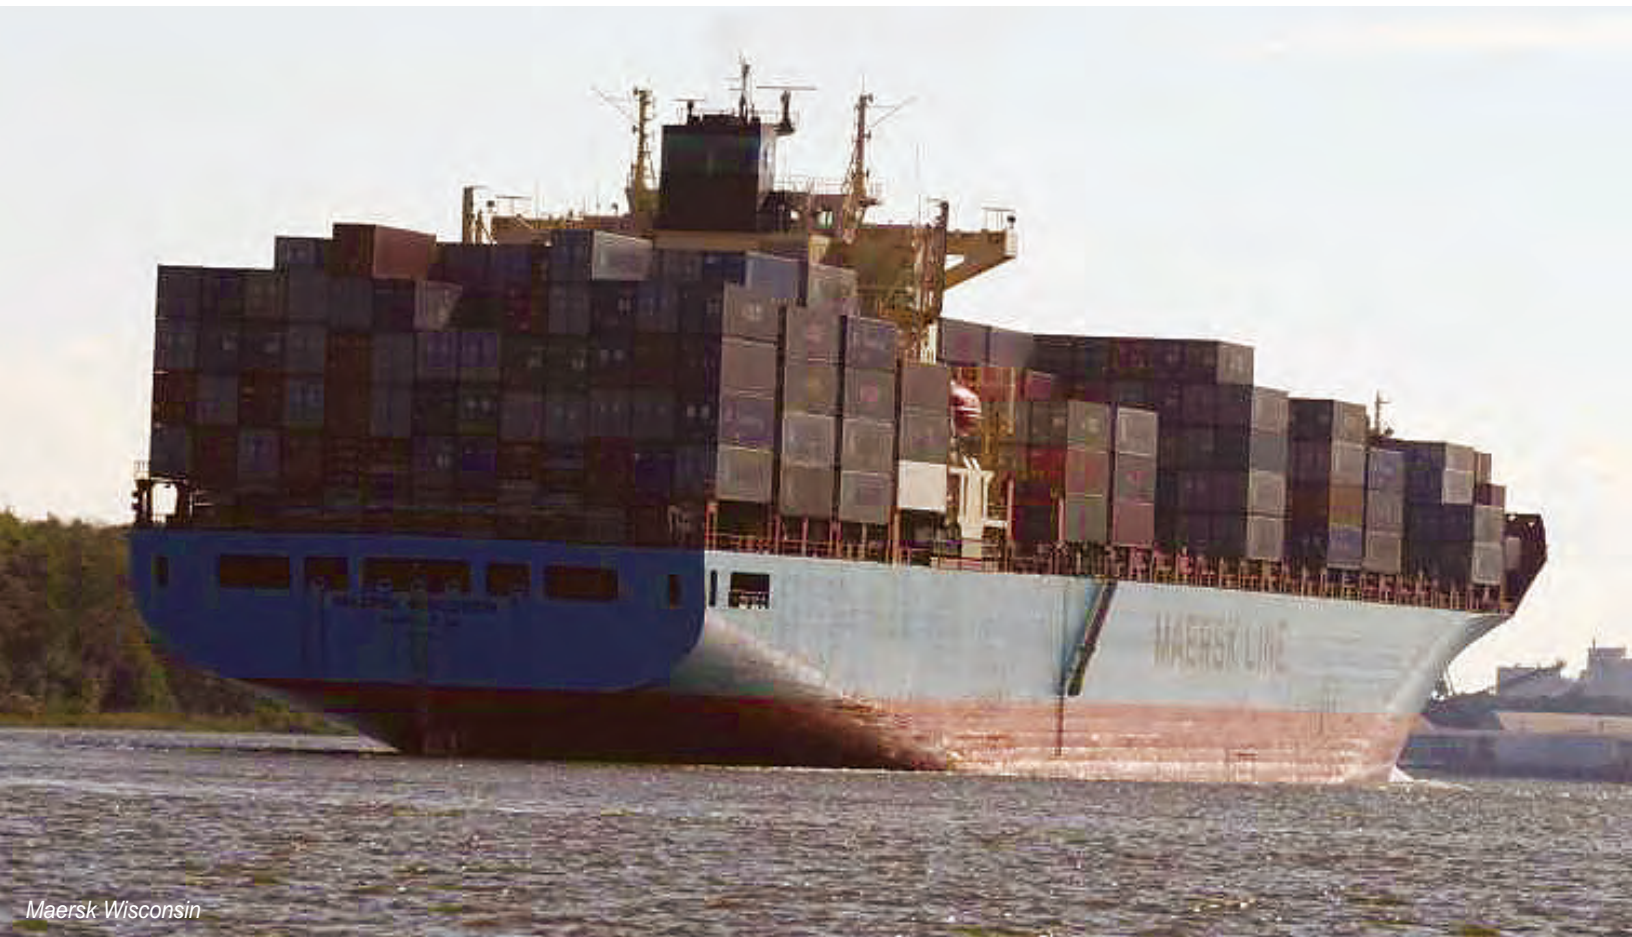
The National Transportation Safety Board determines that the probable cause of the collision was the failure of the docking pilot on board the *Maersk Wisconsin* to position his vessel according to the meeting arrangement with the *Ruth M. Reinauer* to allow adequate separation for passage of the tug and barge in the navigable channel.

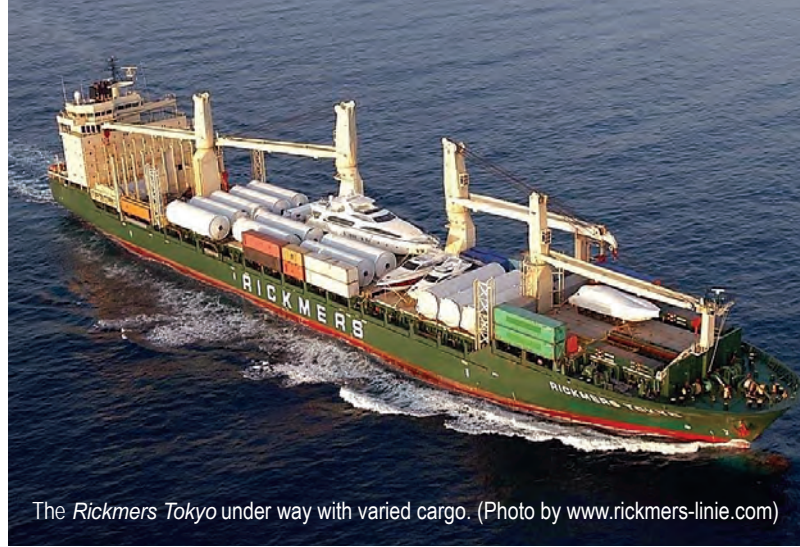
The *Rickmers Tokyo* under way with varied cargo. (Photo by [www.rickmers-linie.com](http://www.rickmers-linie.com))

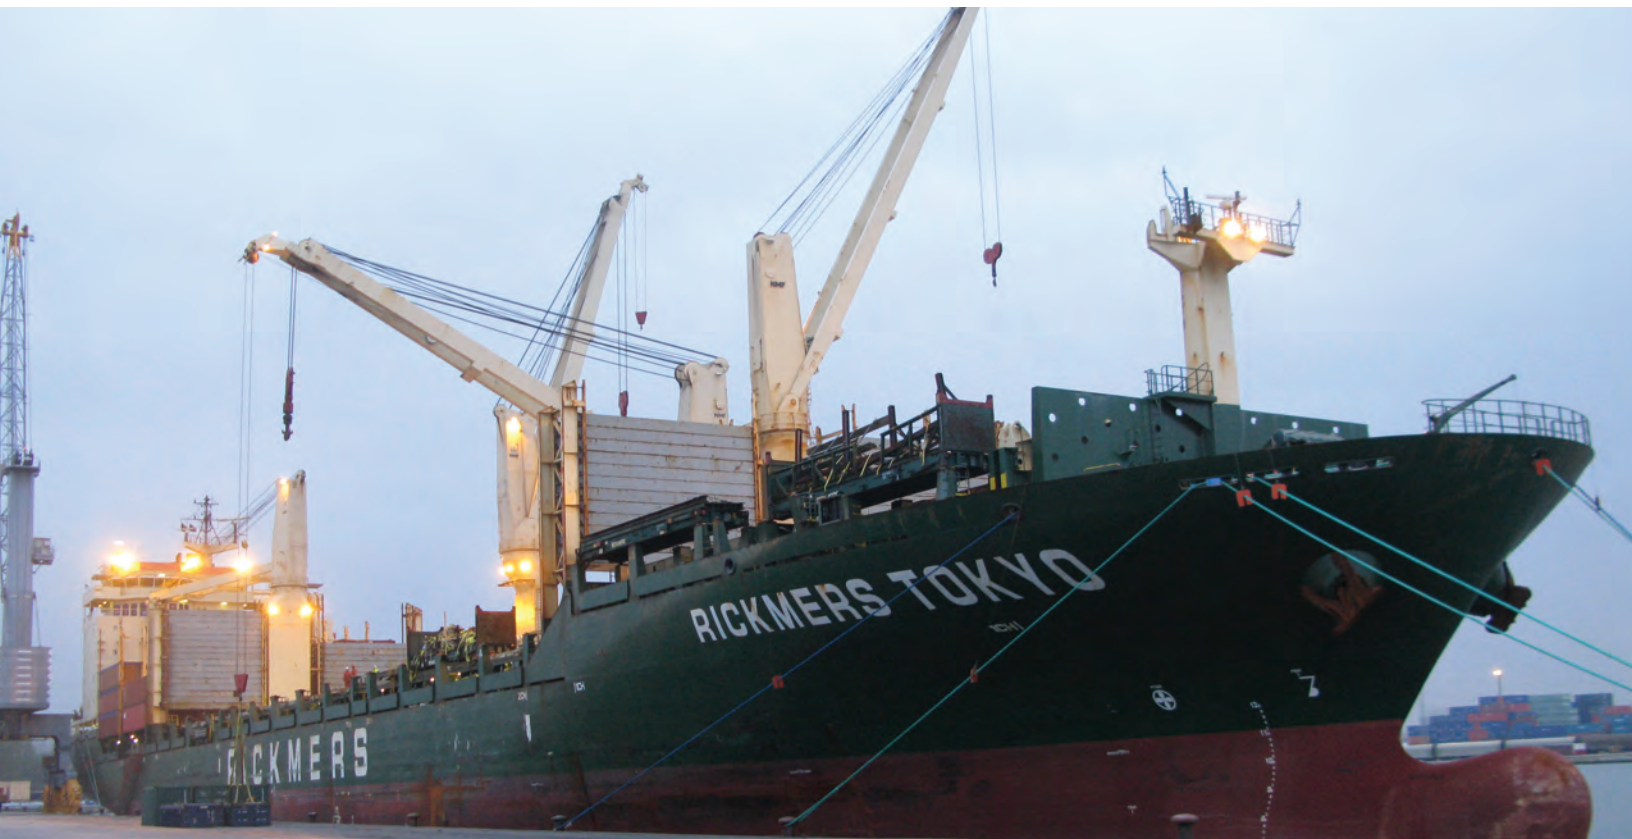
The National Transportation Safety Board determines that the probable cause of the allision of *Rickmers Tokyo* with Pier 11 in the Delaware River was the river pilot not executing the turn at Port Richmond due to his lack of situation awareness regarding the vessel's position in the channel and his inadequate use of all available navigation equipment. Contributing to the allision was the river pilot's failure to wear his corrective eyewear, which was required and would have assisted with distant visual cues on the dark evening.

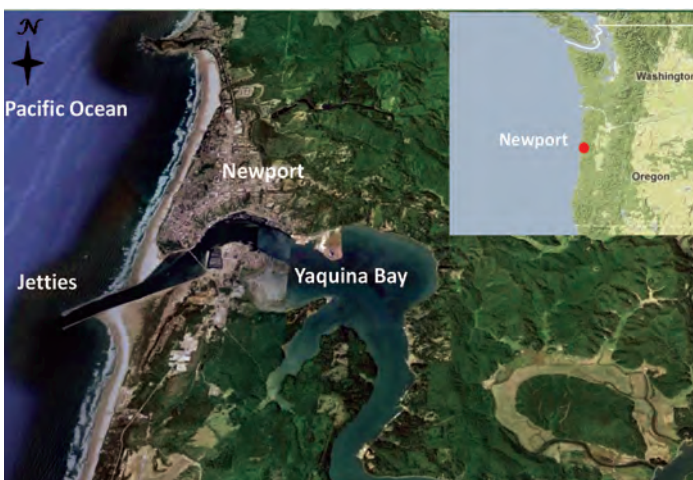
Aerial view of accident location at entrance jetties to Yaquina Bay near Newport, Oregon. Inset map shows location of Newport in the Pacific Ocean. (Satellite images by Google Earth)

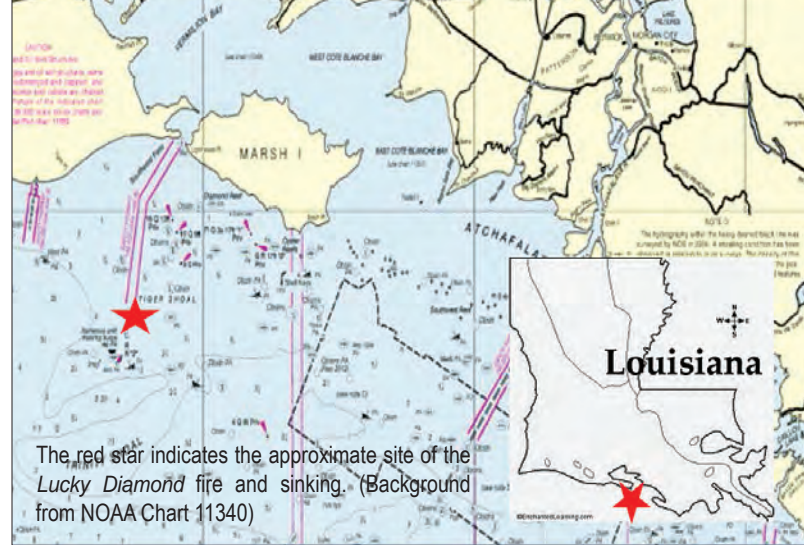
cut the mooring lines to the *Lucky Diamond*, setting the vessel adrift. The *Lucky Diamond* burned for several hours and then sank in about 40 feet of water.

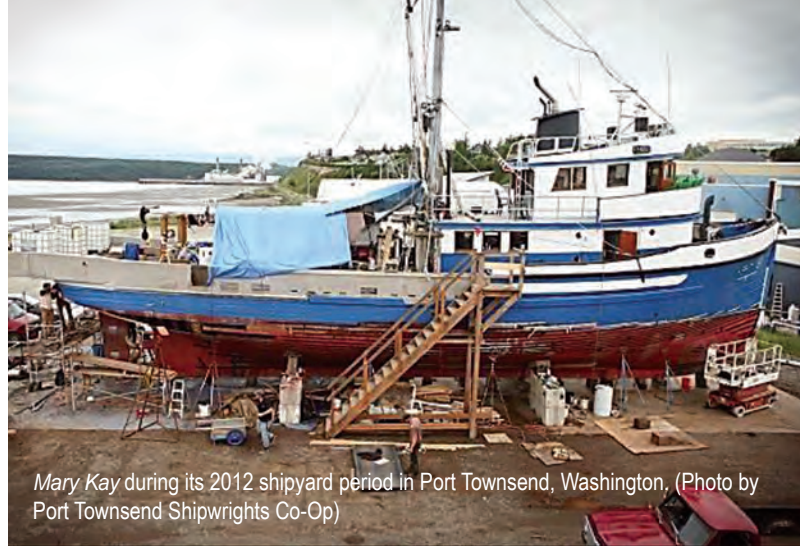
*Mary Kay* during its 2012 shipyard period in Port Townsend, Washington. (Photo by Port Townsend Shipwrights Co-Op)

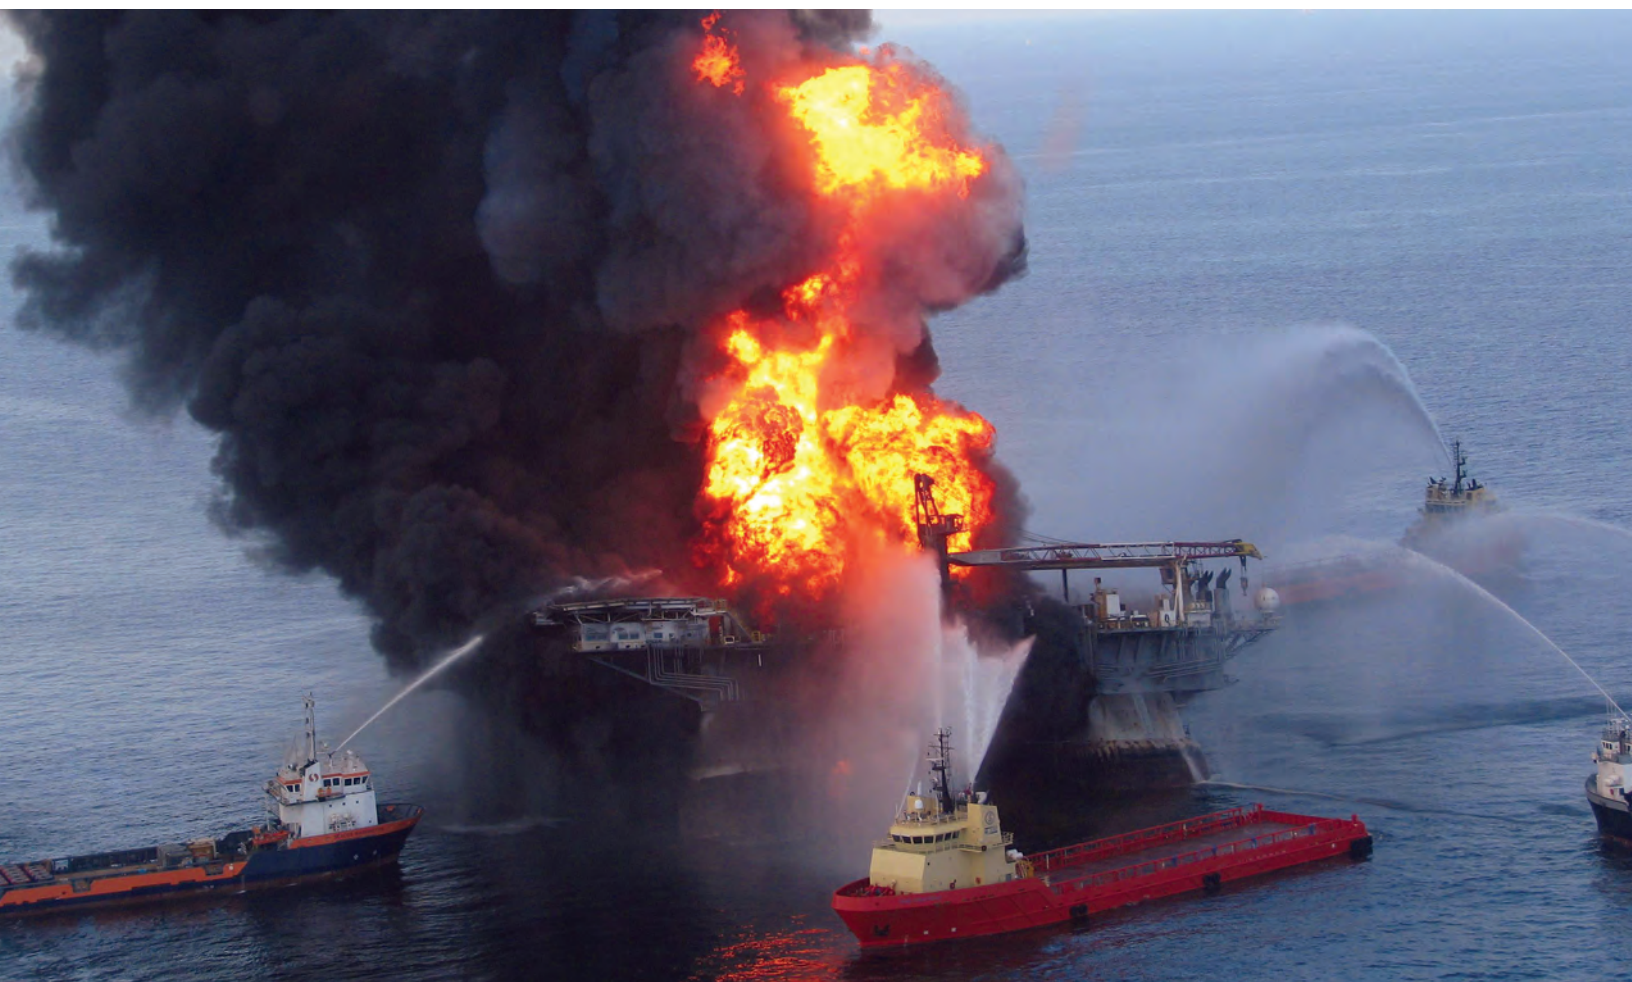
The National Transportation Safety Board determines that the probable cause of the fire on board and sinking of the liftboat *Mako* was a blowout of the wellhead under the adjacent jackup drilling rig *KS Endeavor*, which resulted in an uncontrollable gas fire that rapidly spread to the liftboat.

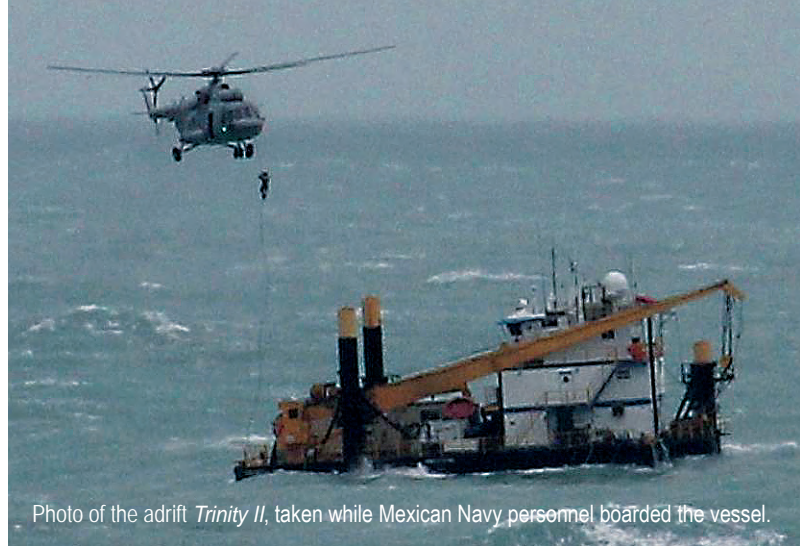
Photo of the adrift *Trinity II*, taken while Mexican Navy personnel boarded the vessel.

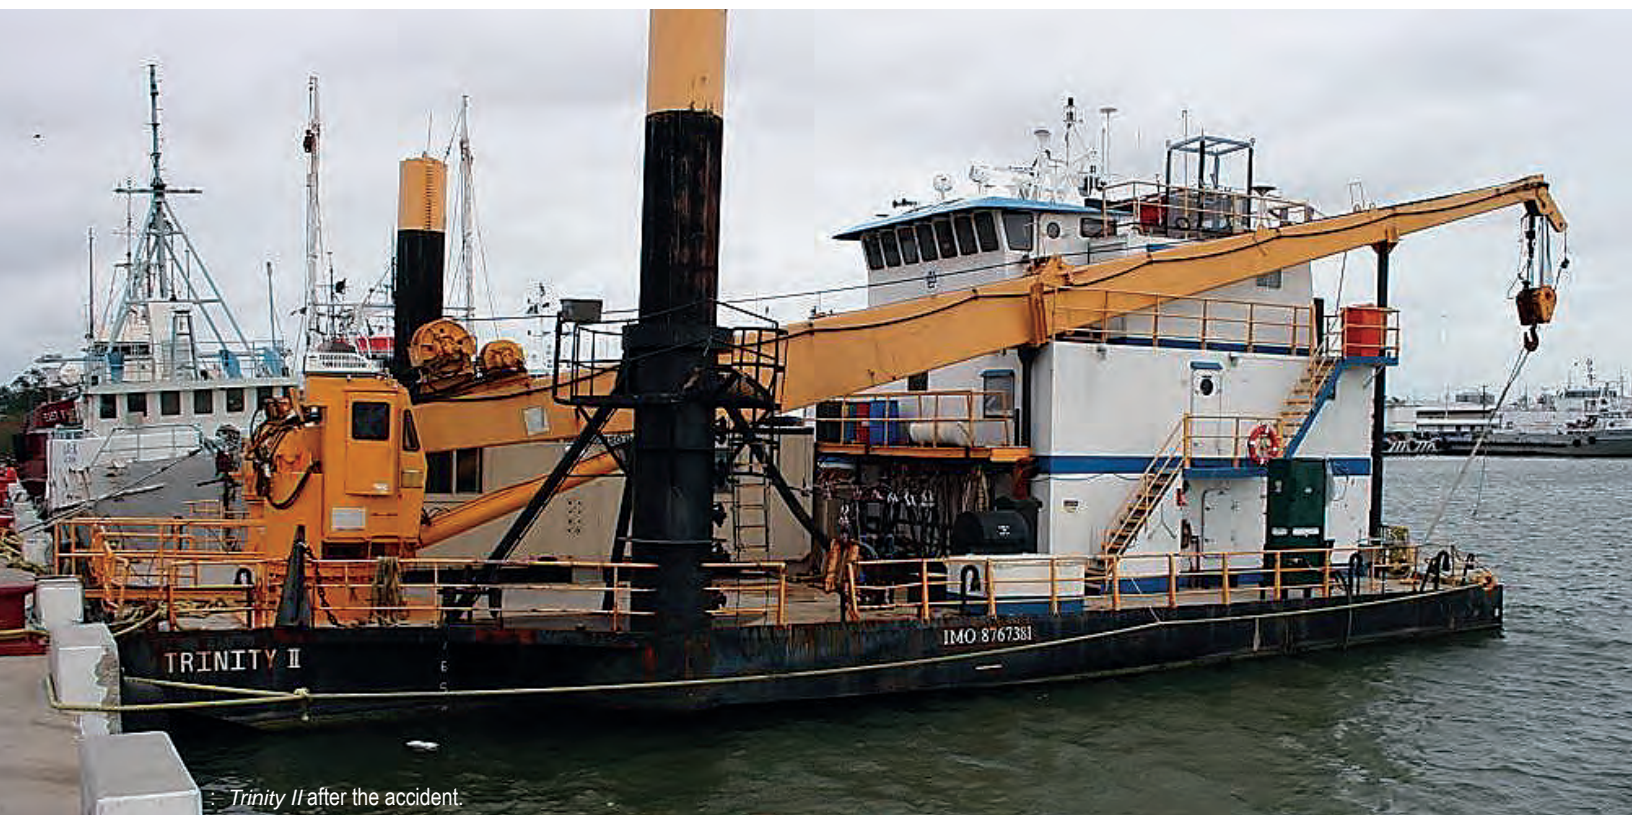
Trinity II after the accident.

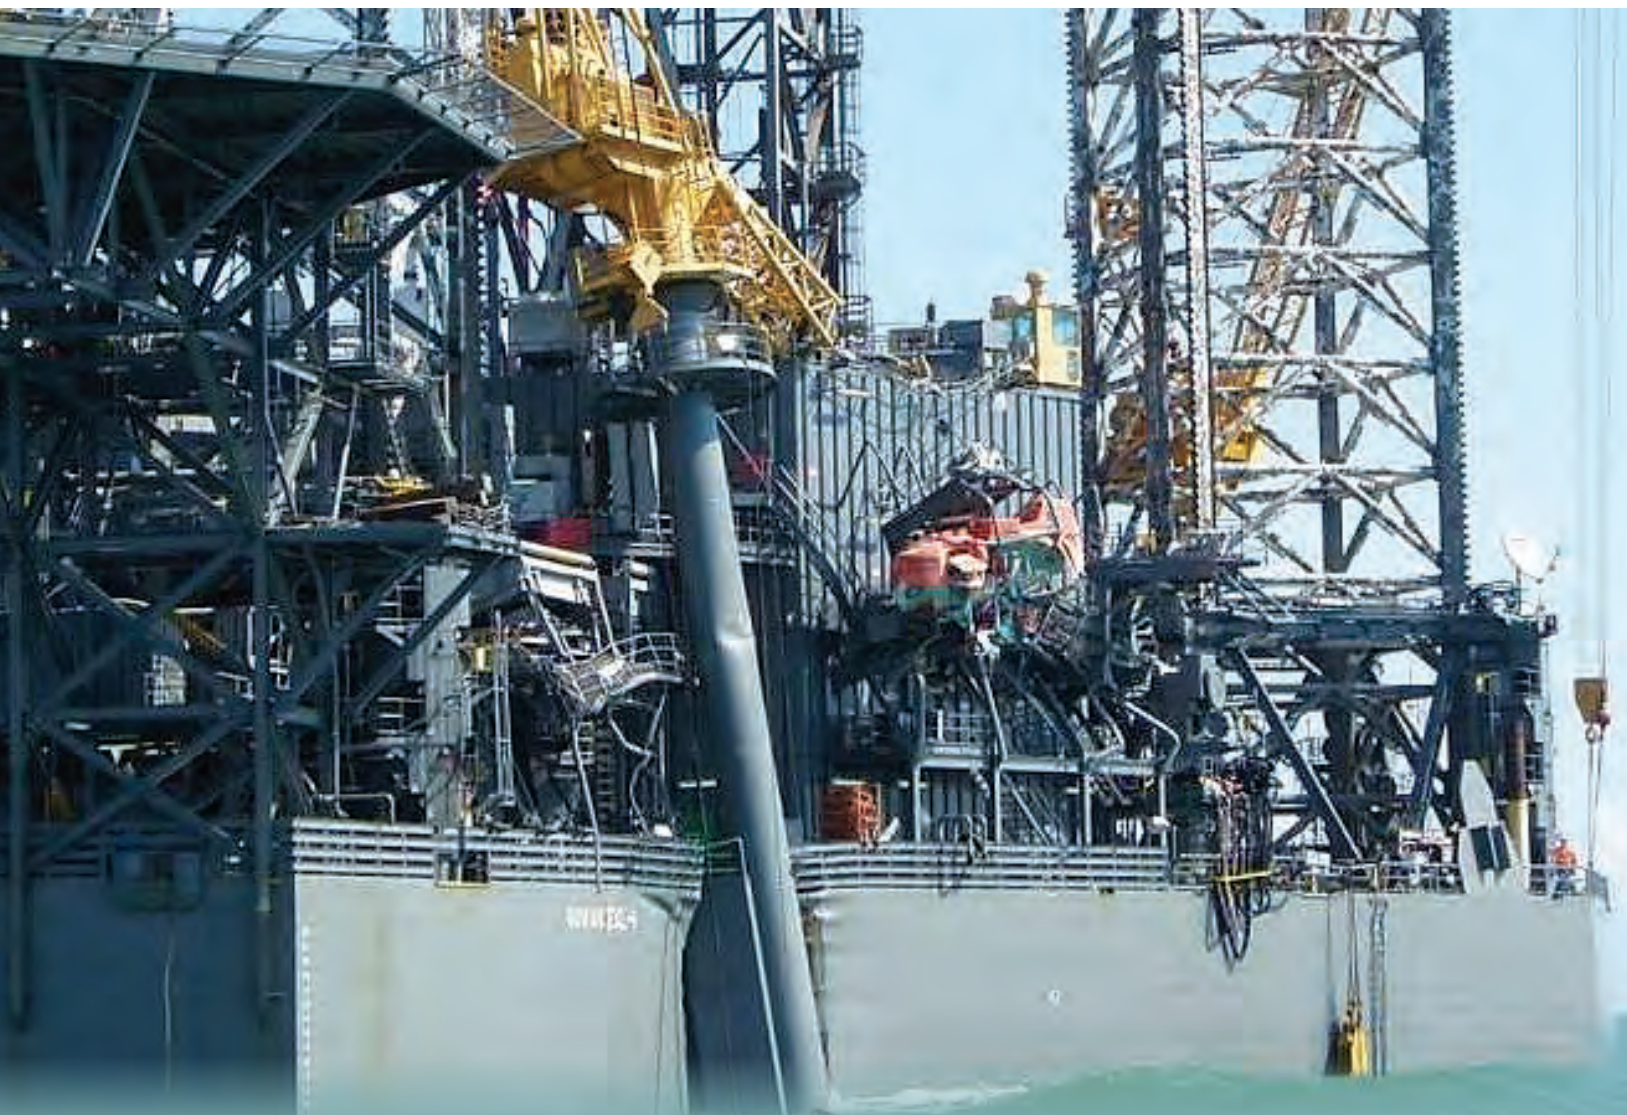
The extensive damage to the port side of the *Rowan EXL I*, including its destroyed survival crafts (orange-colored) near the center of the photo. Photo provided by the Coast Guard.

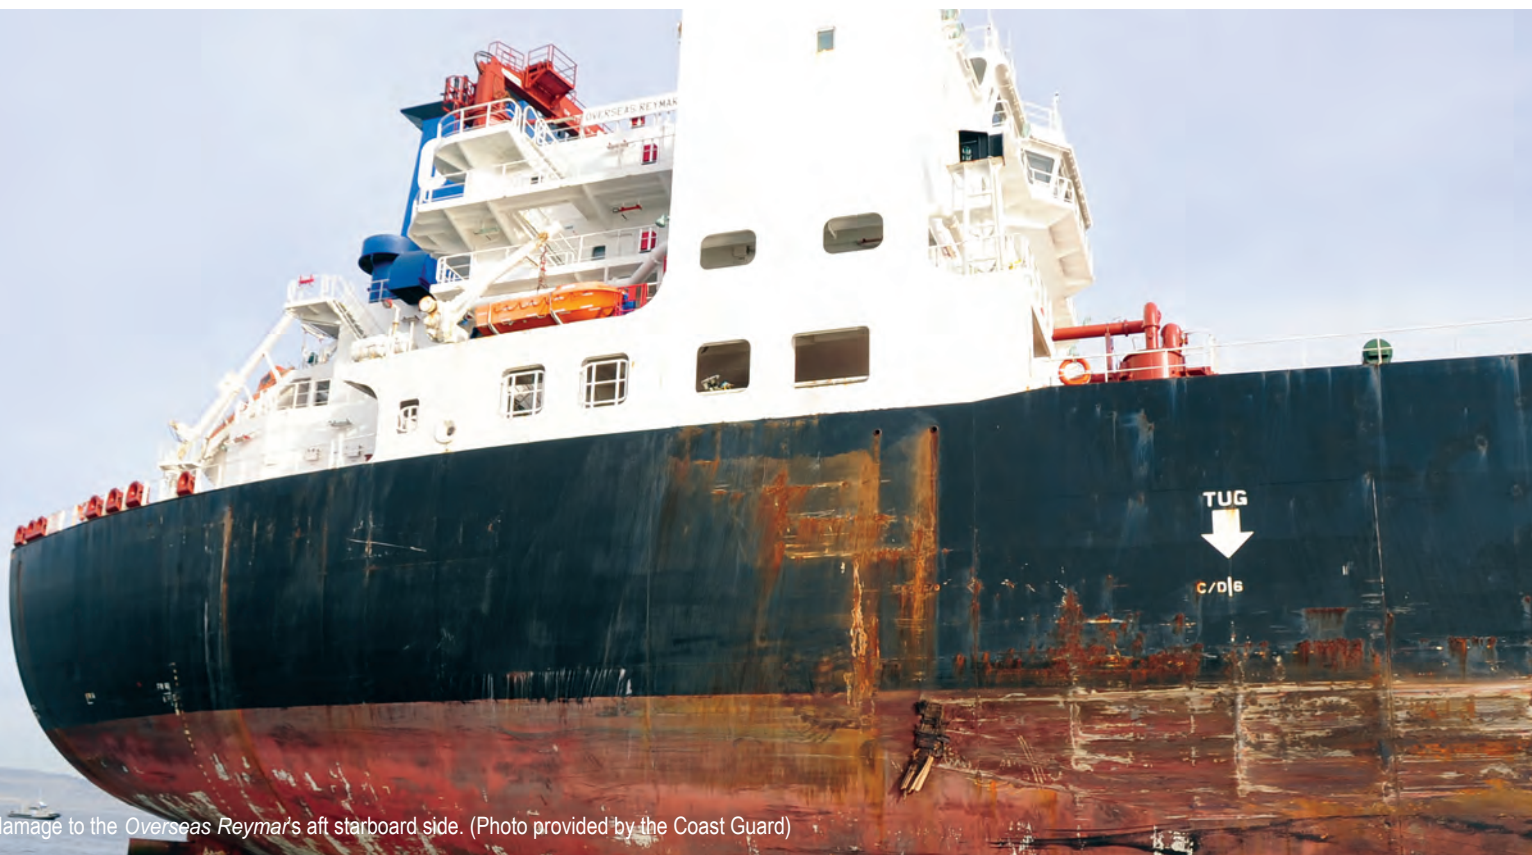
Allision damage to the *Overseas Reymar*'s aft starboard side. (Photo provided by the Coast Guard)

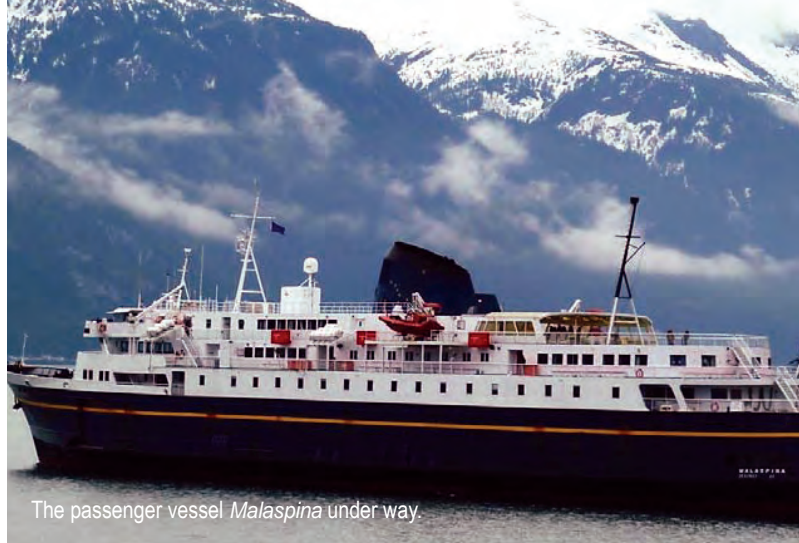
The passenger vessel *Malaspina* under way.

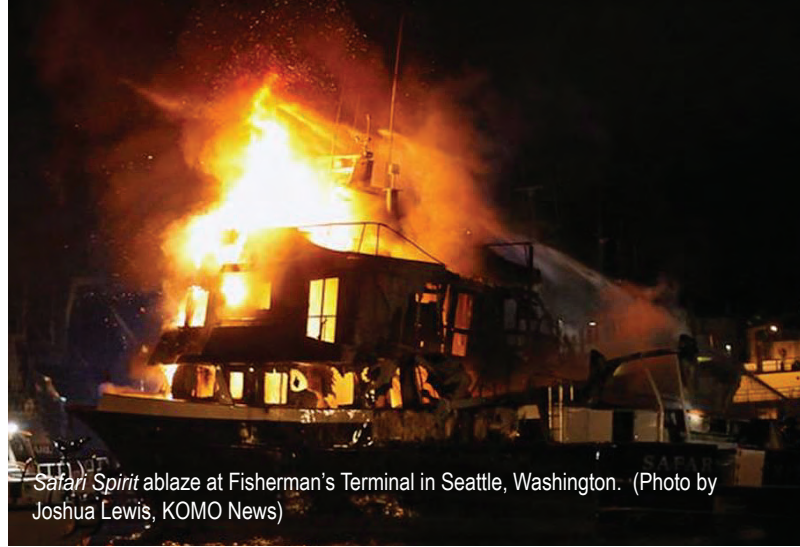
*Safari Spirit* ablaze at Fisherman’s Terminal in Seattle, Washington. (Photo by Joshua Lewis, KOMO News)

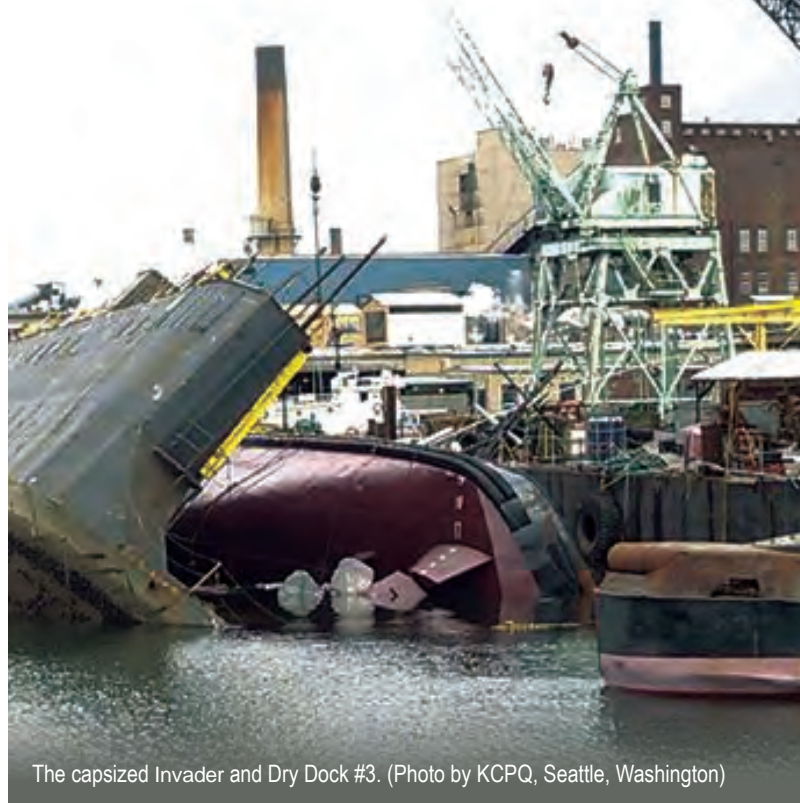
The capsized *Invader* and Dry Dock #3. (Photo by KCPQ, Seattle, Washington)

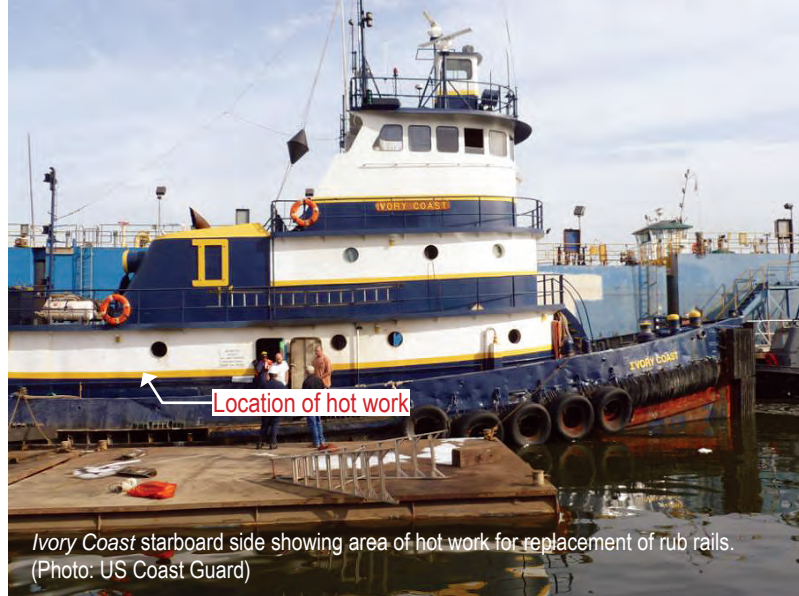
*Ivory Coast* starboard side showing area of hot work for replacement of rub rails. (Photo: US Coast Guard)

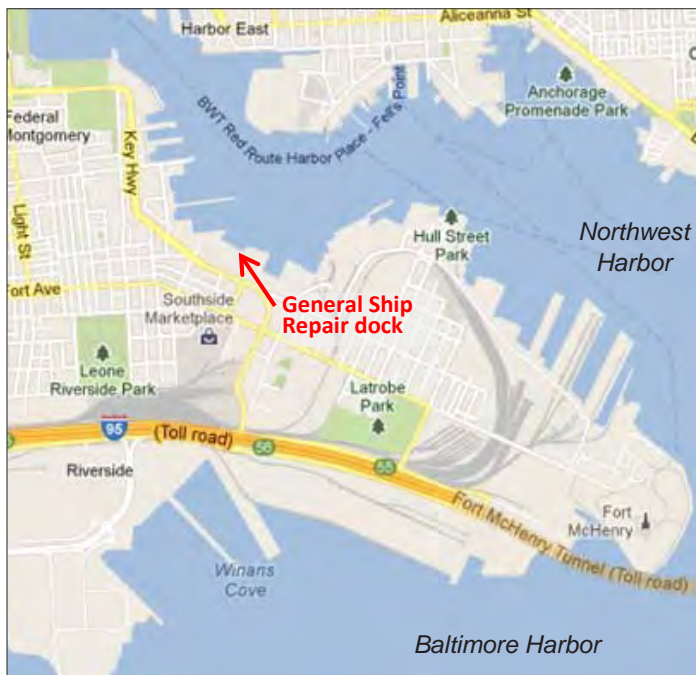
Except from National Oceanic and Atmospheric Administration Chart 12281 showing accident site in Baltimore's Northwest Harbor. (Background by Google maps)

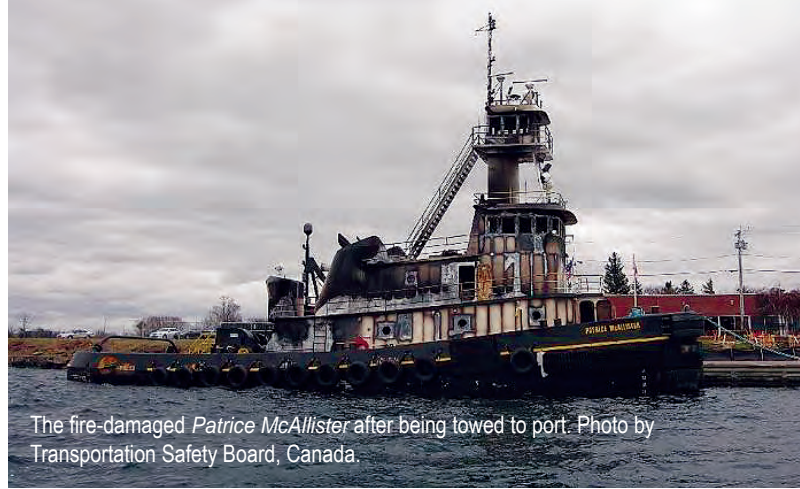
The fire-damaged *Patrice McAllister* after being towed to port. Photo by Transportation Safety Board, Canada.
