# Safer Seas 2013

LESSONS LEARNED FROM MARINE  
ACCIDENT INVESTIGATIONS

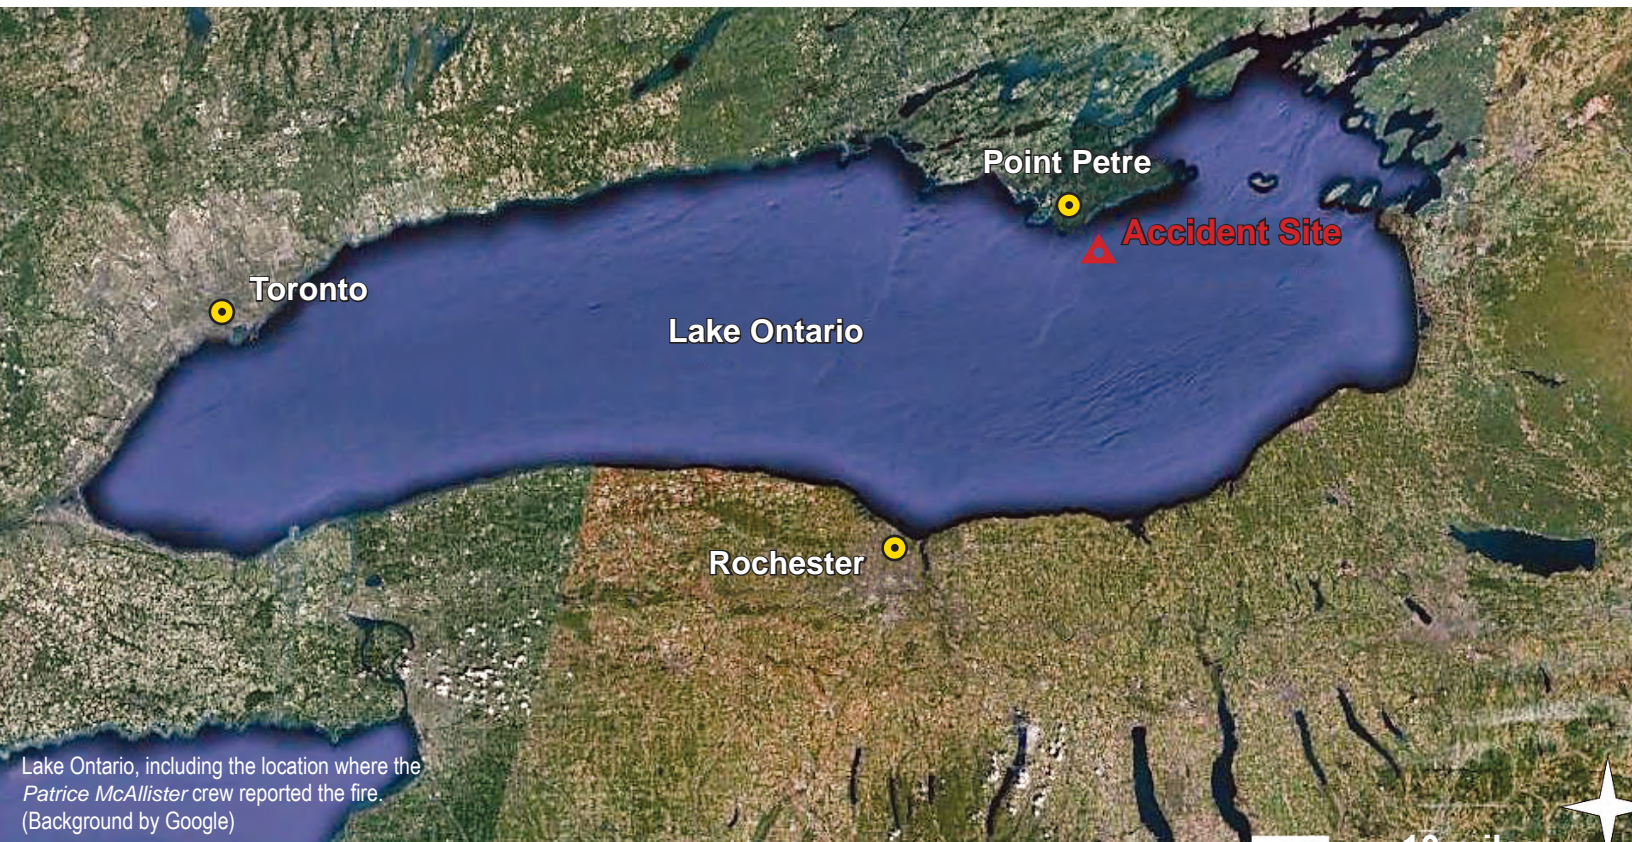
Lake Ontario, including the location where the *Patrice McAllister* crew reported the fire. (Background by Google)
