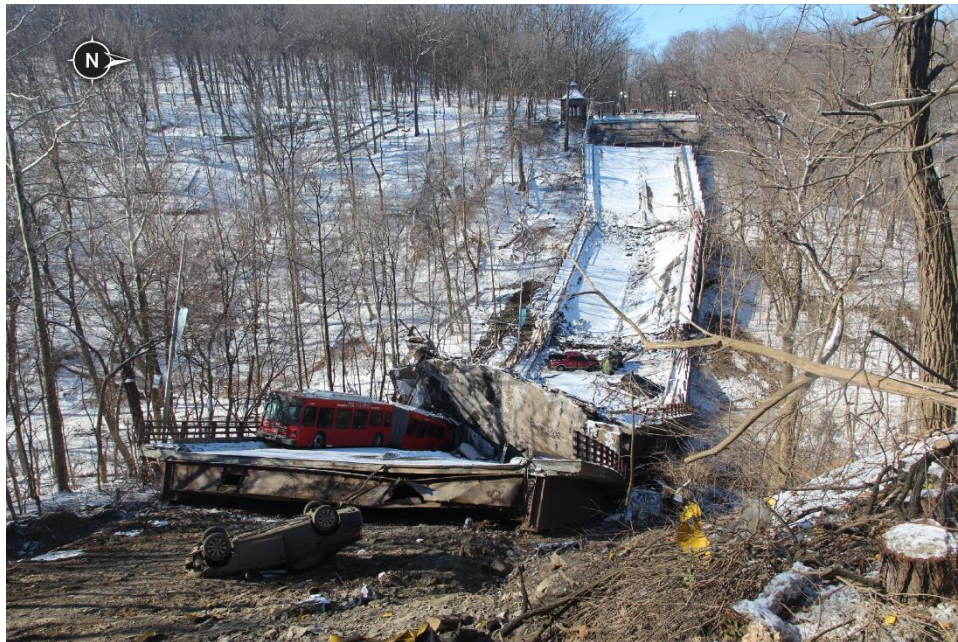
Figure 1. West-looking view of collapsed Fern Hollow Bridge.

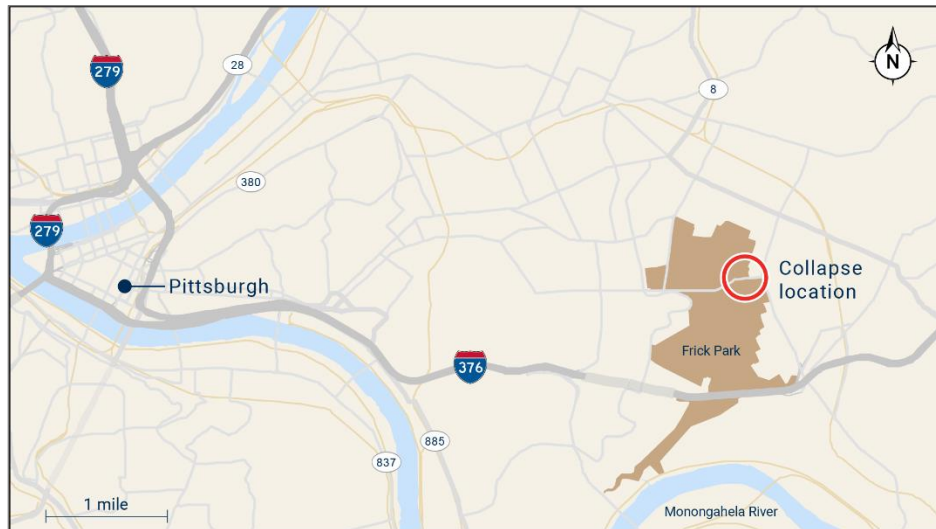
Figure 2. Map of collapse location. (Source: Google Maps; modified by the National Transportation Safety Board)

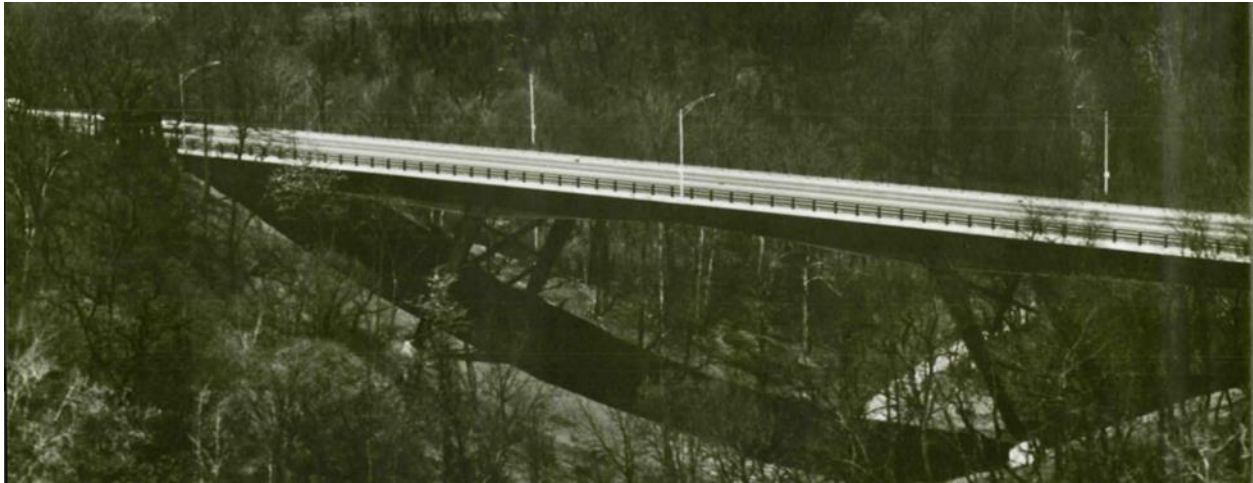
Figure 5. 1973 Fern Hollow Bridge (Source: National Steel Bridge Alliance, [1974 Prize Bridges](#)).

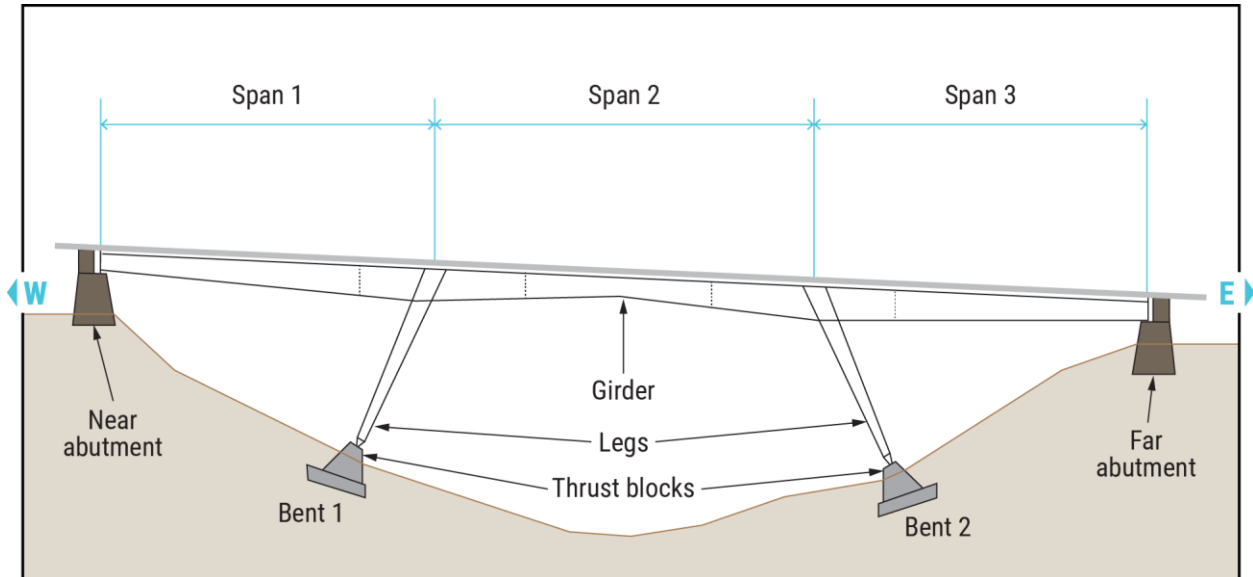
Figure 6. Simplified side (elevation) view of K-frame structure of Fern Hollow Bridge (looking north). Bents 1 and 2 were composed of two legs each; only the southwest and southeast legs are visible in this diagram.

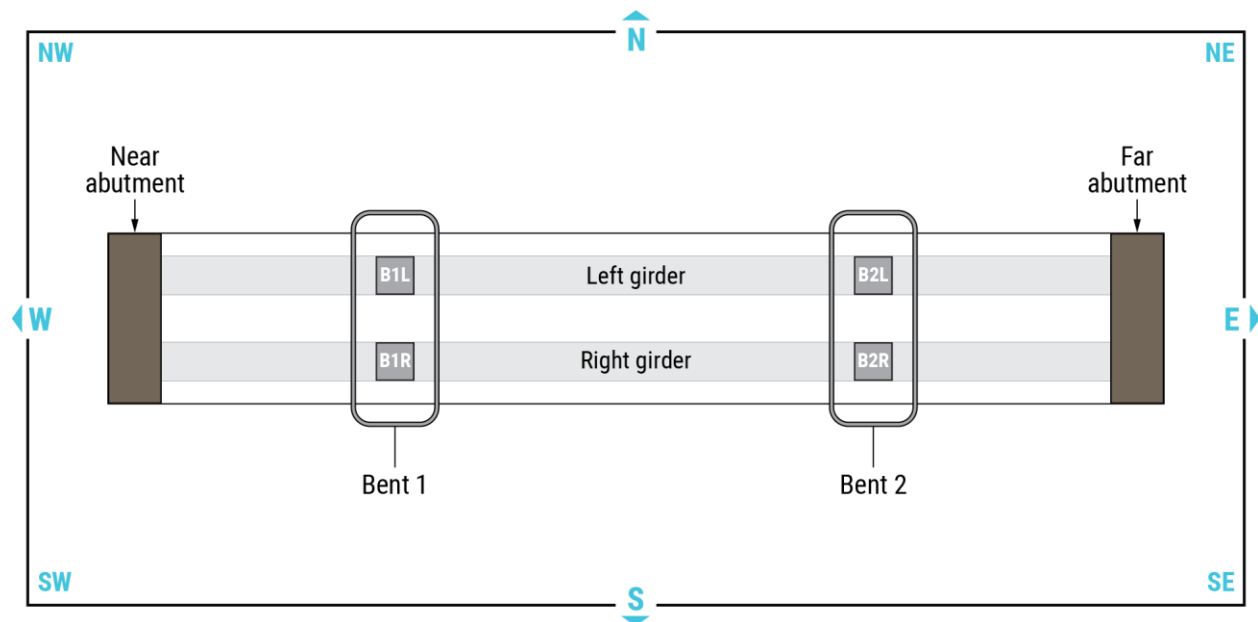
Figure 7. Simplified overhead view of bridge structure.

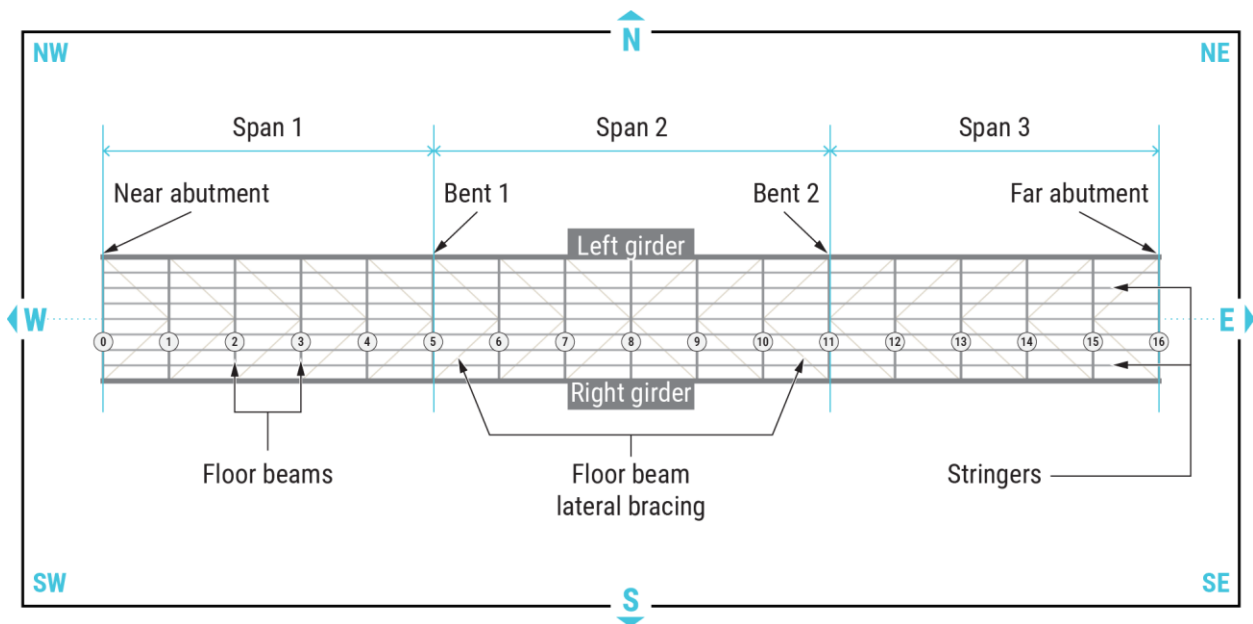
Figure 8. Overhead view of Fern Hollow Bridge showing floor beams and spans. The floor beams were numbered sequentially from left to right, with floor beam 0 positioned directly above the west (near) abutment and floor beam 16 positioned directly above the east (far) abutment.

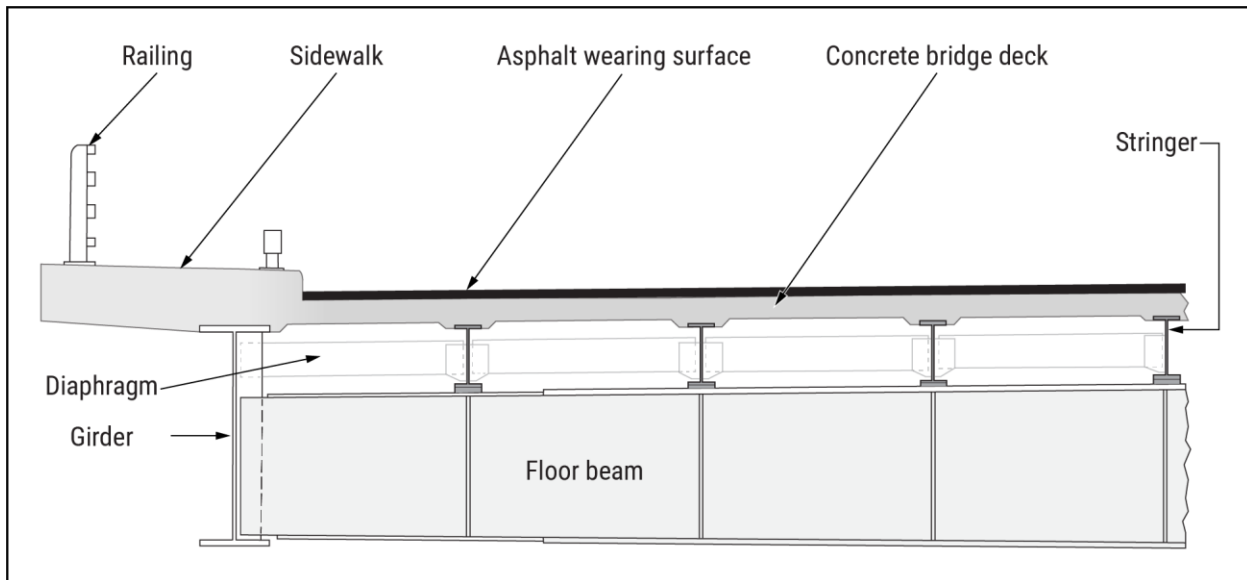
Figure 9. Half-section diagram of Fern Hollow Bridge.¹⁷

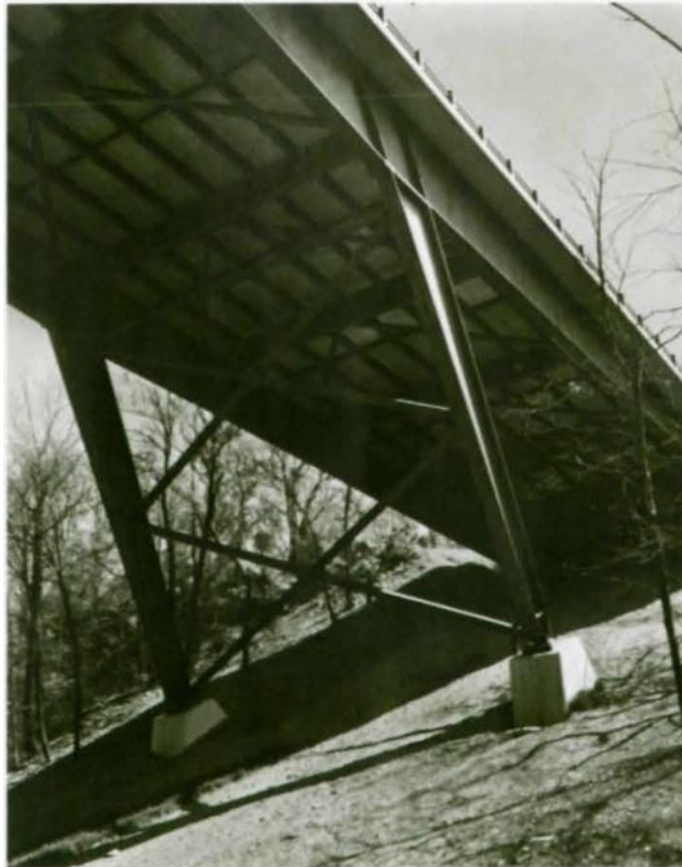
Figure 12. Bent of the Fern Hollow Bridge as originally built. (Source: National Steel Bridge Alliance, [1974 Prize Bridges](#))

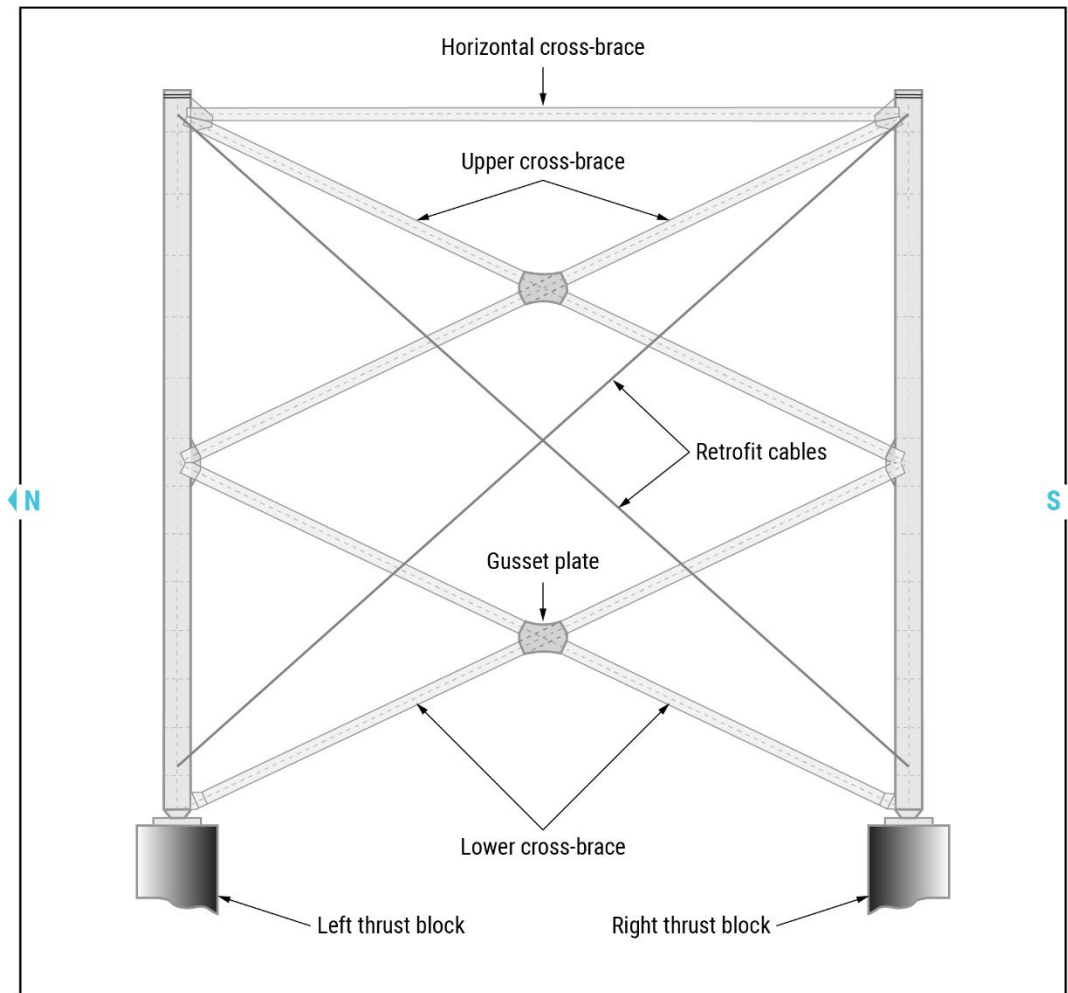
Figure 13. Elevation view of west (near) face of a Fern Hollow Bridge bent, showing original cross-bracing and retrofit cables.

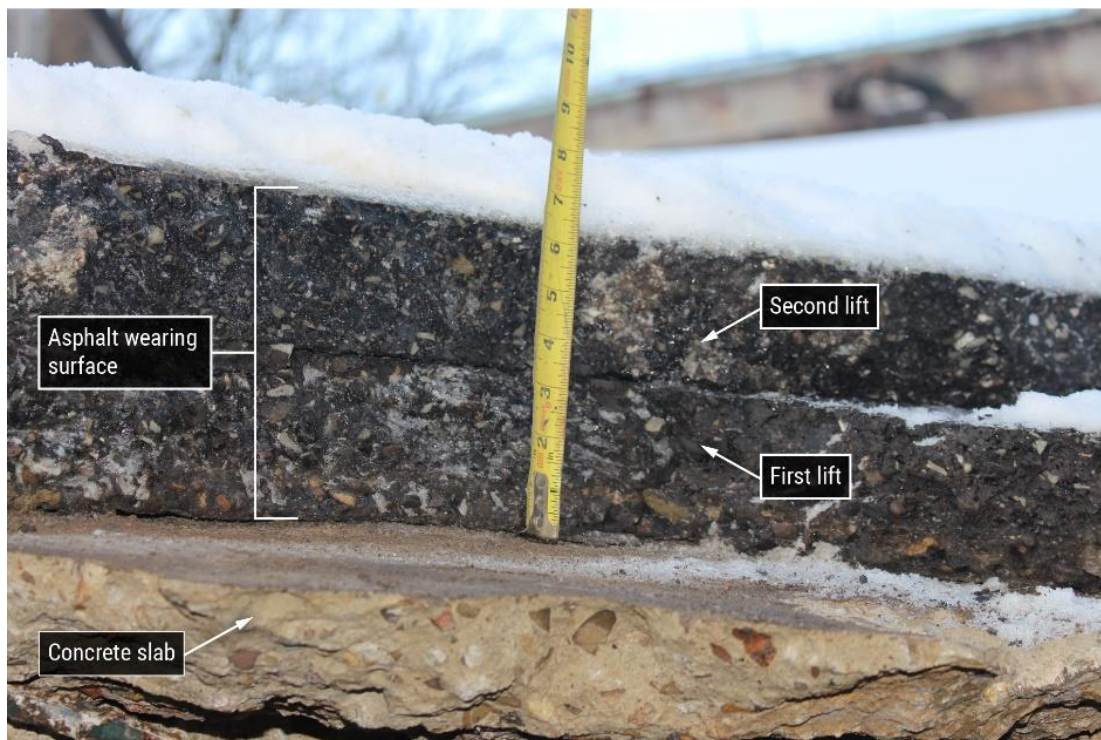
Figure 16. Photograph showing asphalt wearing surface atop reinforced concrete bridge deck in the left eastbound lane near the southwest leg.

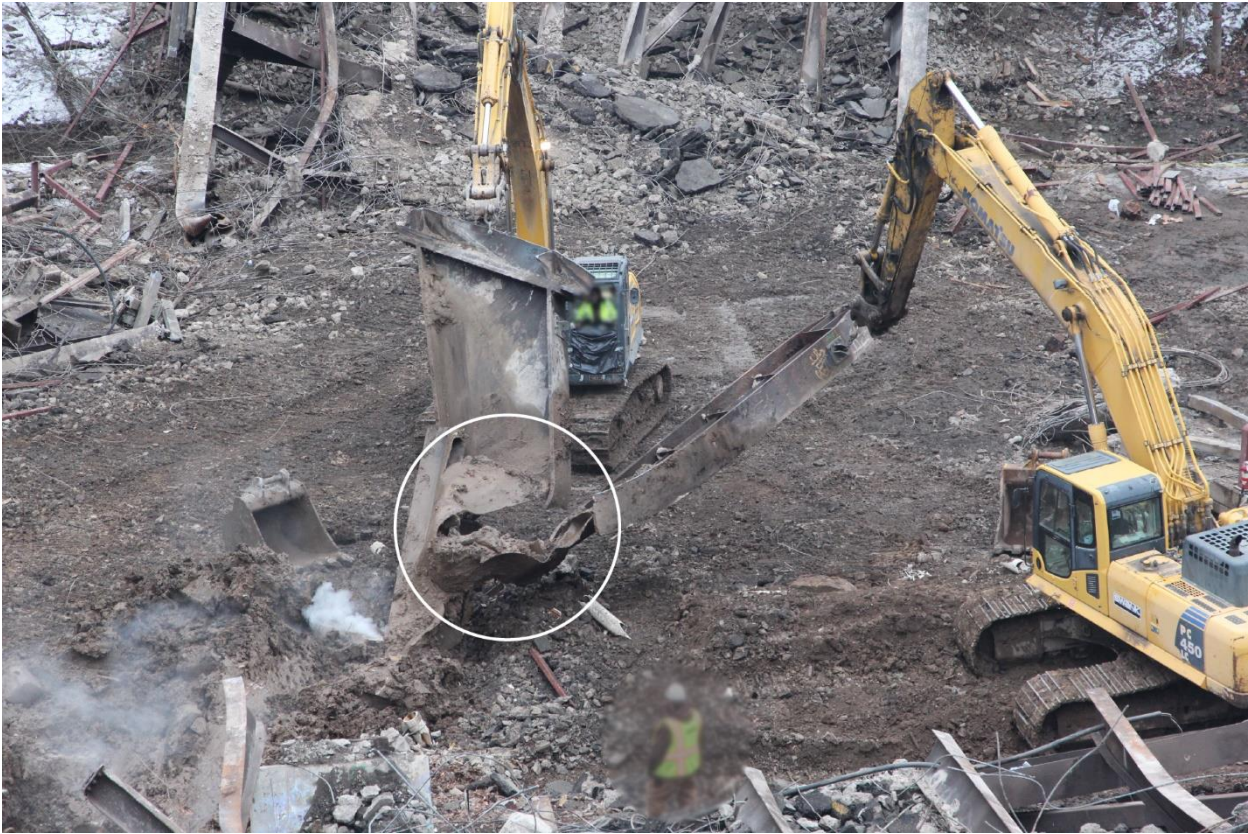
Figure 17. East-looking view of northwest leg (B1L) after excavation, folded back on itself.

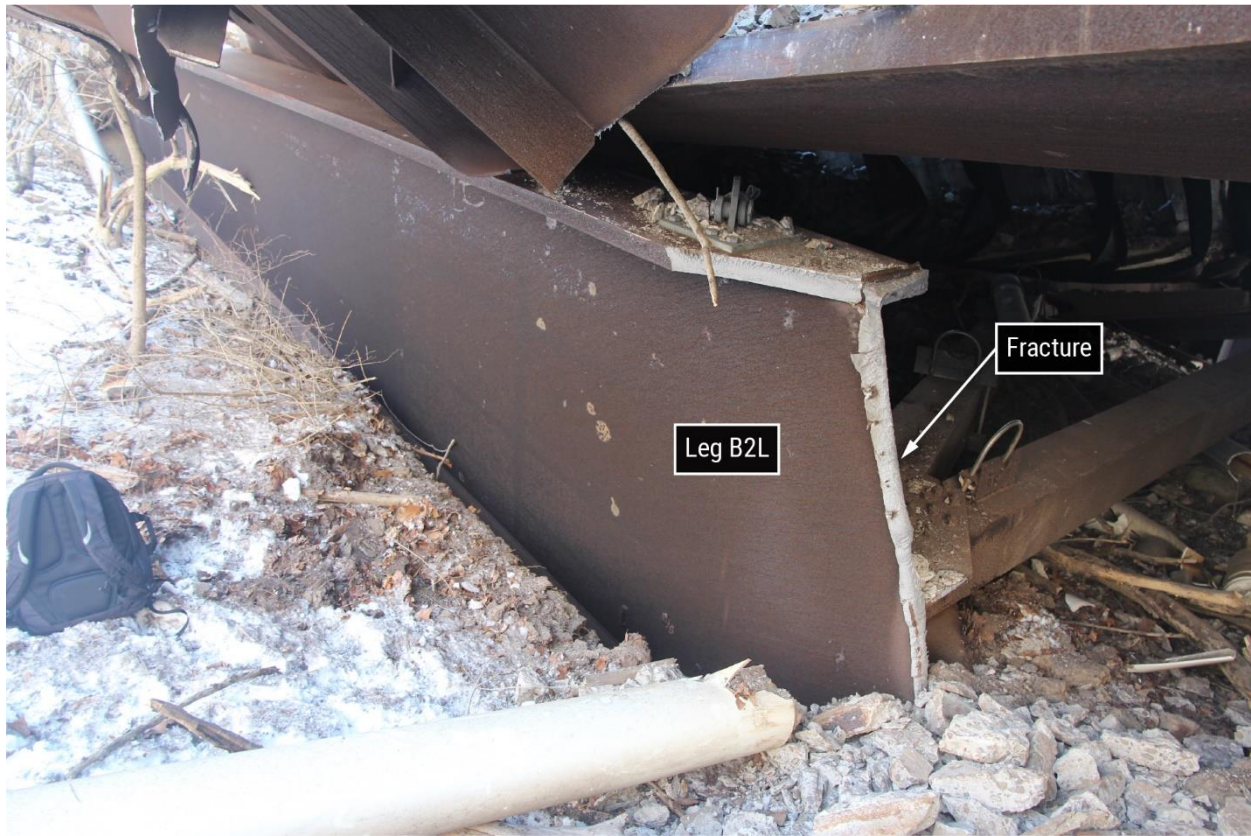
Figure 19. East-southeast–looking view of northeast leg (B2L), showing fracture from the end plate (the end plate is not visible in the photograph).

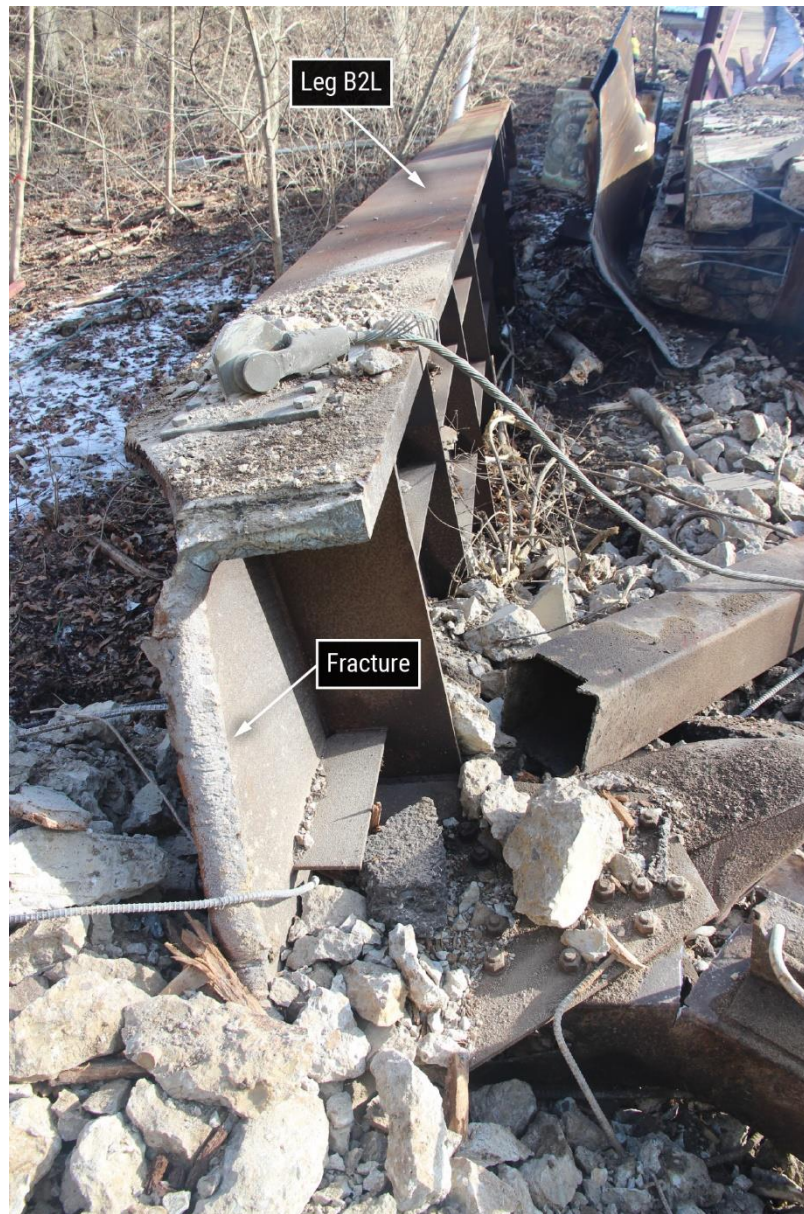
Figure 20. East-looking view of northeast leg (B2L) showing that the leg was intact below the fracture between the end plate and the top of the leg (the end plate is not visible in the photograph).

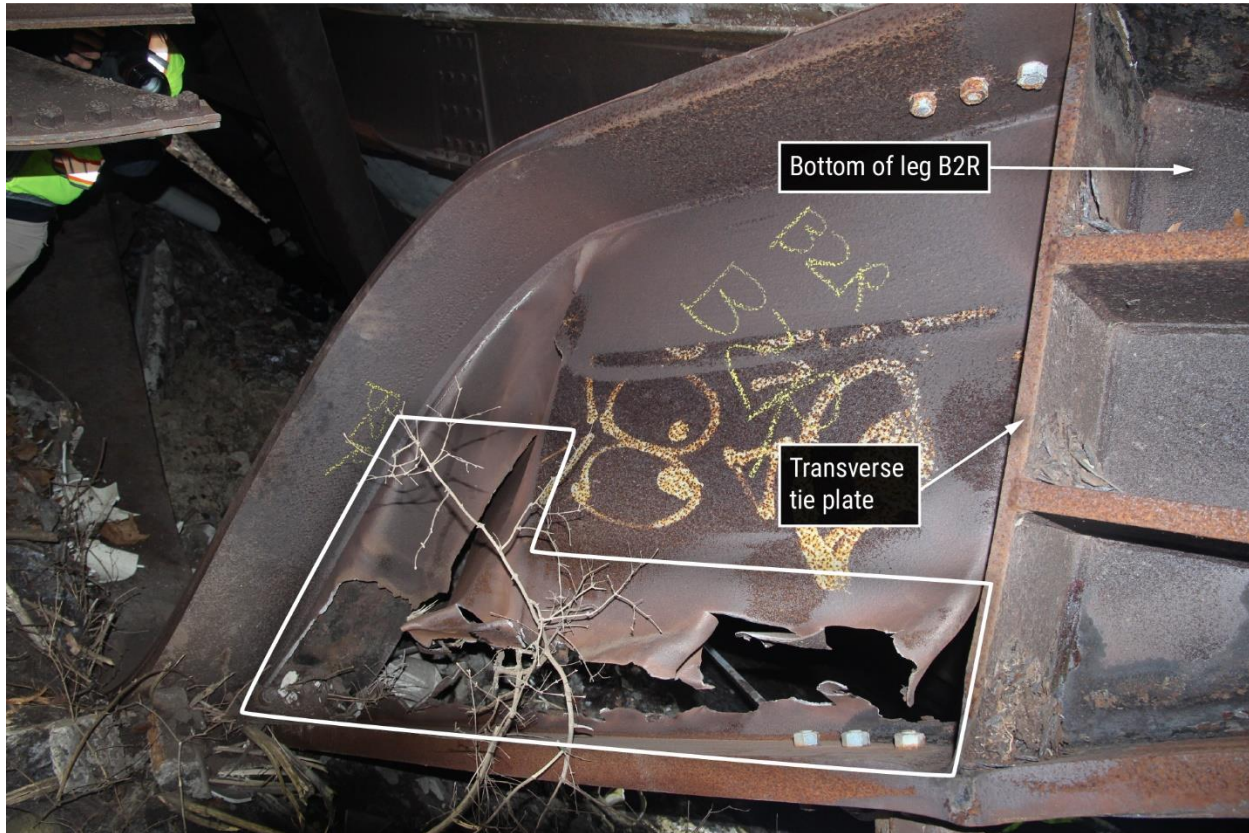
Figure 21. North-northwest-looking view of southeast leg (B2R) showing secondary fracture of the web, outlined in white.

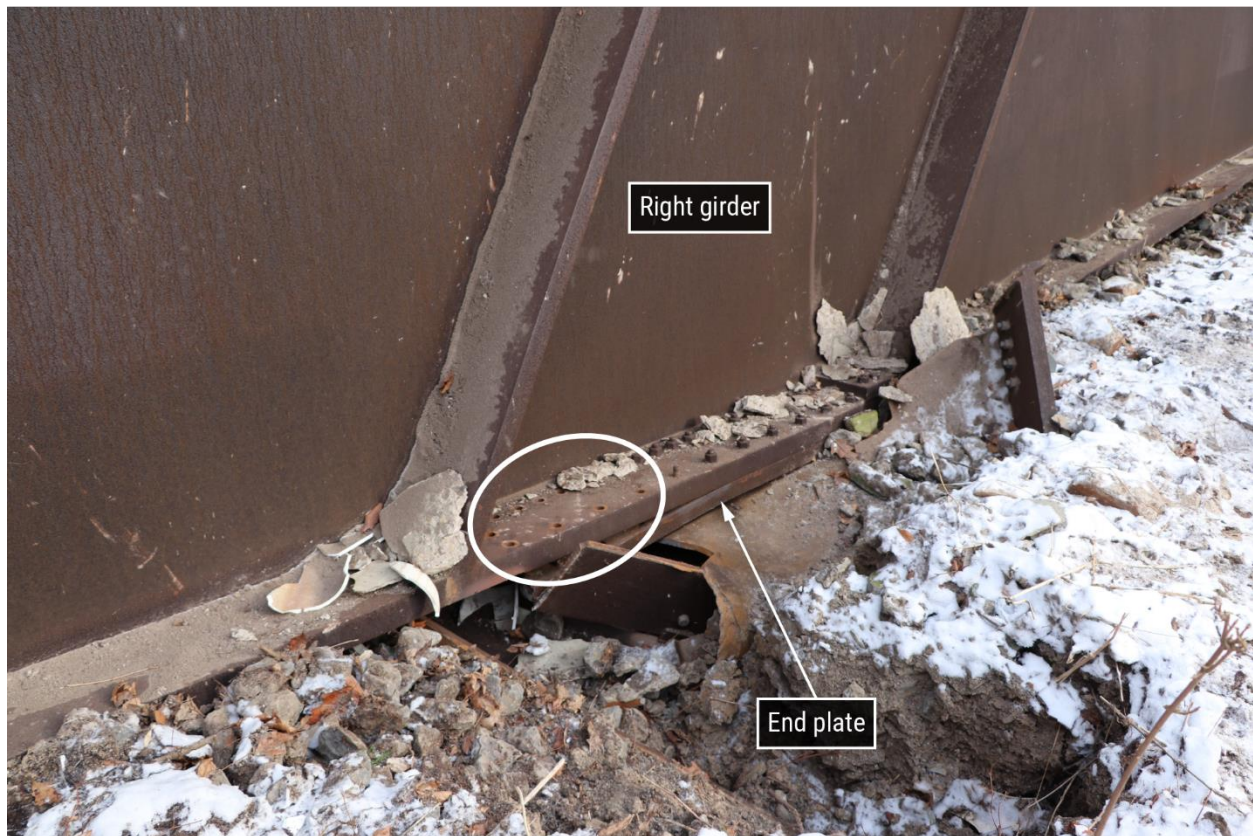
Figure 22. North-northeast–looking view of southwest leg (B1R) end plate still partially connected to south (right) girder. Several connecting bolts and their nuts were missing (white oval).

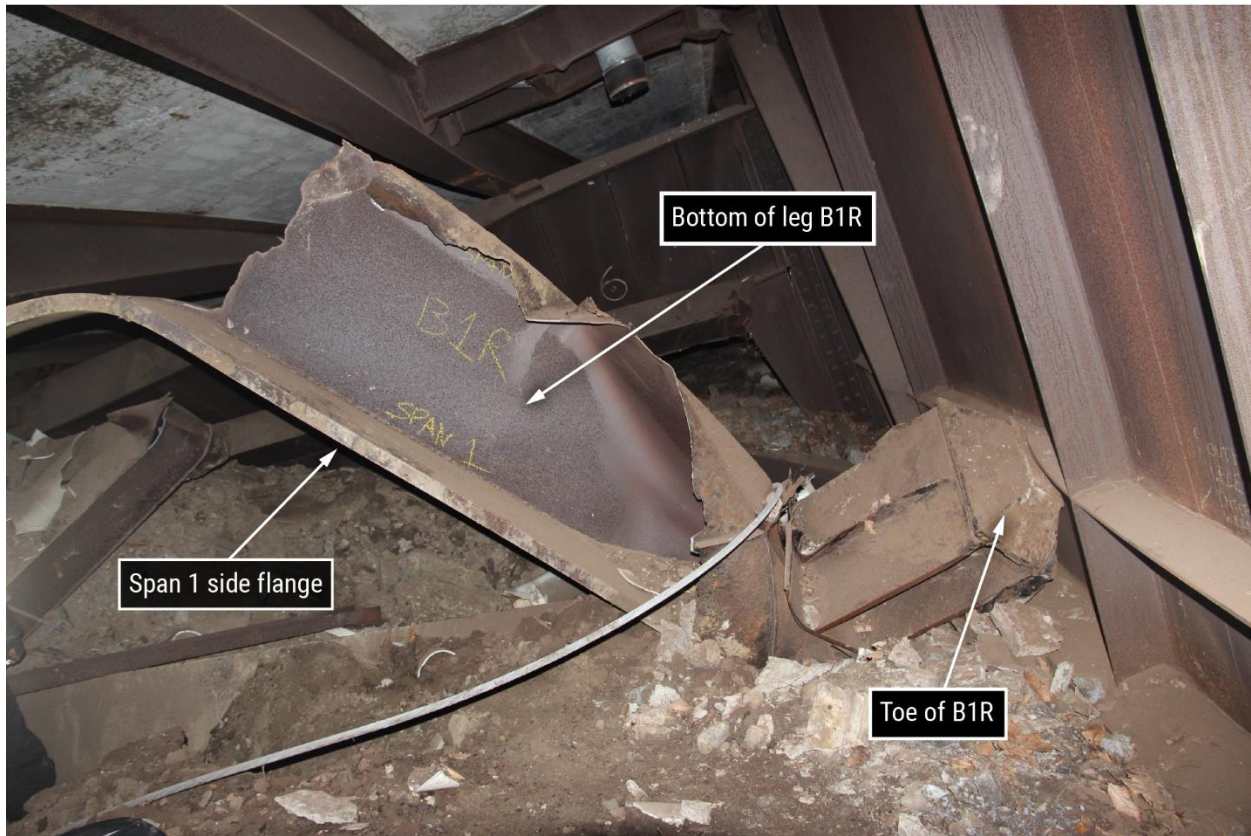
Figure 23. East-looking view of lower portion of southwest leg (B1R) underneath the collapsed structure.

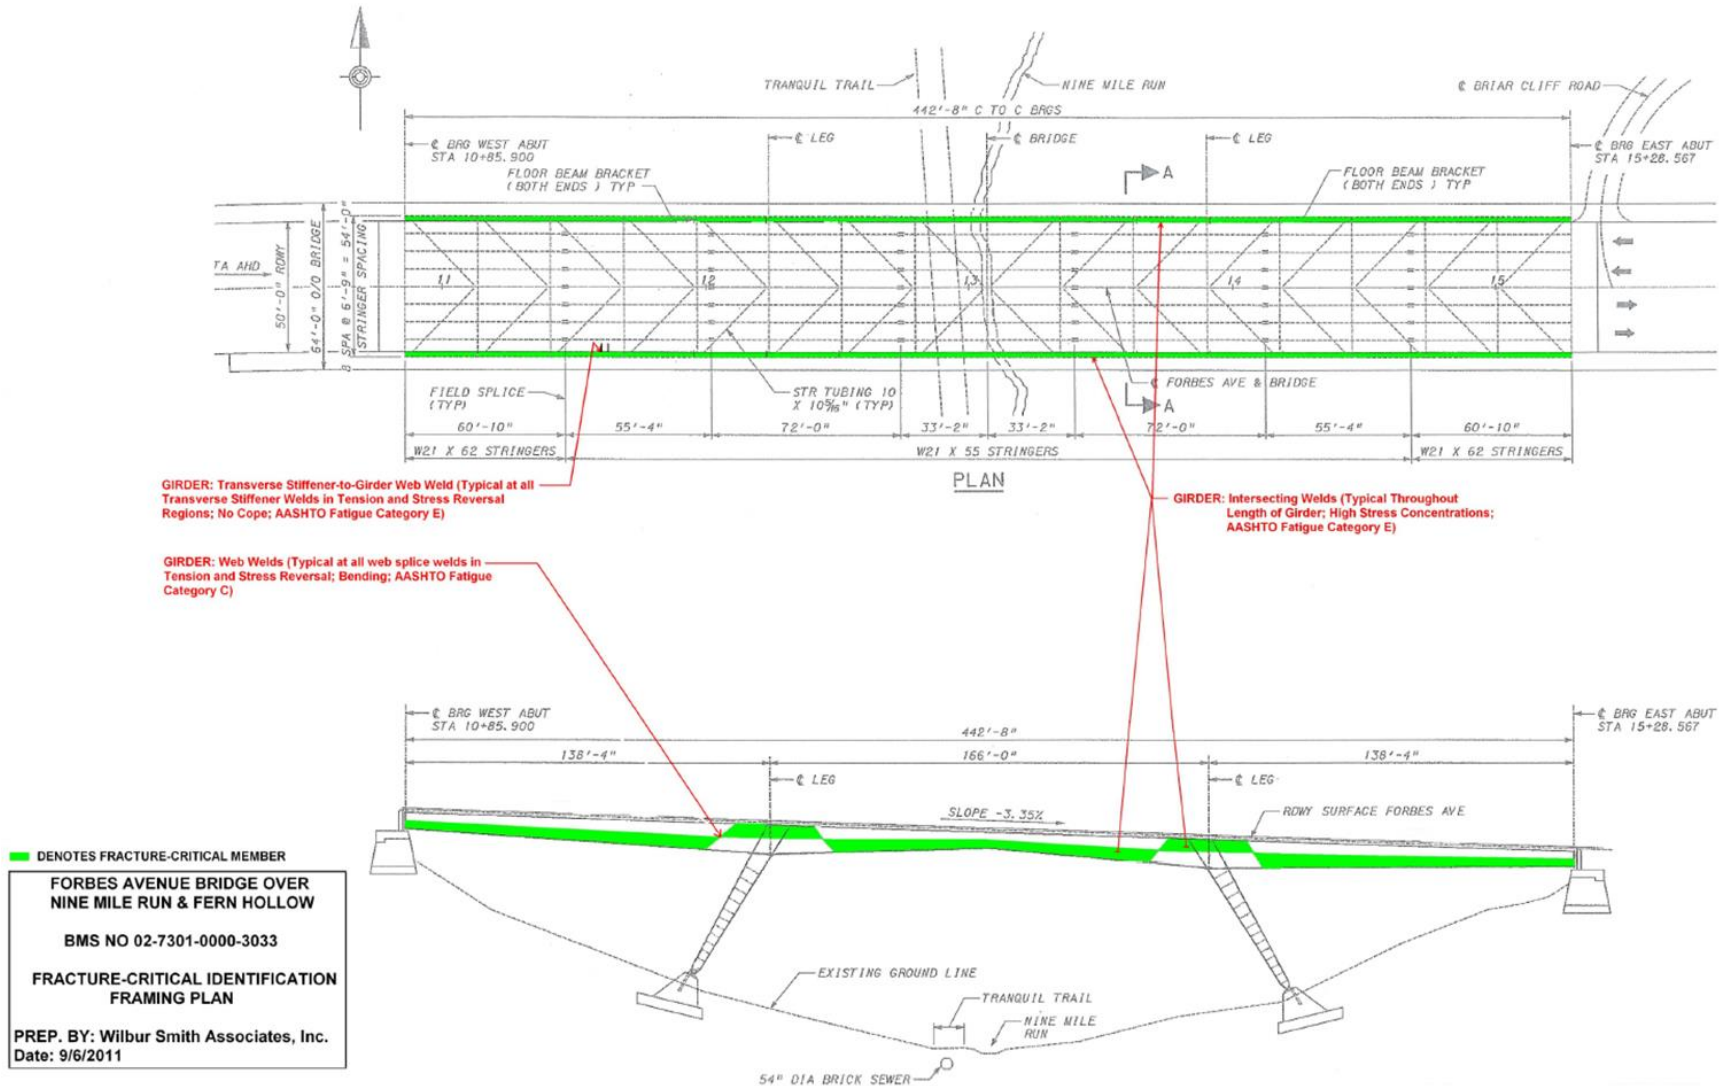
1
2 **Figure 26.** Fracture-Critical Identification Framing Plan developed in 2011 and included in the 2011, 2013, and 2015 inspection
3 reports. (Source: FHWA)

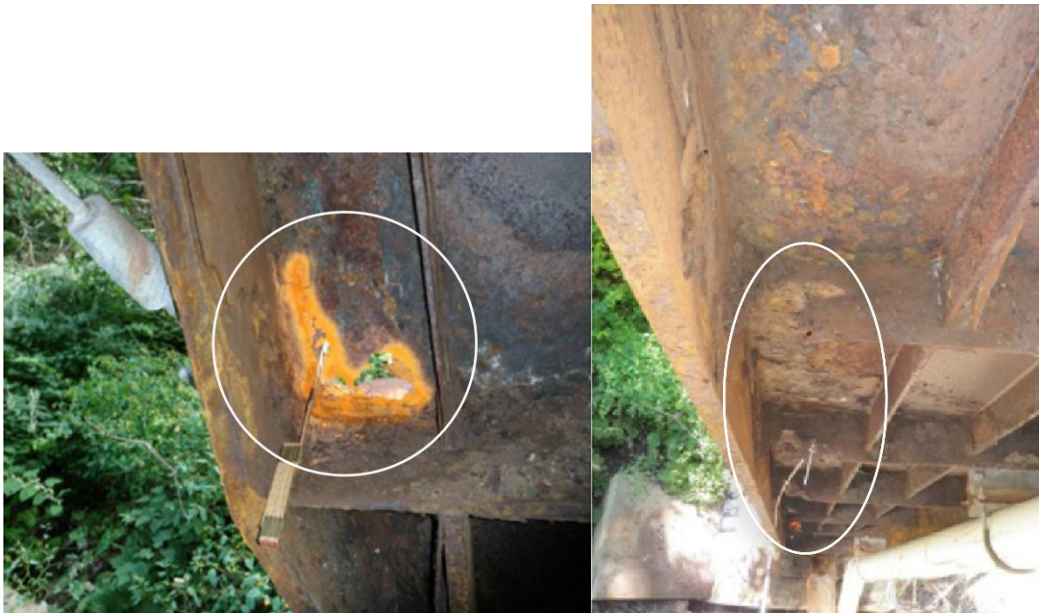
Figure 28. Corrosion of inside face of southwest leg (B1R). (Source: 2013 inspection report)

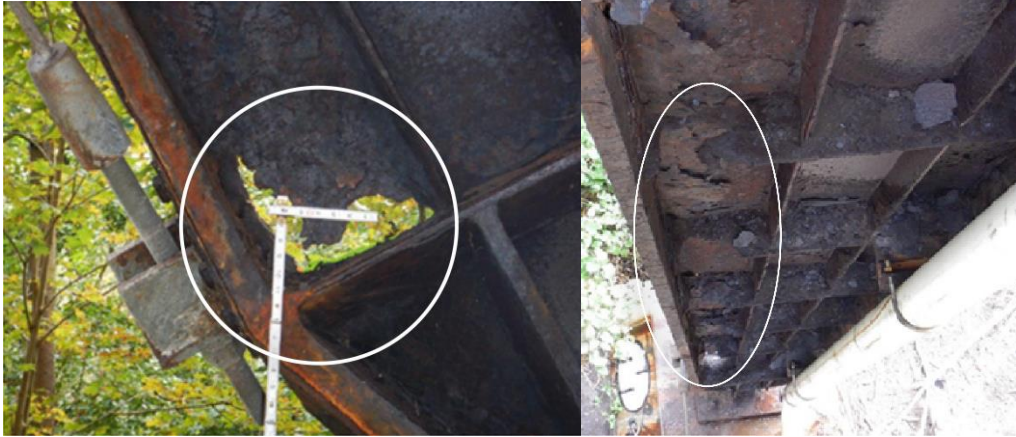
Figure 29. Corrosion of inside face of southwest leg (B1R). (Source: 2021 inspection report)

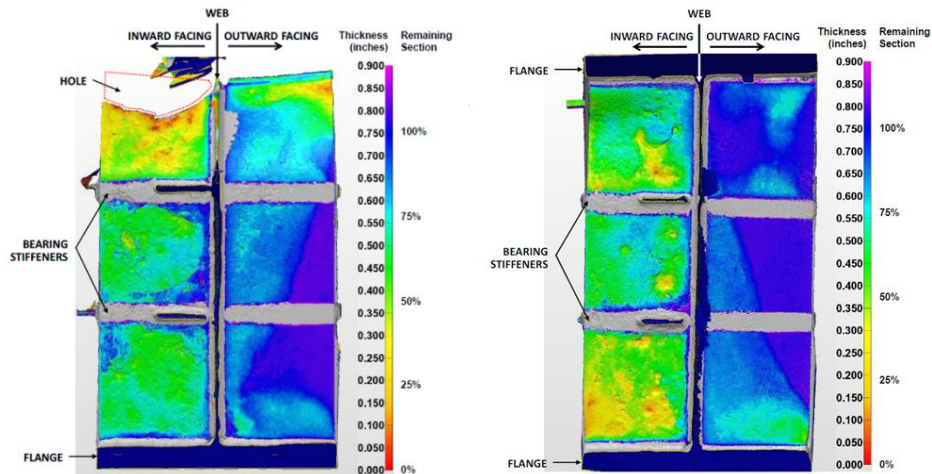
Figure 36. Comparison of southwest leg (B1R) transverse tie plate (left) and southeast leg (B2R) transverse tie plate (right).

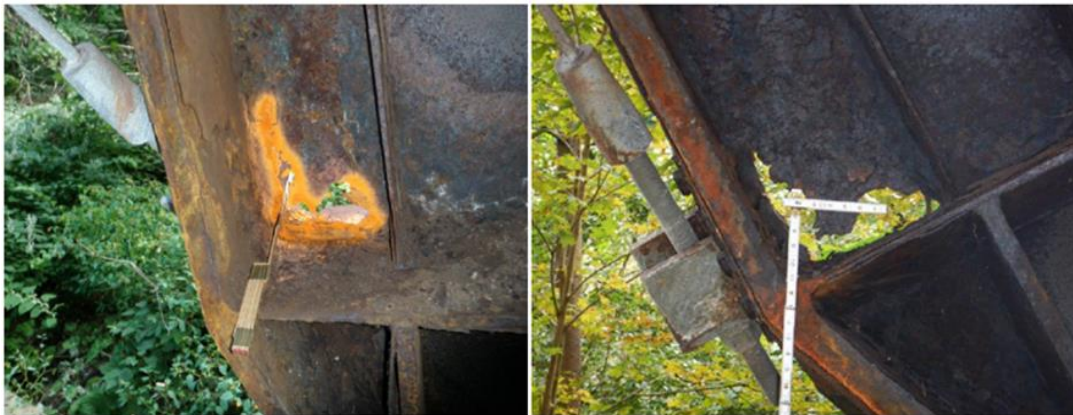
Figure 37. Corrosion damage including areas of 100% section loss on southwest leg (B1R) in panel 1 above the transverse tie plate. (Source: 2013 inspection report [left photograph]; 2021 inspection report [right photograph])

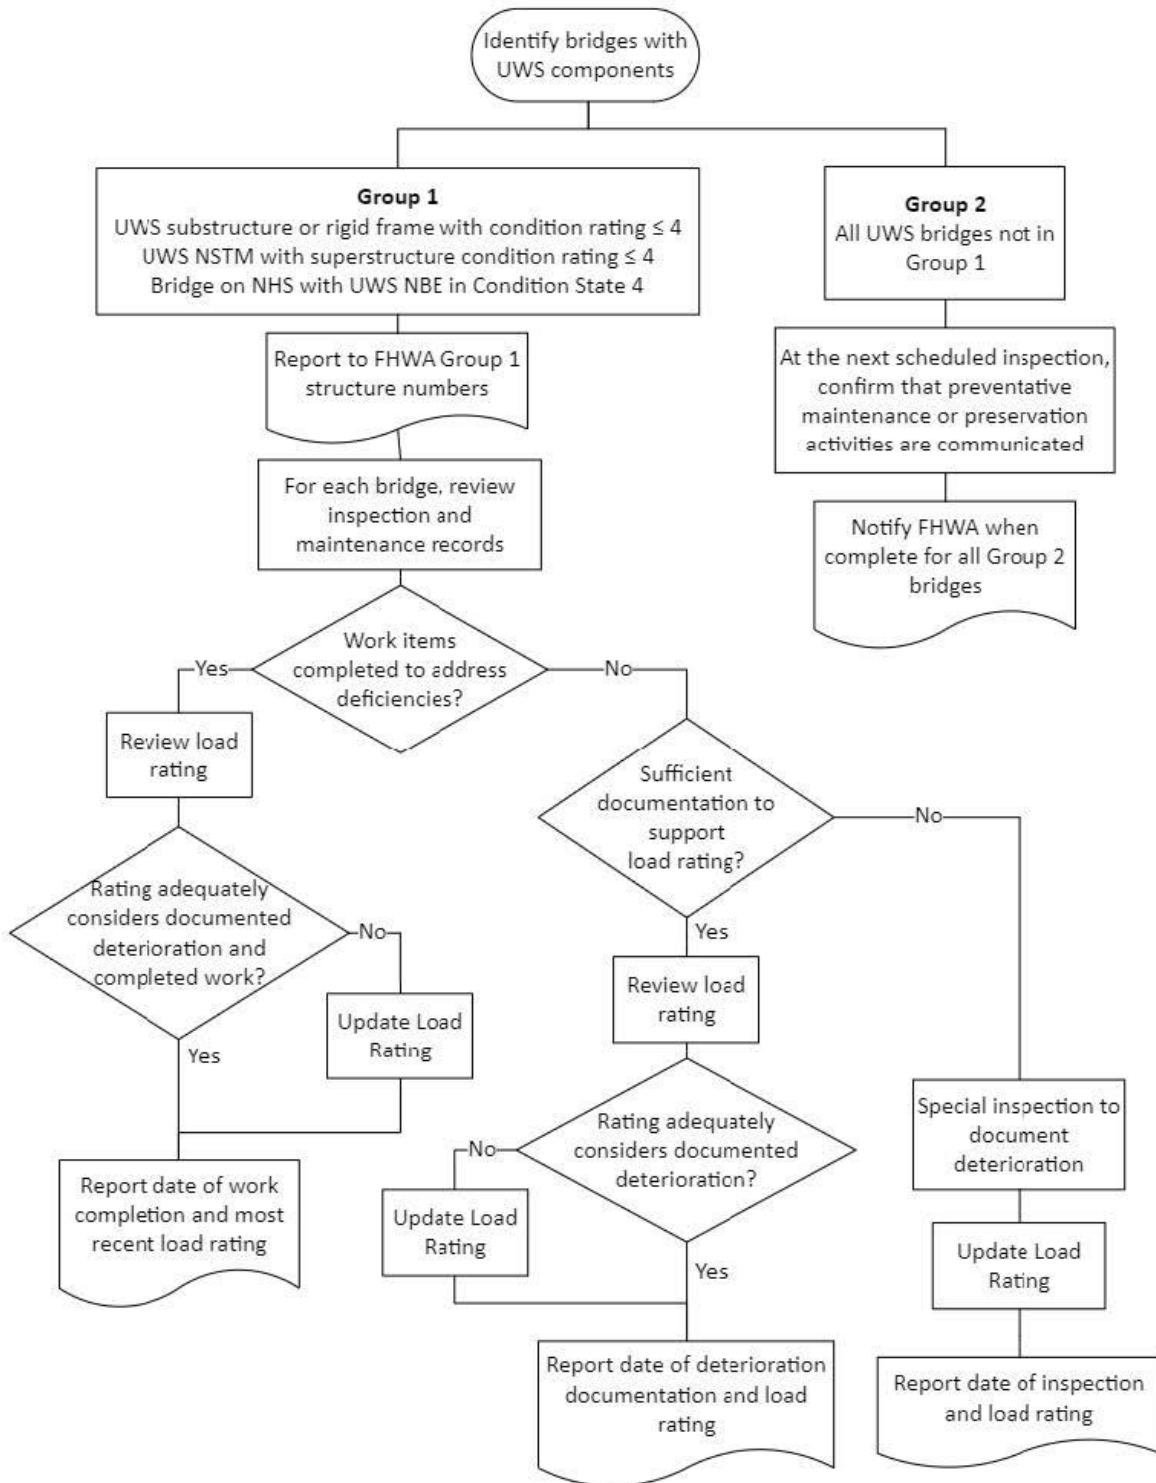
Figure 38. FHWA process to inspect, inventory, and evaluate bridges and bridge components fabricated from UWS. (Source: FHWA 2023b)
