Taxiway Overflight  
Air Canada Flight 759  
Airbus A320-211, C-FKCK  
San Francisco, California  
July 7, 2017

**Incident Report**

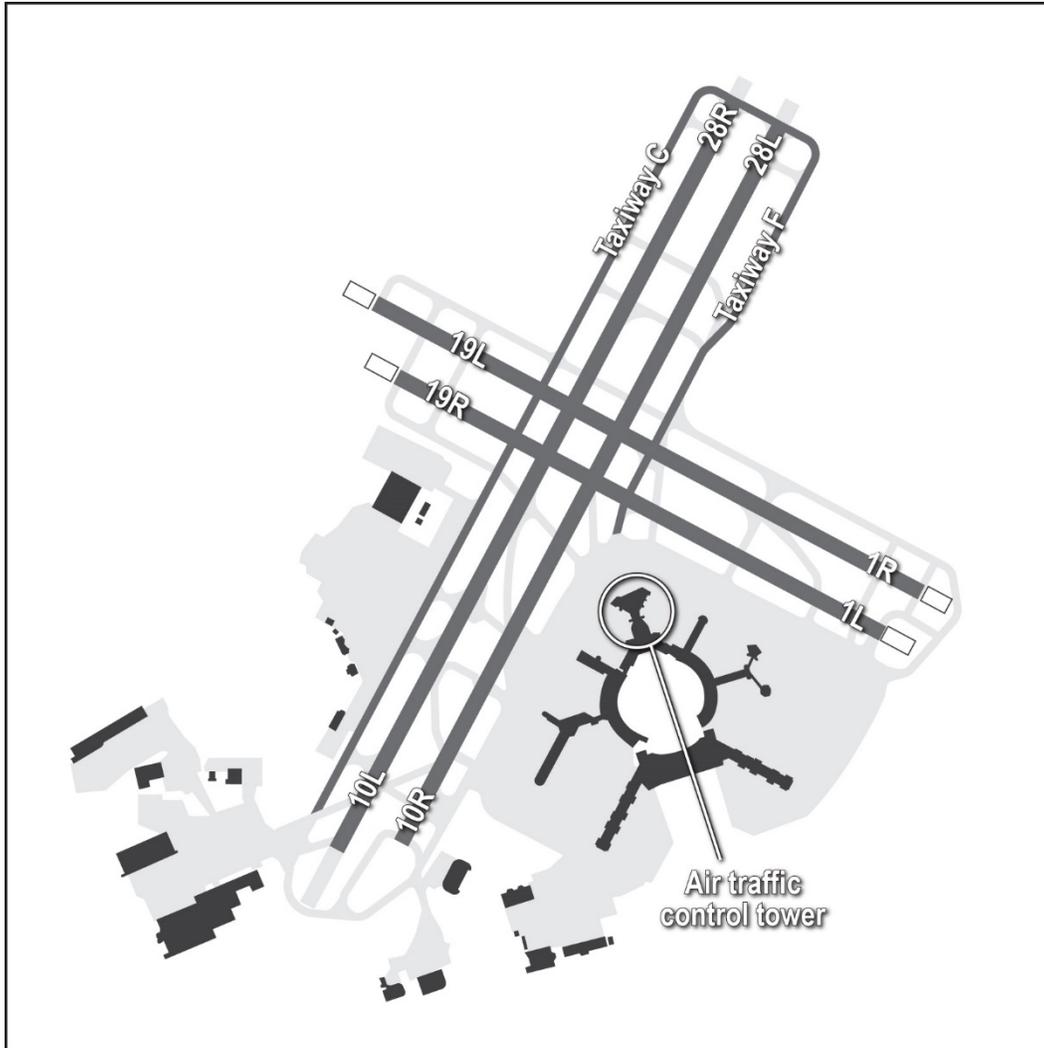
**Figure 3.** SFO layout map.

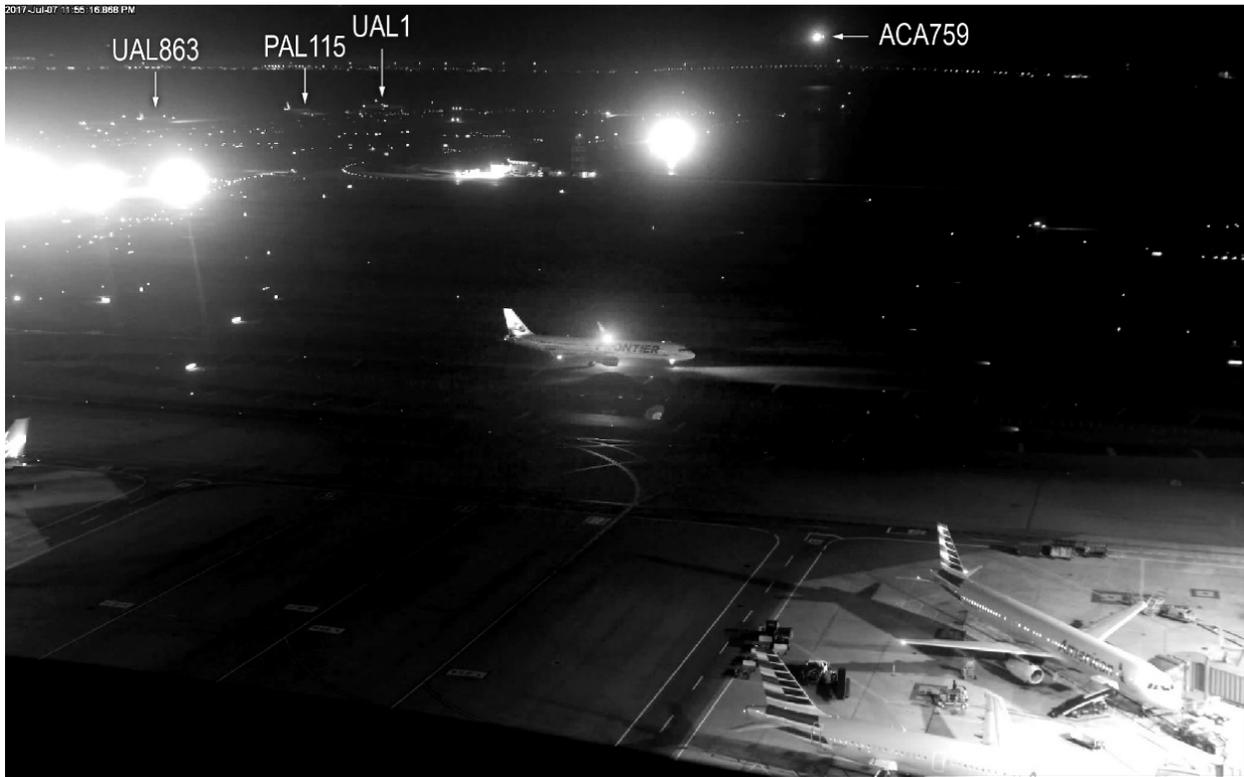
<sup>64</sup> The radar, which was about 10 nm from the incident location, updated data every 4.5 seconds.
