National Transportation Safety Board

Washington, D.C. 20594

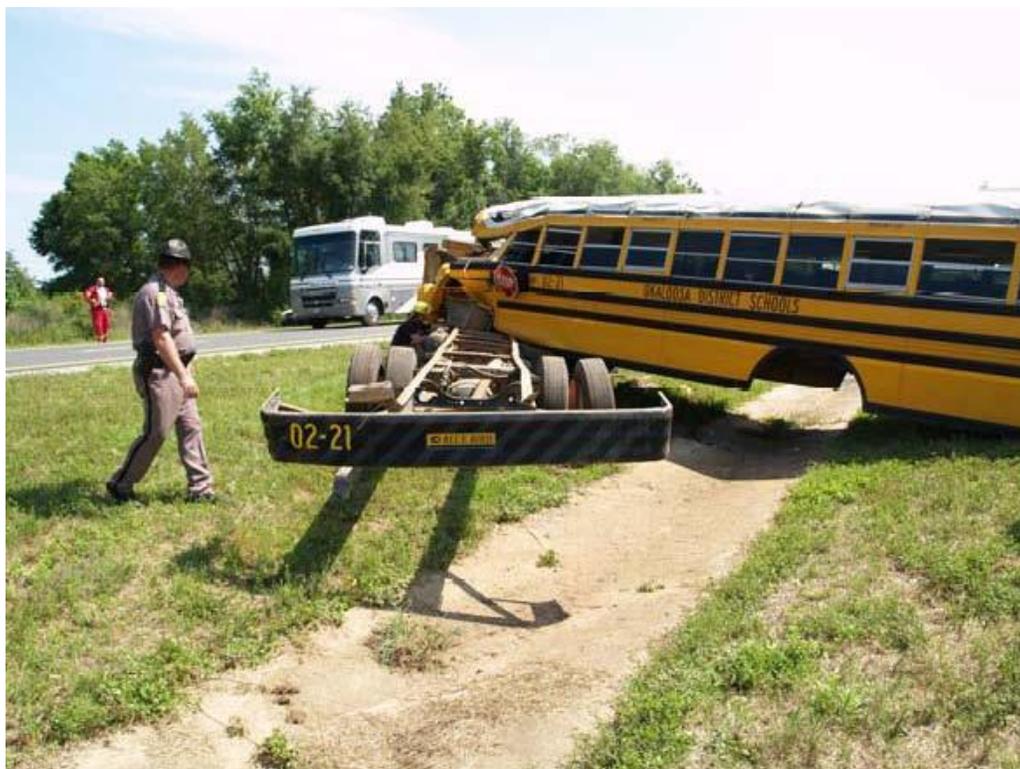
Figure 2. Final rest position of bus body and chassis.
