National Transportation Safety Board

Washington, D.C. 20594

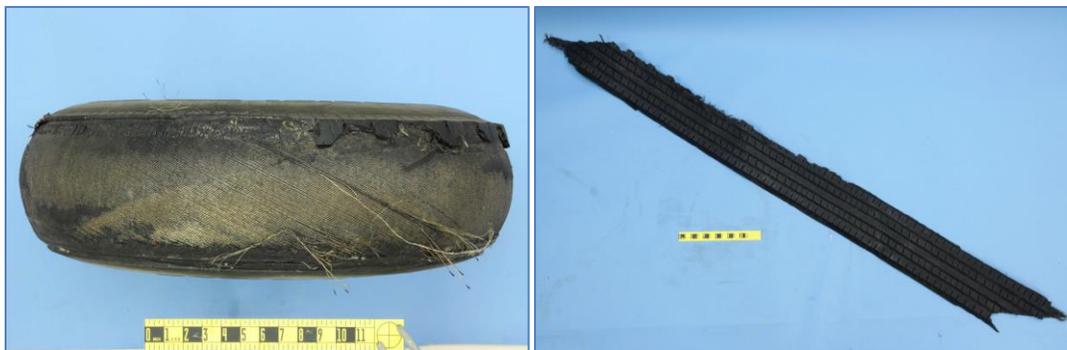
Figure 3. Tire crown from accident vehicle's left rear tire (left) and separated tire tread from left rear tire (right).

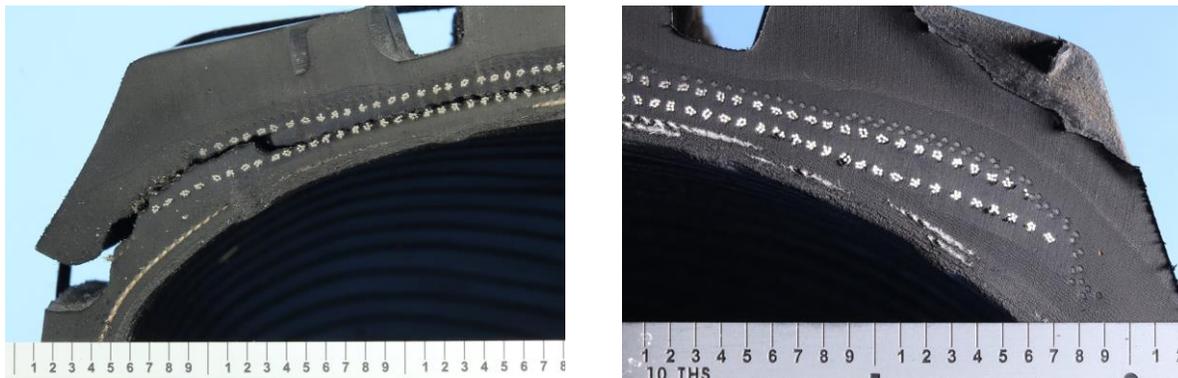
Figure 4. Cross-sectional images of outboard shoulders of left rear tire (left) and right rear tire (right).
