Amphibious Passenger Vehicle *DUCK 6*
Lane Crossover Collision With Motorcoach
on State Route 99, Aurora Bridge
Seattle, Washington
September 24, 2015

Accident Report

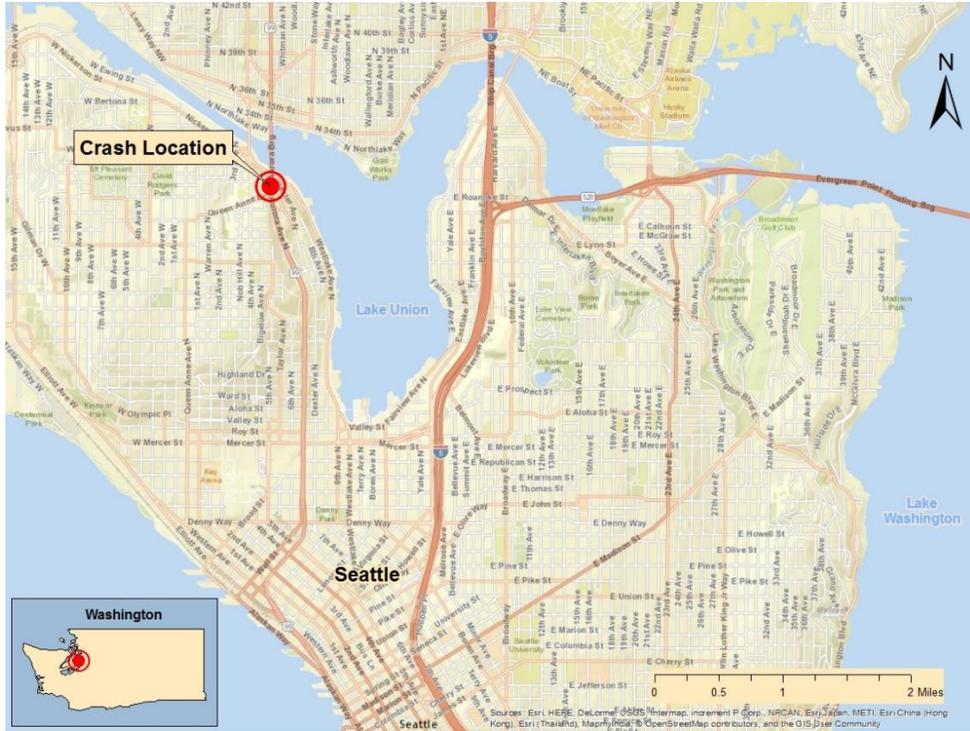
Figure 1. Crash location on SR-99 Aurora Bridge.

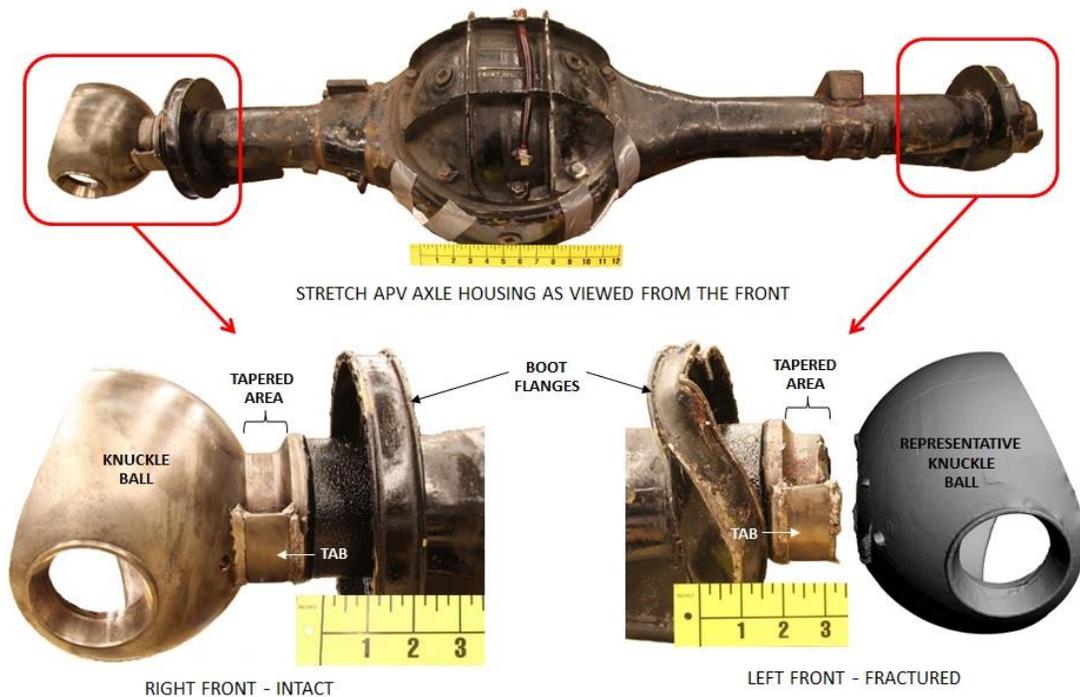
Figure 9. Top image shows front axle of the *DUCK 6* (as viewed from the front of the vehicle and looking rearward) with the two axle housings in their postcrash condition. Bottom images show the two axle housings (intact right housing is on the left and fractured left housing is on the right) in greater detail. (A “representative knuckle ball” image is used to indicate the damaged left knuckle ball.)

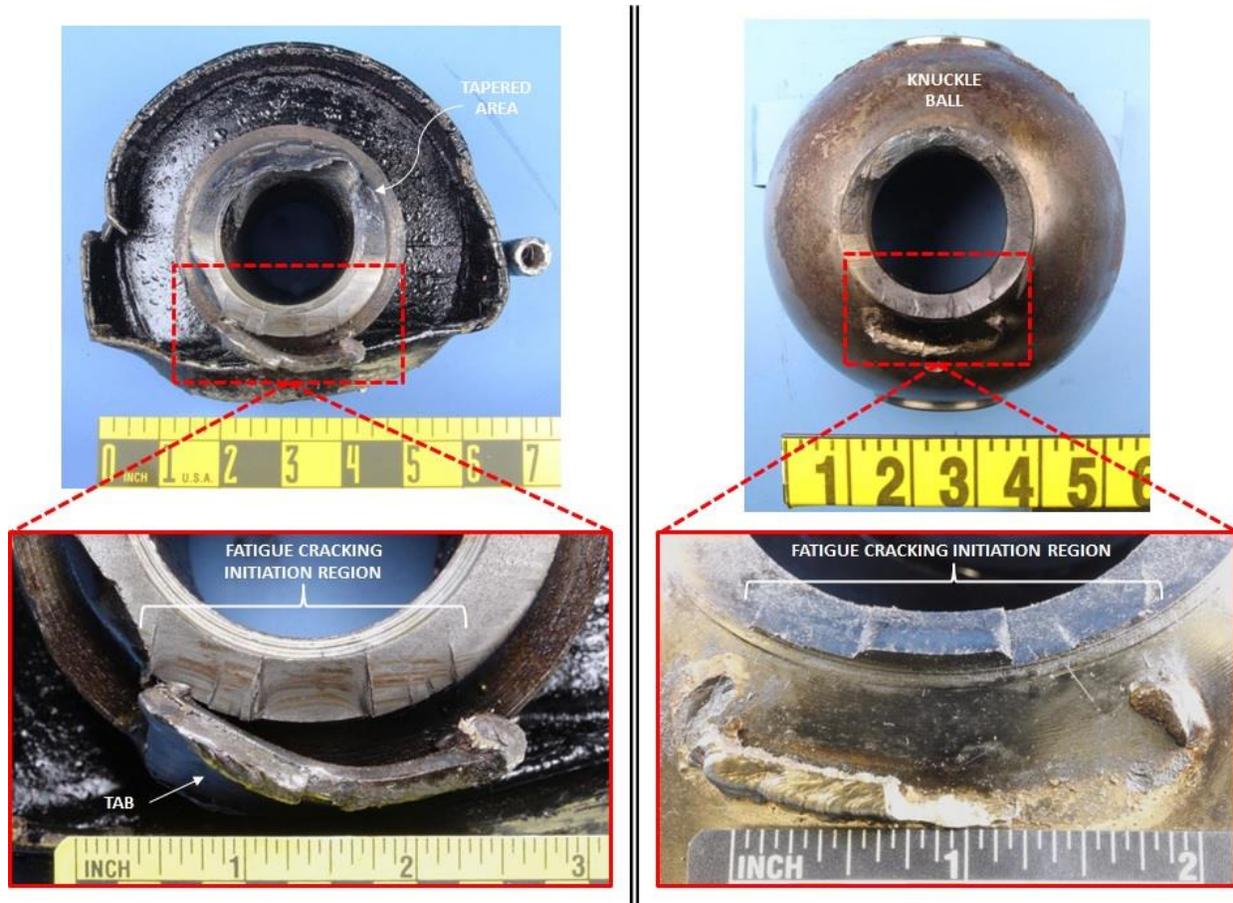
Figure 10. Mating fracture surfaces of the separated left side of the front axle housing. The images on the left show the fracture surface of the front axle housing in the taper area. The images on the right show the mating fracture surface on the knuckle ball of the front axle housing. The fatigue cracking initiation region is indicated on each fracture surface. The tab that separated at the outboard weld is also shown.

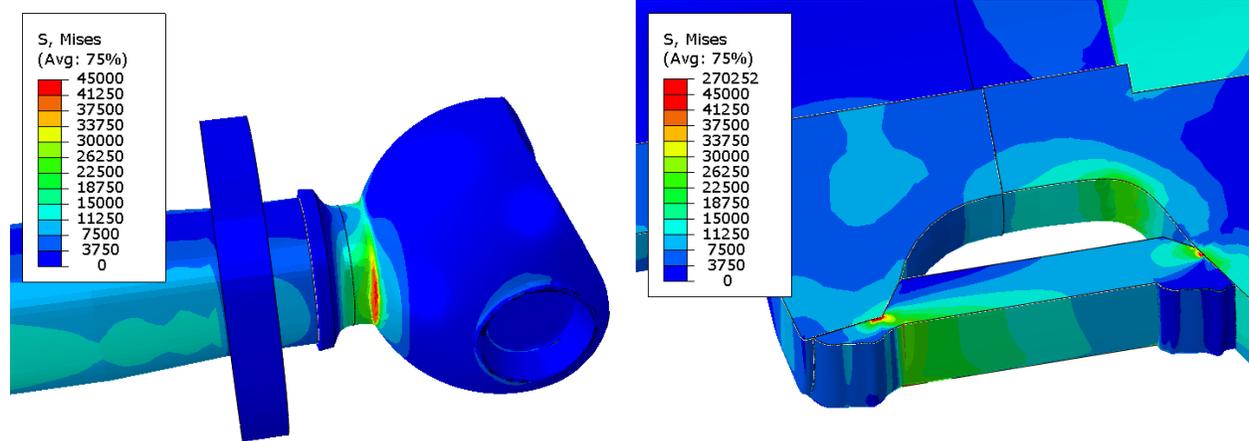
Figure 11. Mises stress distribution images. The left image depicts the Mises stress distribution in the vicinity of the left front axle transition region, rotated to show the bottom of the axle housing. The right image depicts a cross section, zoomed-in view of the Mises stress distribution in the vicinity of both the left front axle transition region and the tab modification welded to the bottom of the axle housing.

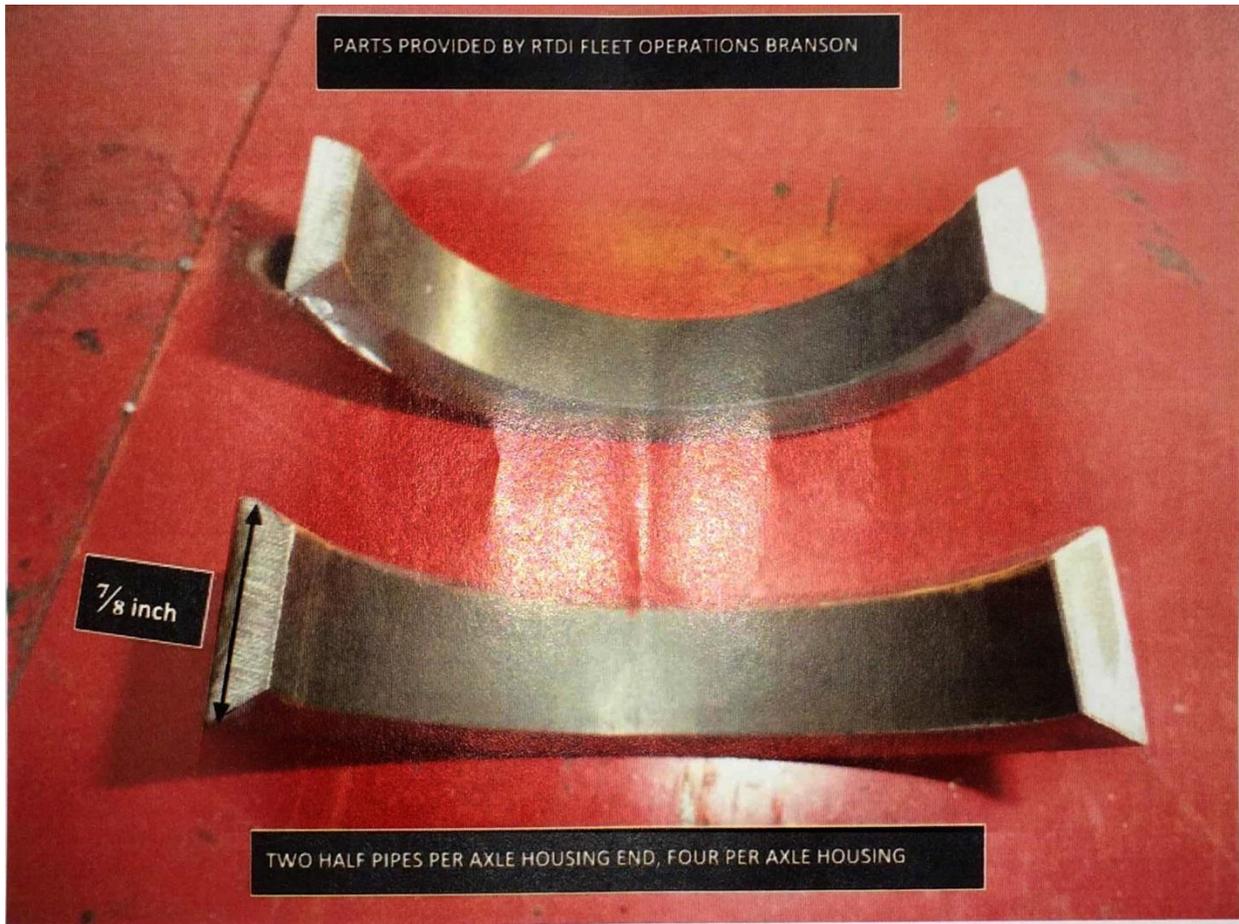
Figure 12. Image of collar assembly for recommended repair provided in SB-00-14-13 from RTDI.

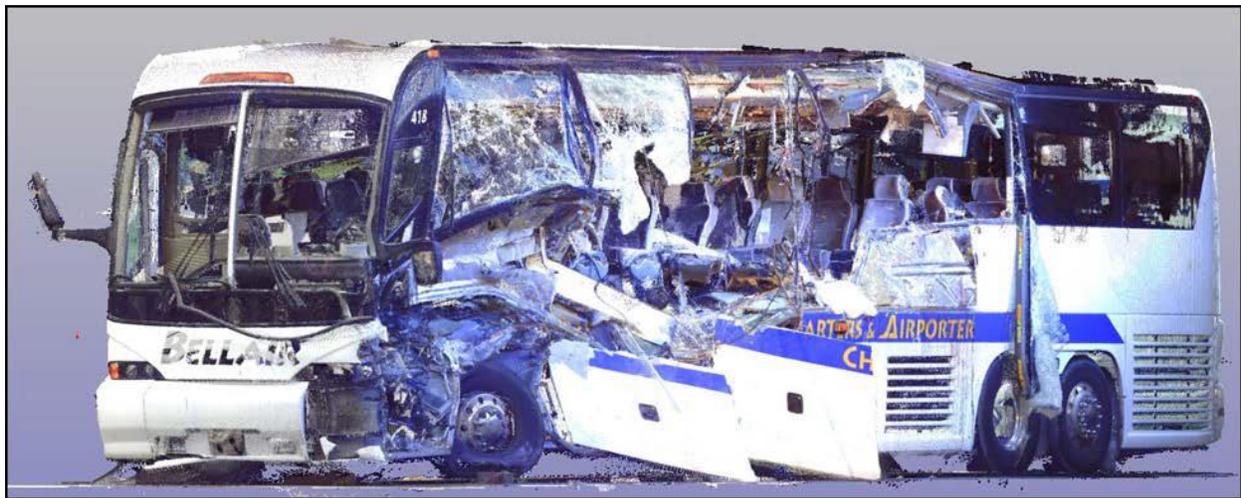
Figure 13. Colorized 3D postcrash scan of motorcoach.

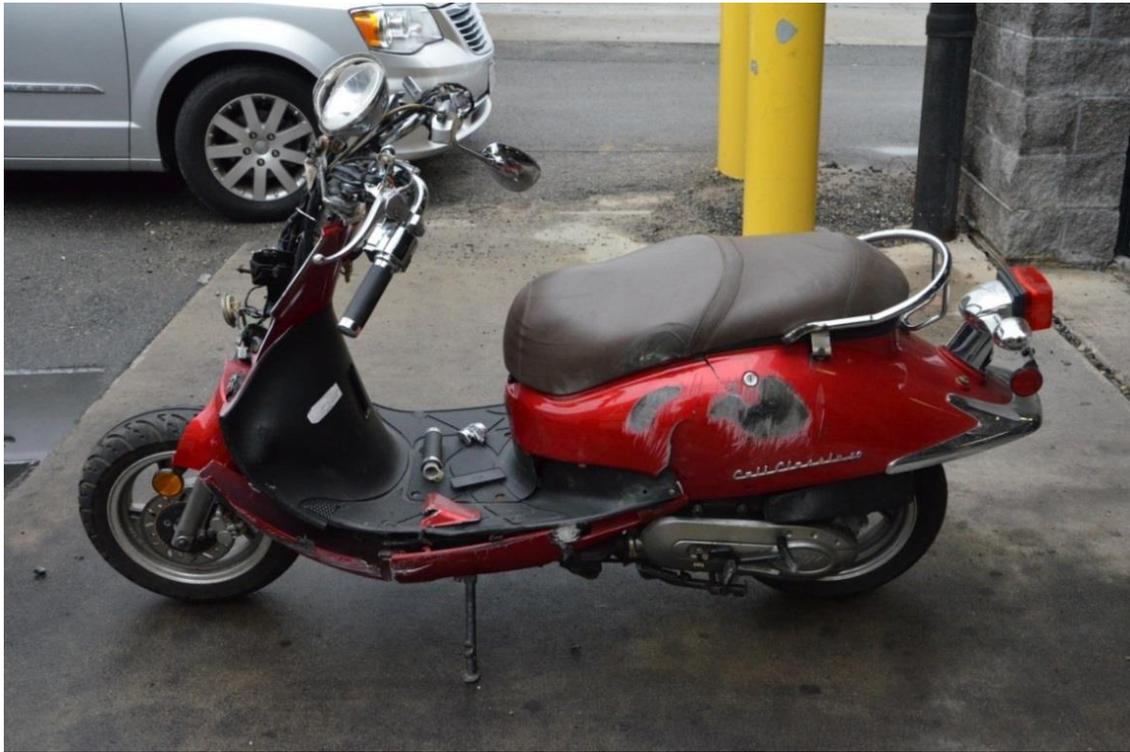
Figure 15. Boston crash motor scooter, showing damage.
