# National Transportation Safety Board

## Marine Accident Brief

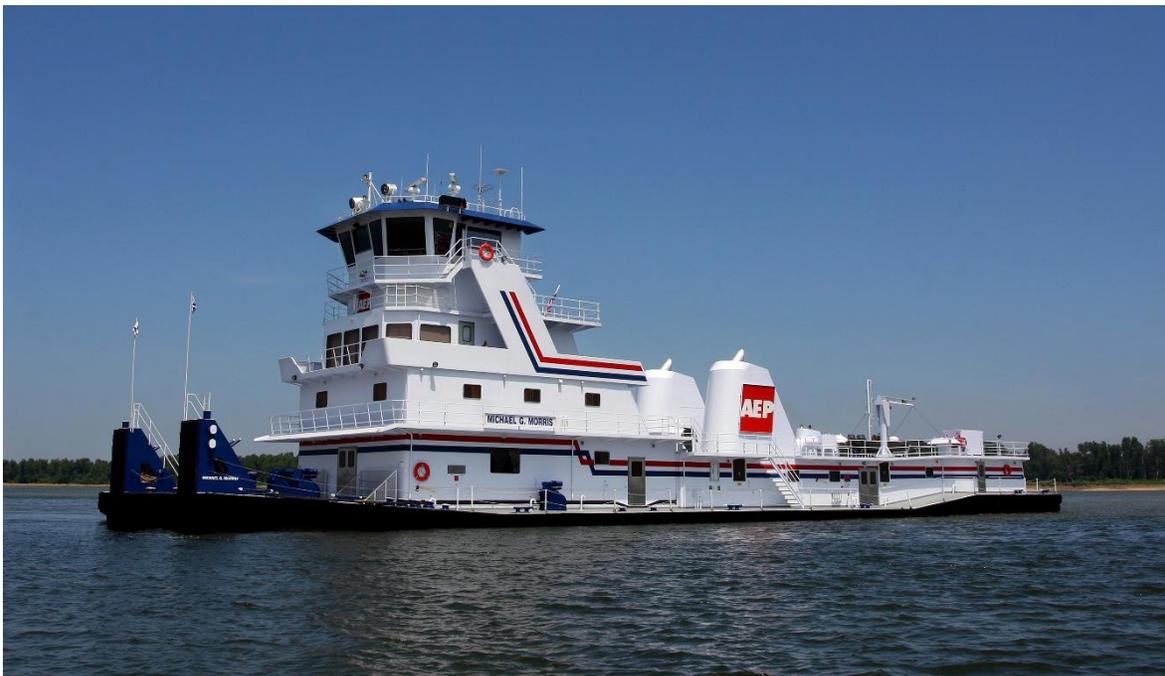
Towing vessel *Michael G Morris* under way. (Photo courtesy of AEP)
