January 30, 2025

# Container Loss aboard Containership *President Eisenhower*

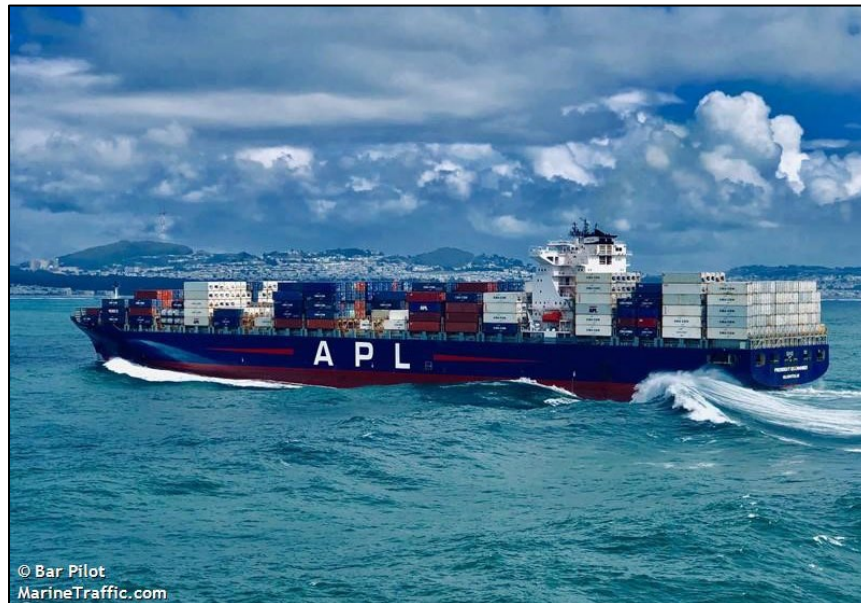
**Figure 1.** *President Eisenhower* underway at unknown date before the container loss. (Source: Bar Pilot, marinetraffic.com)

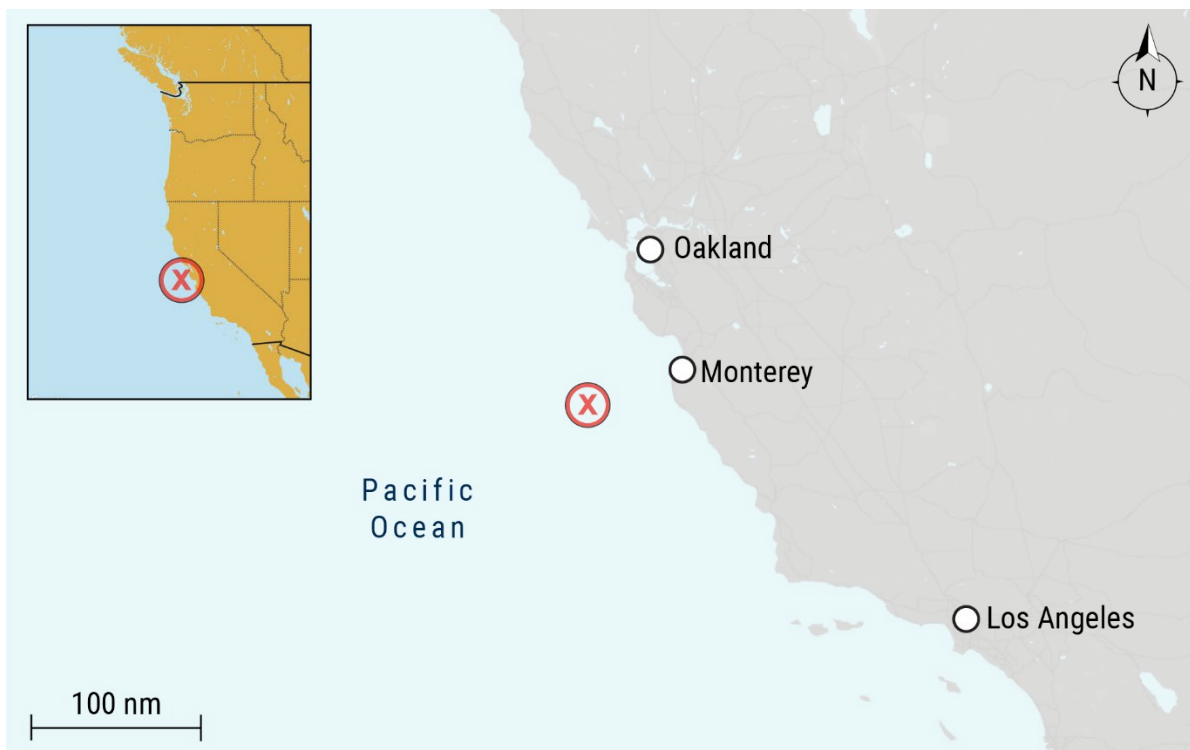
**Figure 2.** Area where the *President Eisenhower* container loss occurred, as indicated by a circled X. (Background source: Google Maps)

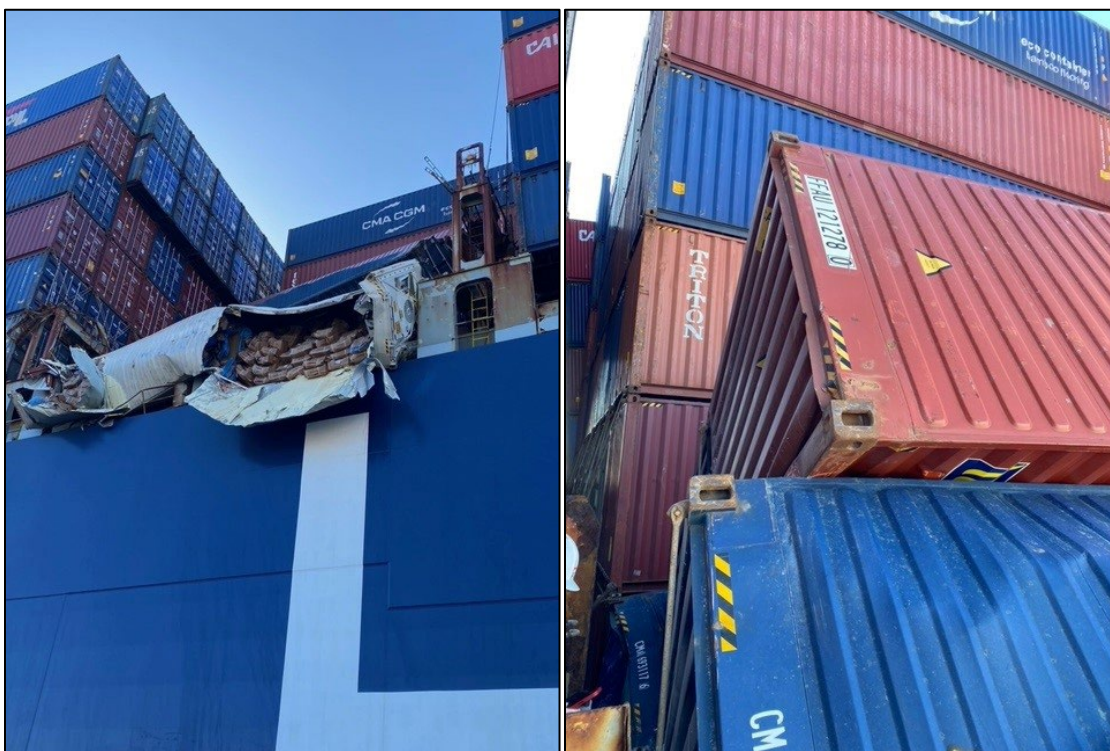
**Figure 4.** Left to right: Area of the container collapse in bay 42 on the port side of the *President Eisenhower* and closer view of collapsed containers in bay 42. (Source: Coast Guard)

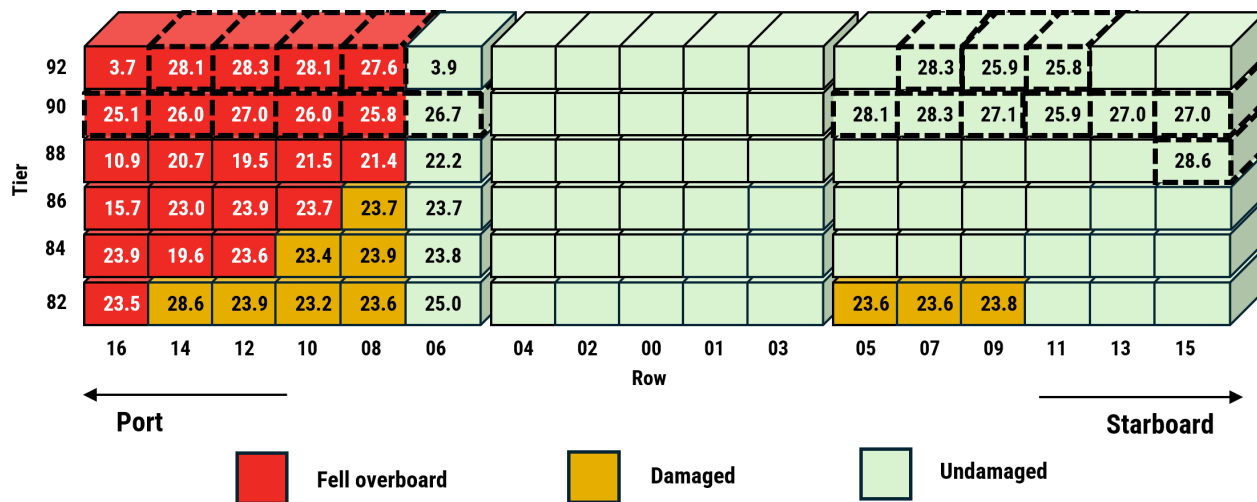
**Figure 6.** Bay 42 container stacks showing the location of the lost and damaged containers as well as the actual, shipper-provided VGM for each container in metric tons. The containers with the incorrect VGMs on the cargo loading plan are outlined with a dashed line.
