Collision of Two Union Pacific Railroad Freight Trains
Hoxie, Arkansas
August 17, 2014

Accident Report

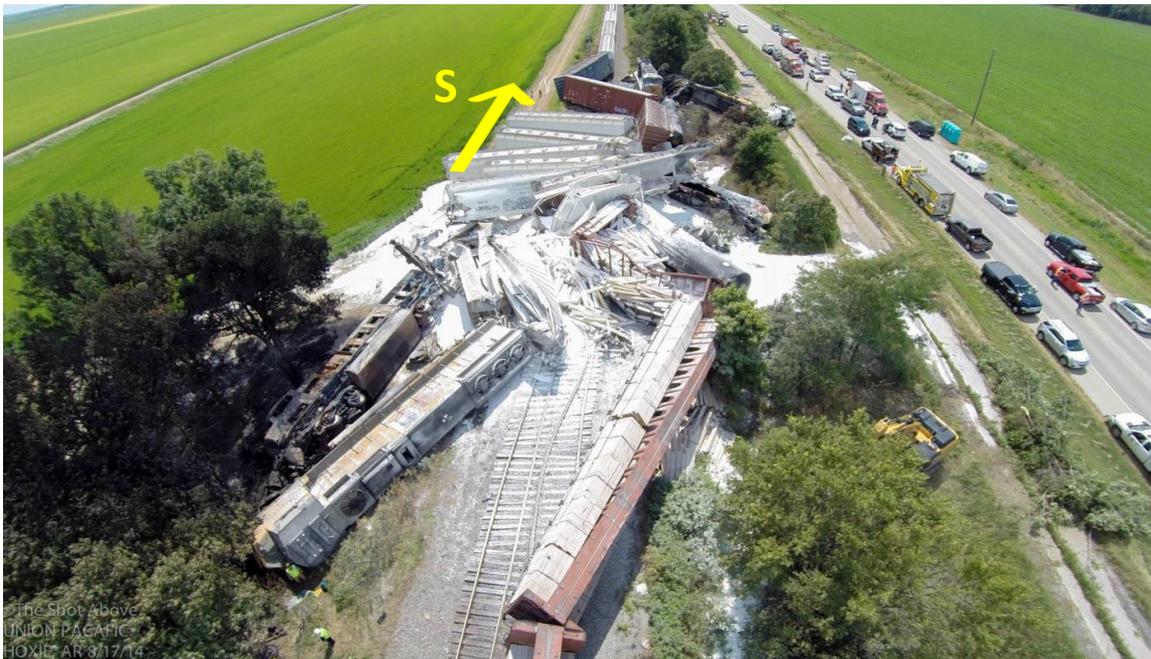
Figure 1. Collision at CP Y-229. (Photo courtesy of UP.)

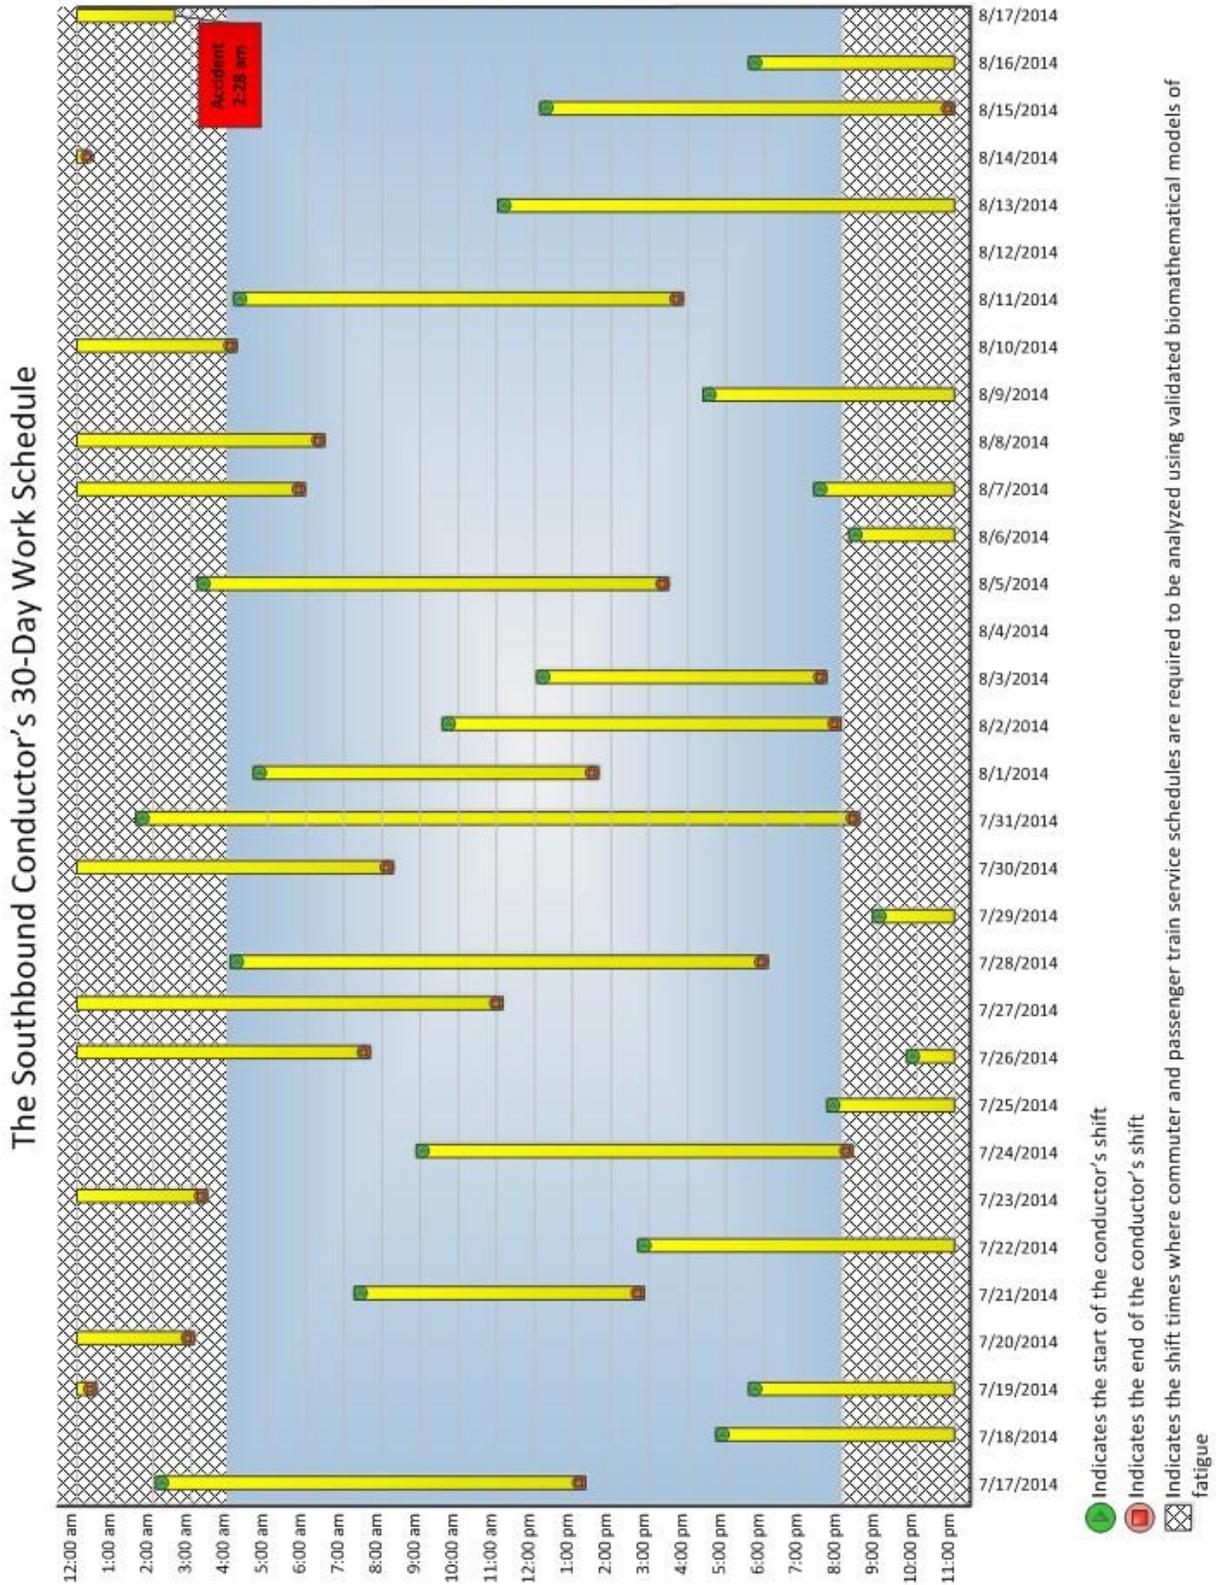
Figure 4. Southbound conductor's 30-day work schedule.

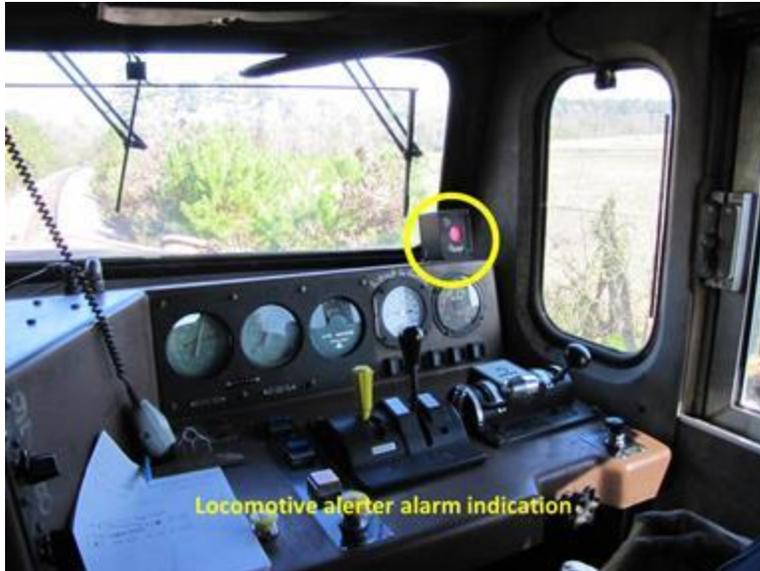
Figure 6. Exemplar locomotive alerter indication.
