*Office of Railroad, Pipeline &
Hazardous Materials Investigations*

**Collision of Metrolink
Passenger Train 111 and
Union Pacific Freight Train
LOF65-12**

**Chatsworth, California
September 12, 2008**

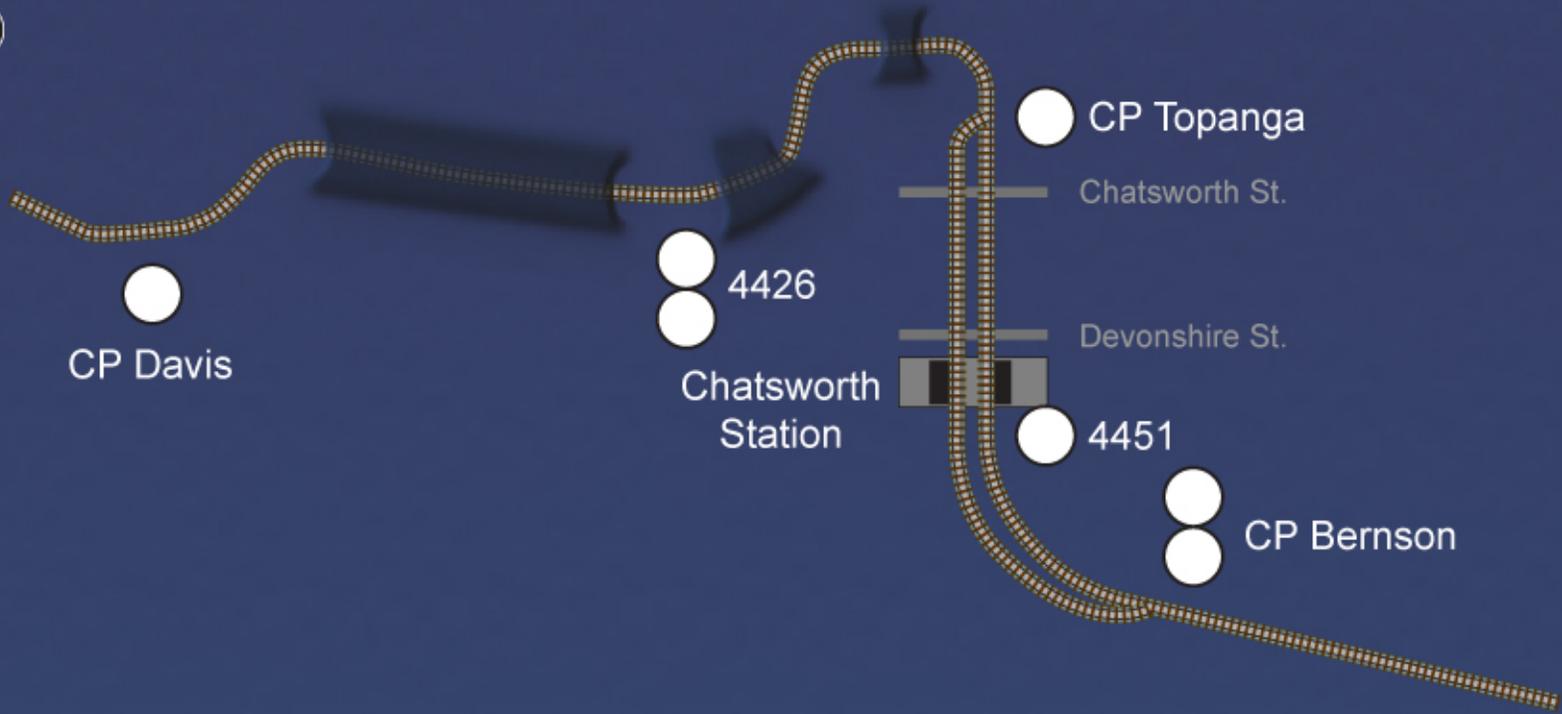
- Recorded data
 - Metrolink Dispatch Center
 - Wayside signal equipment
 - Locomotive event recorders onboard both trains
 - Locomotive forward video on UP train
- Track switch damage at Topanga caused by Metrolink train
- All recorded data and physical evidence consistent with the Metrolink train failing to stop at the red signal at Topanga
- Metrolink train continued along main track that was reserved for the UP train

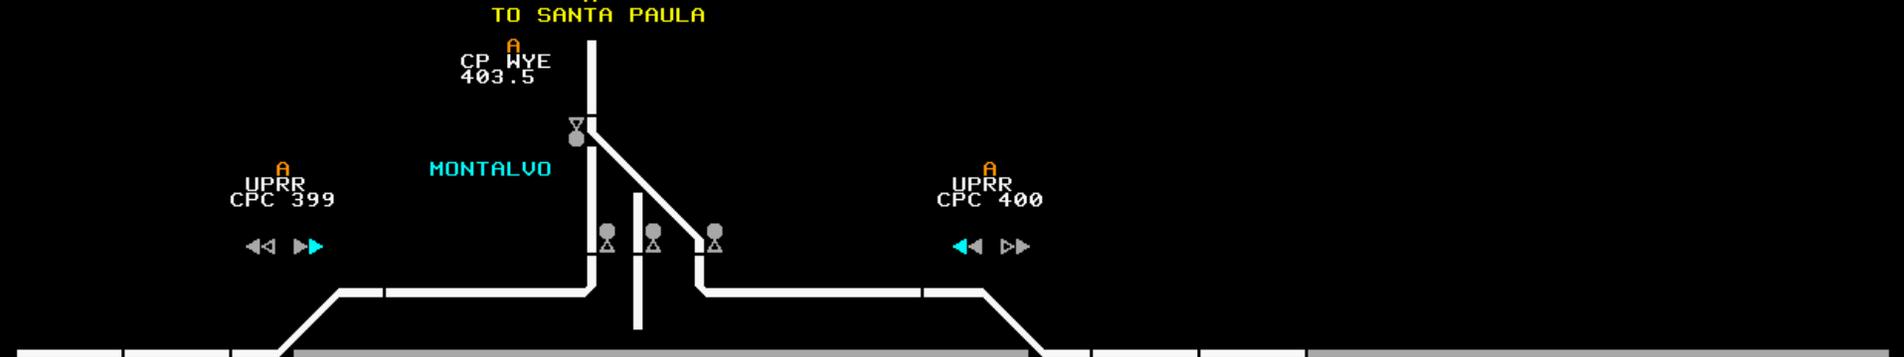
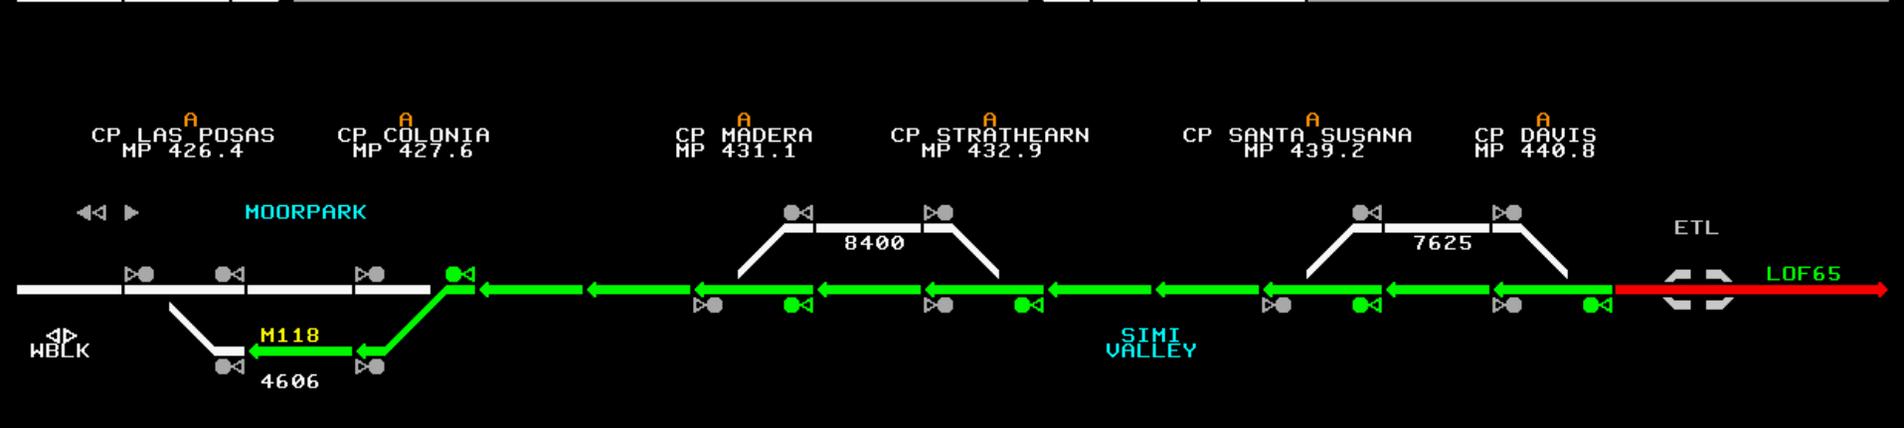
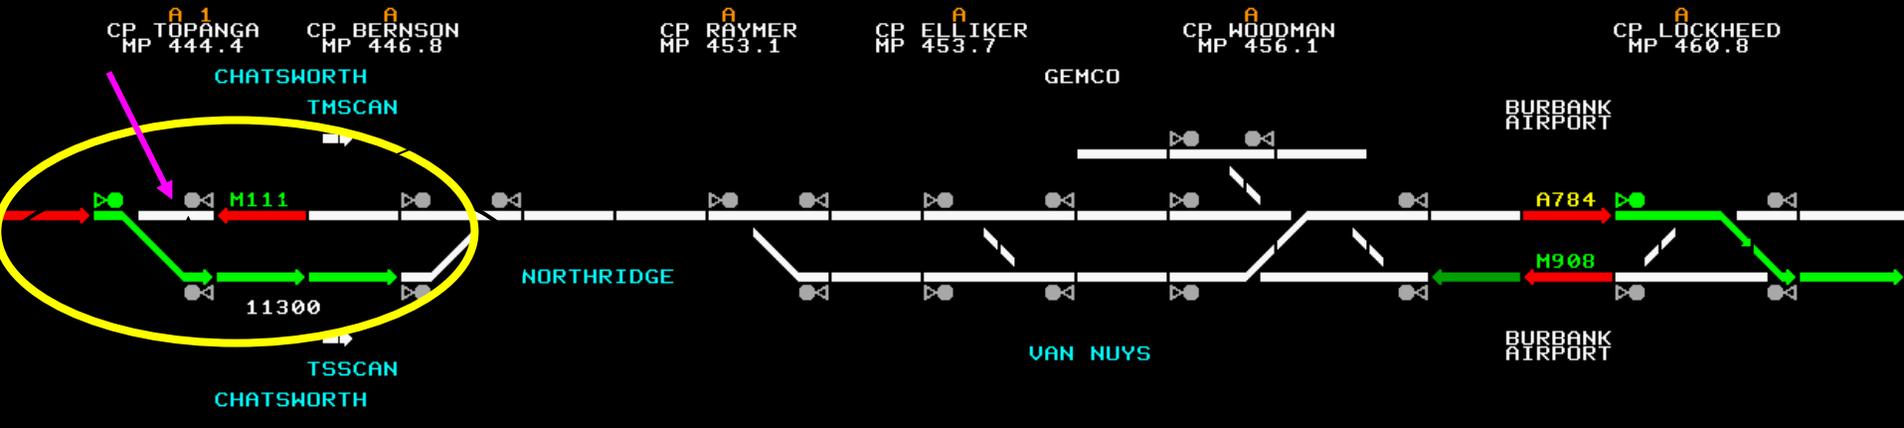
FAST ►► PAUSED MRZ DISP VENTURA DAVIS 25 TK OCCUPY INDICATION 9/12/08 4:20:22P

- Extensive testing and examination of all recorded data show track and signal systems functioning properly
- Recorded data from the Metrolink Dispatch Center and wayside signal equipment show signals were set 6 minutes before the Metrolink train approached the area

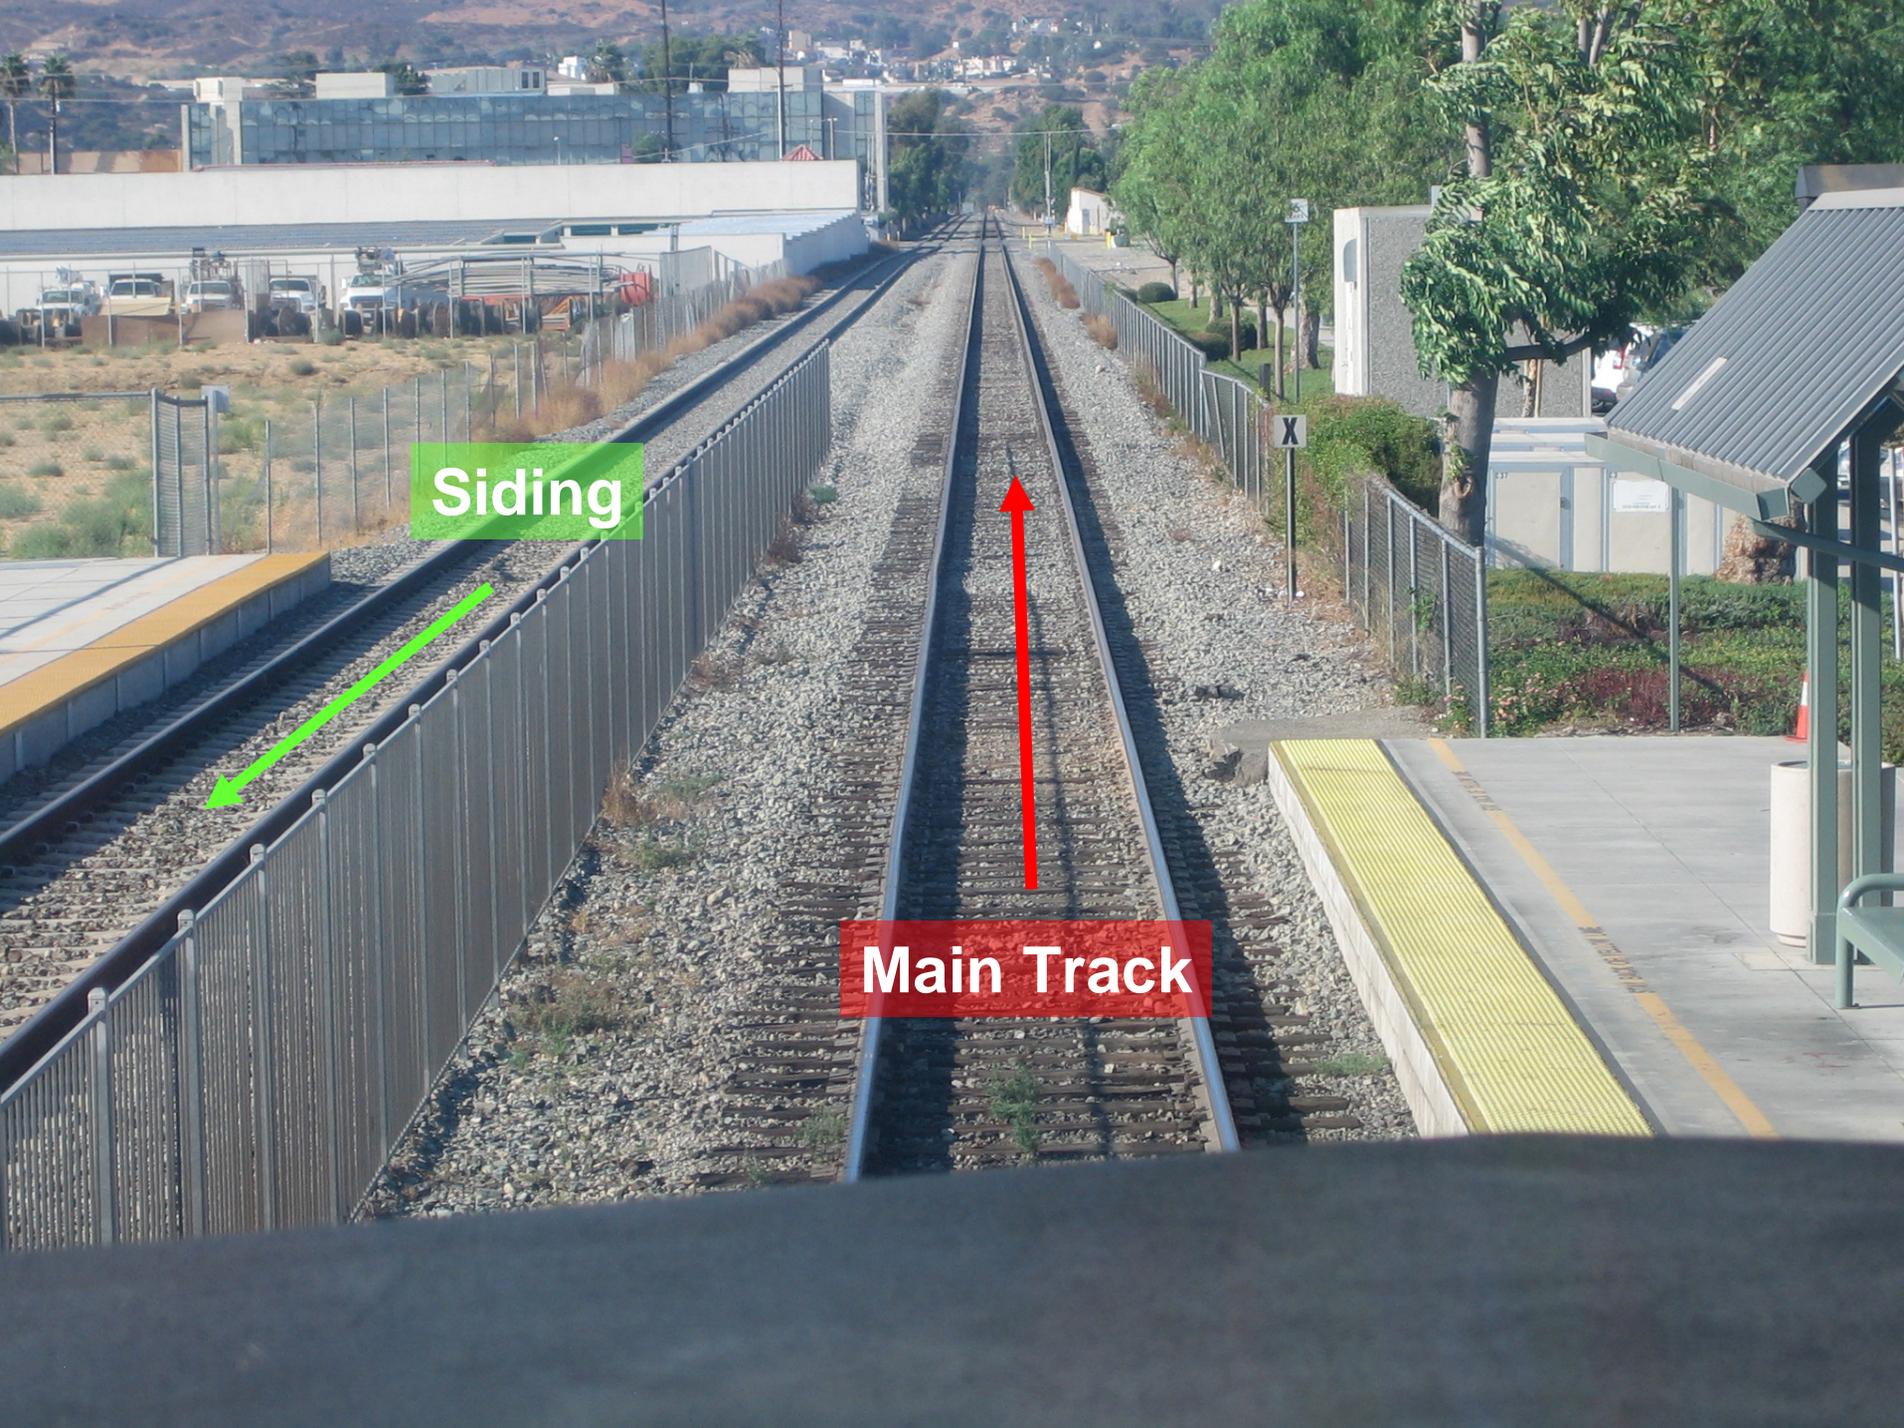
Siding

Main Track

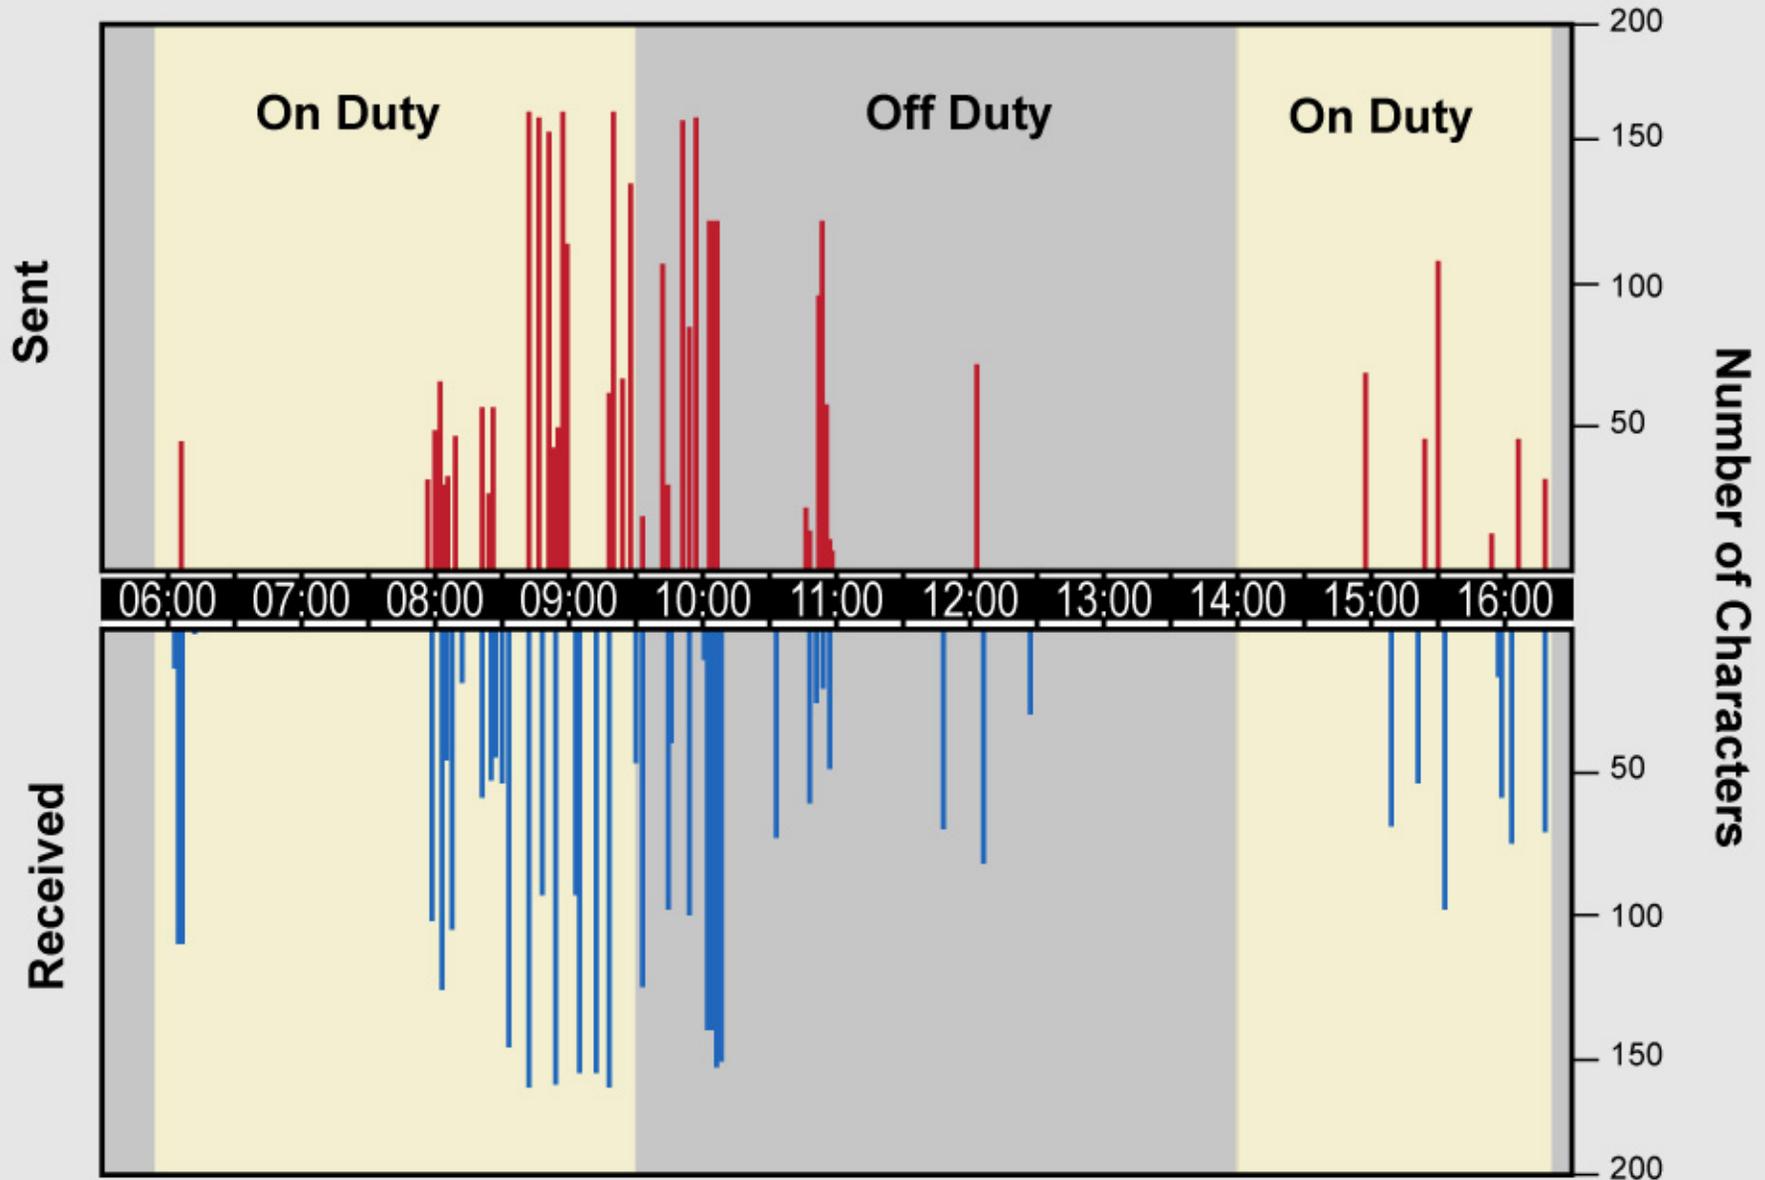
Metrolink Engineer's Text Messages

- Metrolink engineer's cell phone calls and text messages collected from the service provider
- Records show the Metrolink engineer sent and received numerous text messages while on duty
- Metrolink engineer's last text message was sent shortly before the accident while the train was in motion
