NTSB National Transportation Safety Board

Mexican Hat, Utah

Motorcoach Overturn

January 6, 2008

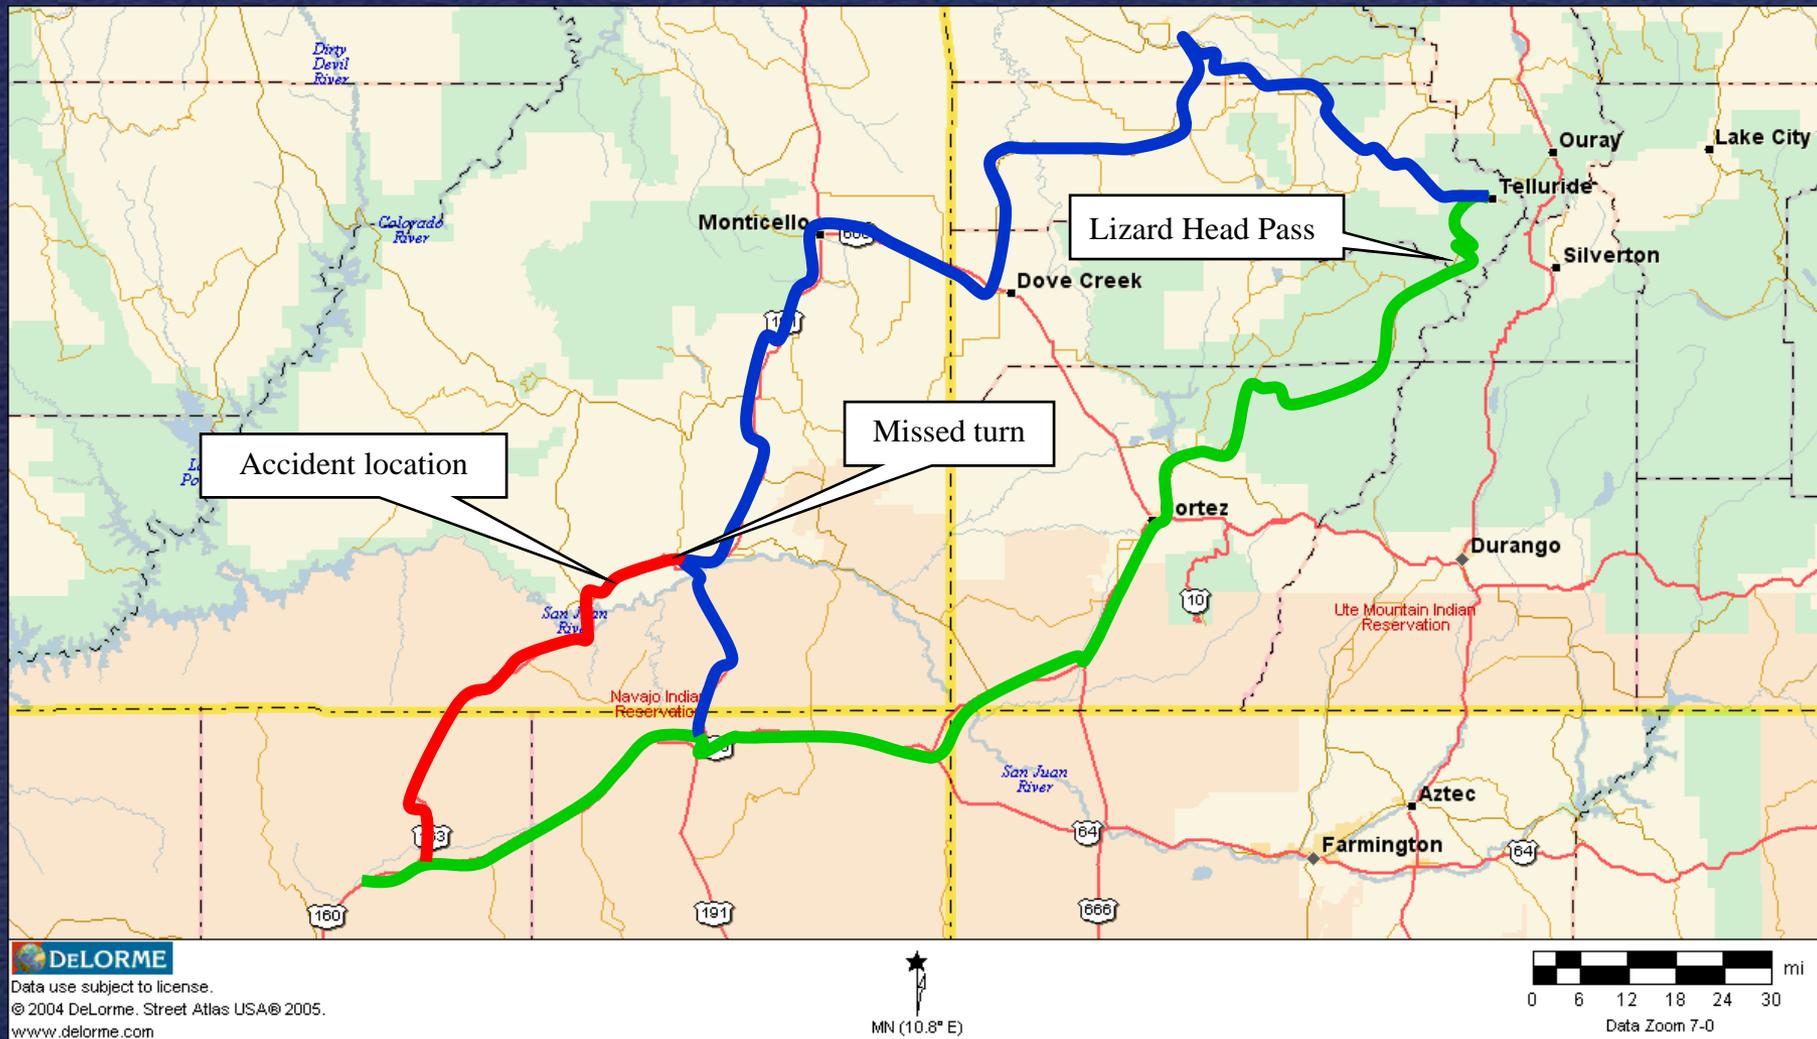
Accident Trip

- Departed Telluride, Colorado, at 3:15 p.m.
- Removed tire chains outside Telluride
- Driver missed turn
- Continued straight on Utah U.S. Route 163
- Accident occurred at 8:02 p.m.

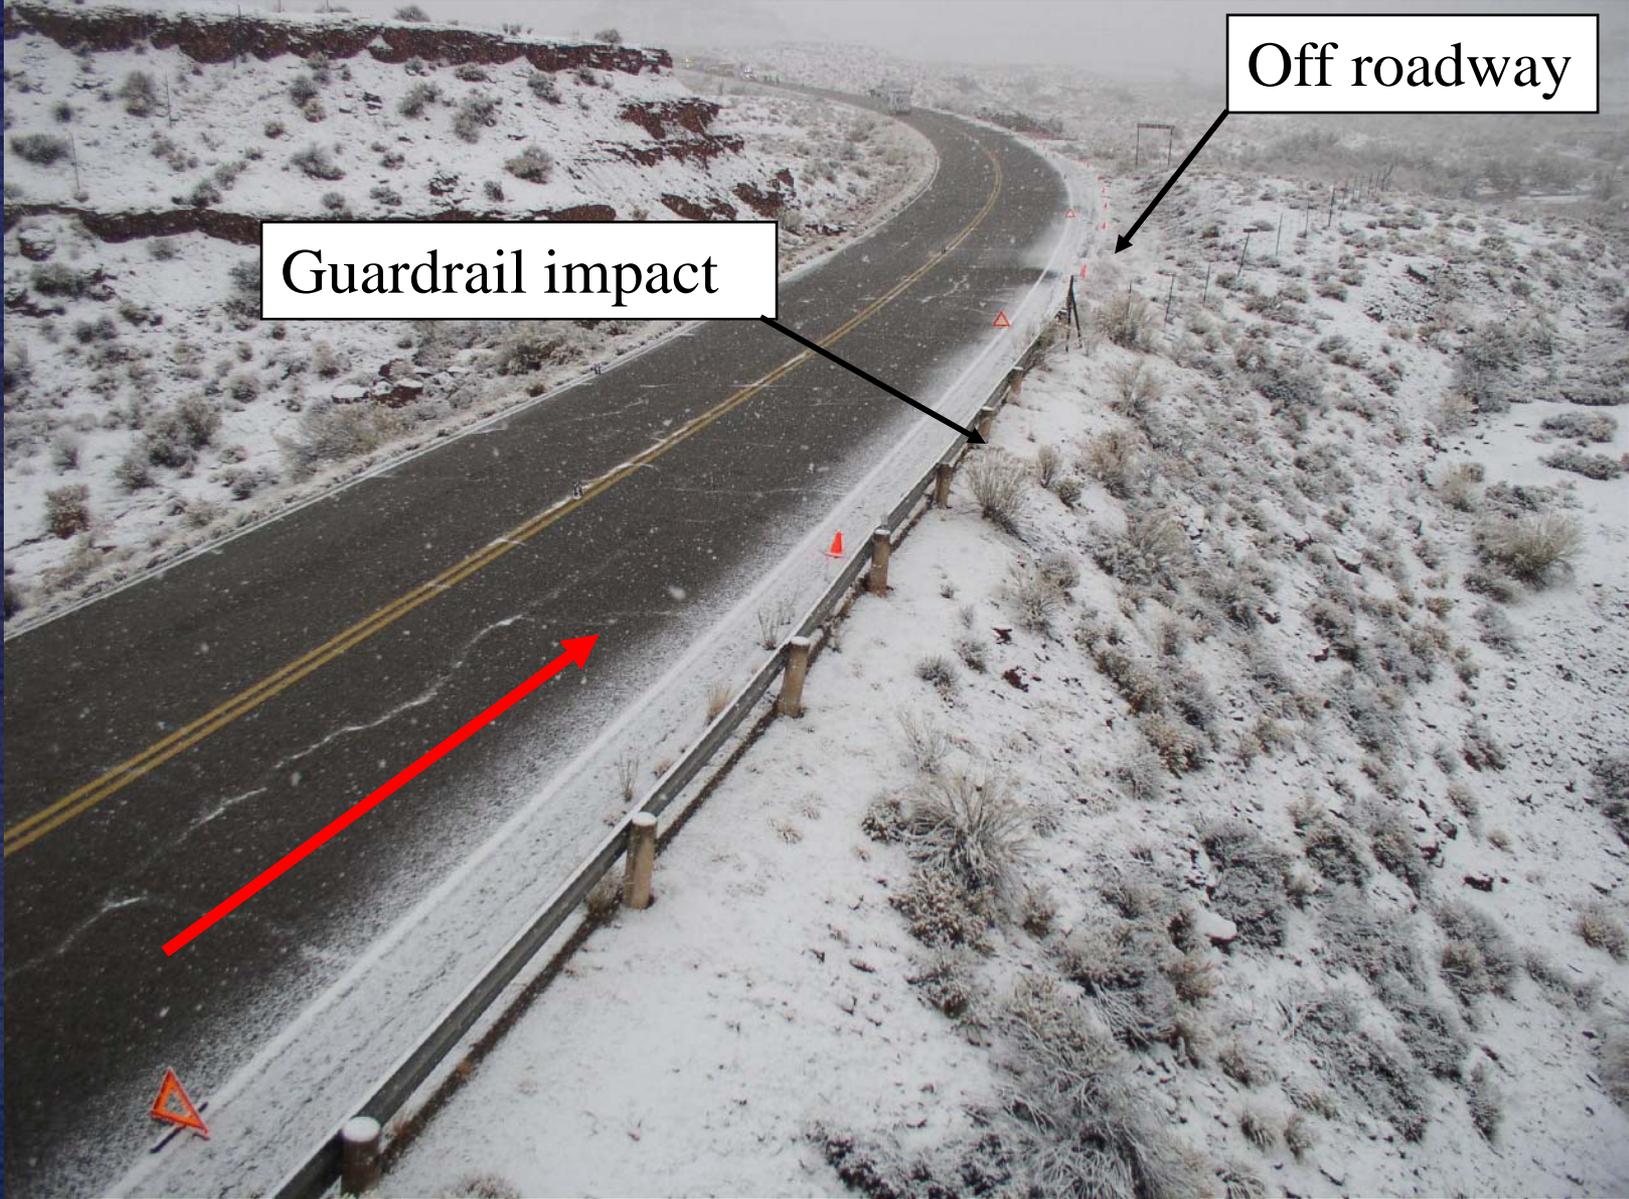
Off roadway

Guardrail impact

- Roof separated from motorcoach during rollover sequence
- 51 of 53 occupants ejected

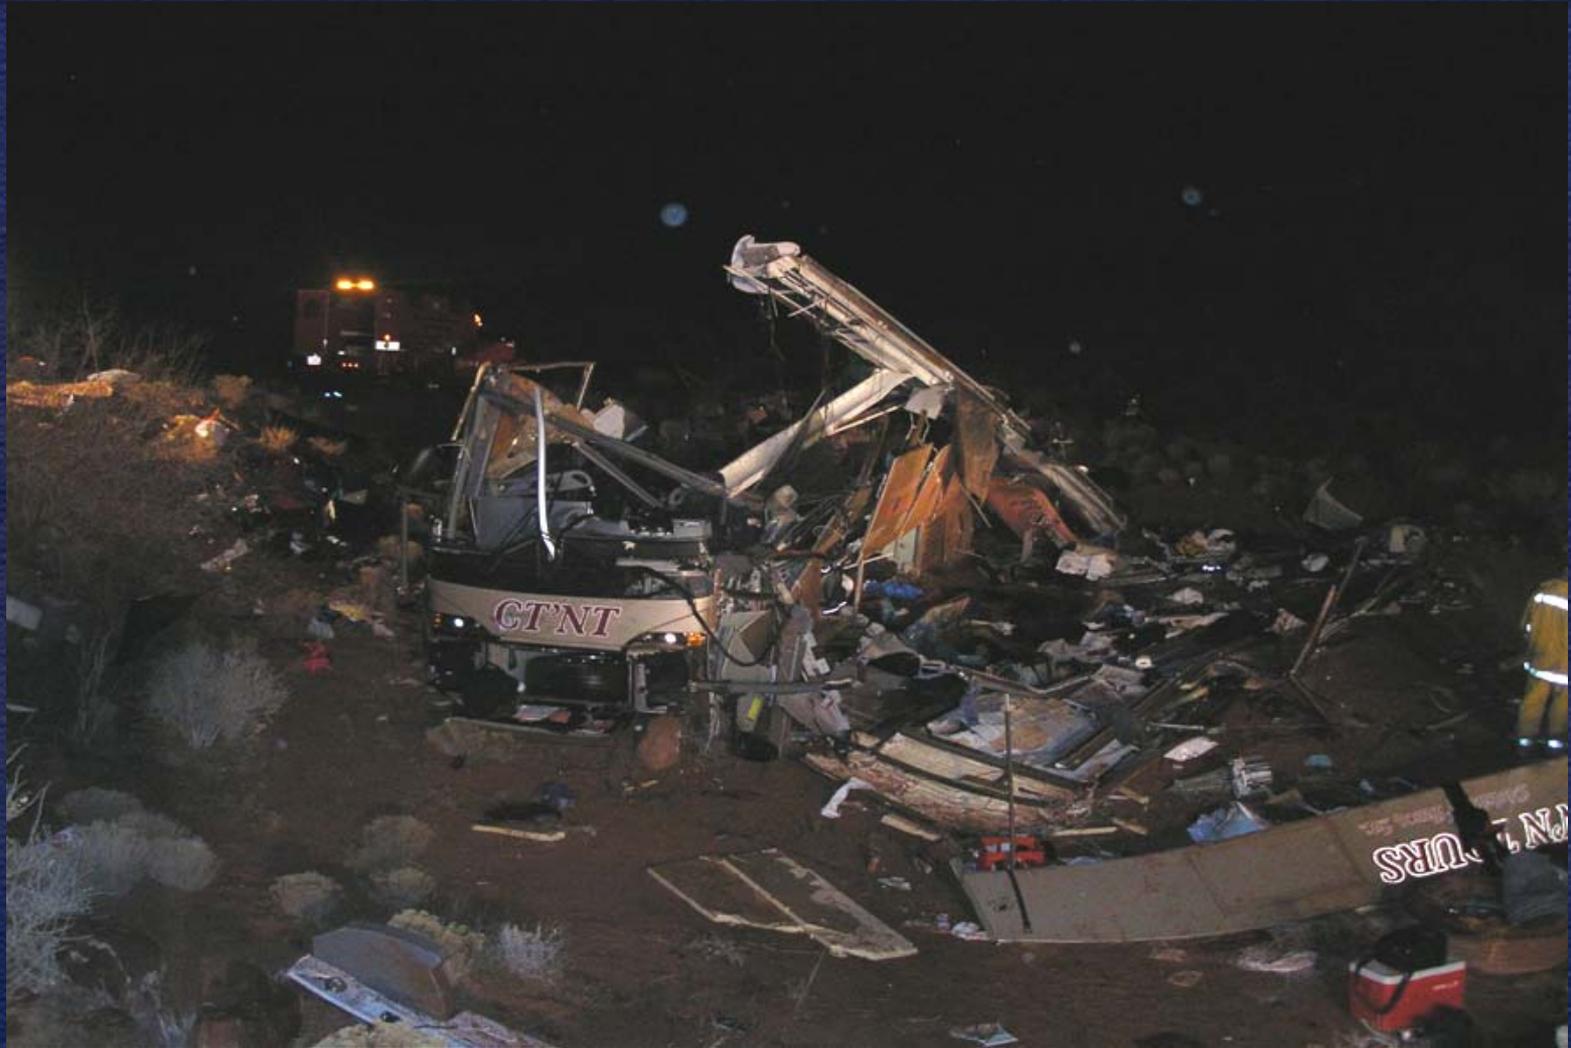
Accident Description

- Motorcoach equipped with a video recording device
- Forward-facing view
- Rear interior view
- Acceleration and turning forces

- Forward-facing view of the motorcoach as it approached curve
- Motorcoach moves right of center line

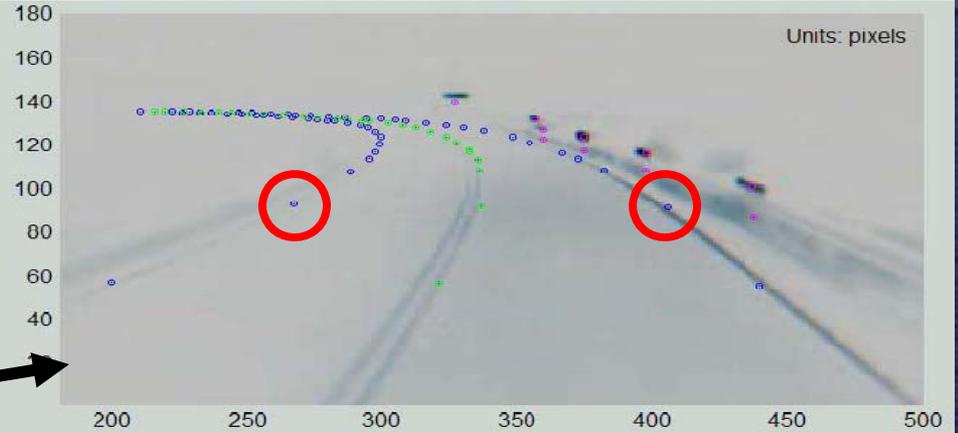
Video forward view

- RE staff developed a video analysis program
 - Referenced points
 - Time of video image
- Speed determined to be 88–92 mph
